# INITIAL FIRE ASSESSMENT REPORT (FAR)

Factory Name: **THE CIVIL ENGINEERS LIMITED**

Assessor: **Bureau Veritas**

Date: **18 May 2014**

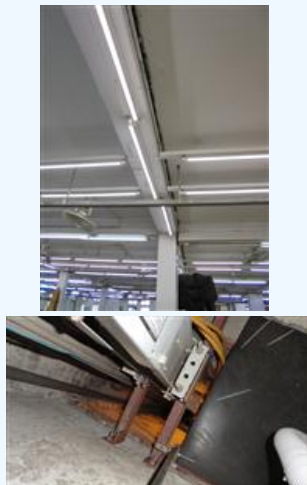
| Description: | There are non-rated openings with the production area through partition walls in every store and also the dining area on the 7th floor has an opening through the rated wall separated to the production area. | |
| Source of Findings: | Visual Assessment: Unprotected openings were found at different locations. | |

| Suggested Plan of Action: | Close all windows and other openings on all the fire rated wall across the entire premises, or protect the penetrations of fire resistive rated assemblies with a listed through penetration fire-stop system tested in accordance with ASTM E814. | |

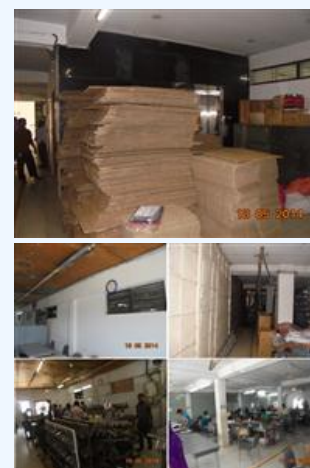
| Description: | No occupancy certificate is available for any building in the factory premises. |
| Source of Findings: | Document Review: There was no occupancy certificate for any of the buildings among the documents shown by the factory concerned people. |

| Suggested Plan of Action: | Apply to Rajuk for issuance of occupancy certificate and pursue the matter to expedite. |
