# INITIAL STRUCTURAL INTEGRITY ASSESSMENT REPORT (SIAR)

Factory Name: **Orchid Garments Ltd**  
Address: **Degerchala Road, Choidana, National University,  
Gazipur Gazipur Dhaka Bangladesh**  
Assessor: **Emkay Enterprises LTD**  
Date: **26 Feb 2014**

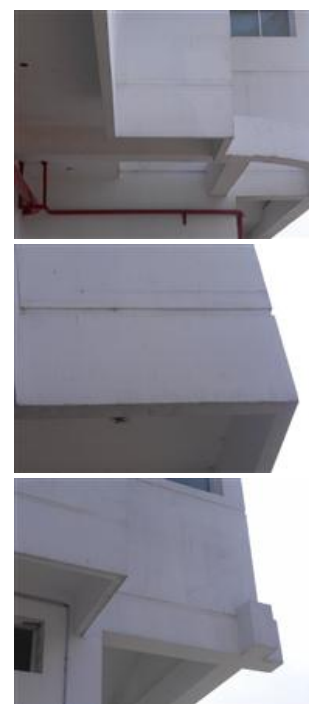
| Description: | Alliance Standard Part 8 Section 8.2 Exterior facade crack found in the front side cantilever portion in the 1st floor. |
| Source of Findings: | Photograph: Crack in the front side exterior facade in the first floor |
