# INITIAL STRUCTURAL INTEGRITY ASSESSMENT REPORT (SIAR)

Factory Name: **SEA BLUE TEXTILE LIMITED**

Assessor: **BD Technologies**

Date: **02 Apr 2014**

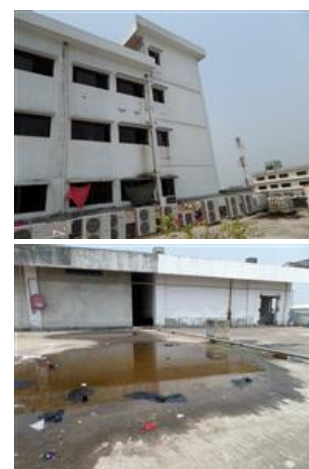
| Description: | Standing Water was found on roof-top of Building no.3 & Building no.4. Efflorescence / dampness in infill brick wall at 4th floor of building. no.4. Exposed hole in columns for wiring. |

| Suggested Plan of Action: | Under guidance from a qualified structural engineer, address all areas of needed maintenance by correcting the identified issues. |

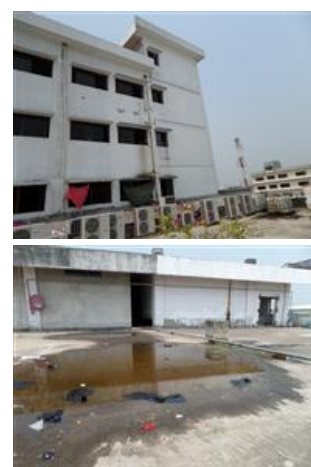
| Description: | All the top roof slab of three (1,2,3 no) buildings are constructed with MCAC exposed to rainfall or other sources of water like leakage of water supply pipe network (see photo) are not sealed with a protective coating to prevent water intrusion. |

| Suggested Plan of Action: | Provide a protective coating at the structural elements constructed with MCAC exposed to rainfall or other sources of water. Have protective coating approved by the Alliance or a qualified structural engineer |
