# INITIAL STRUCTURAL INTEGRITY ASSESSMENT REPORT (SIAR)

Factory Name: **DNV CLOTHING LTD**

Assessor: **Walter P. Moore**

Date: **26 Jun 2013**

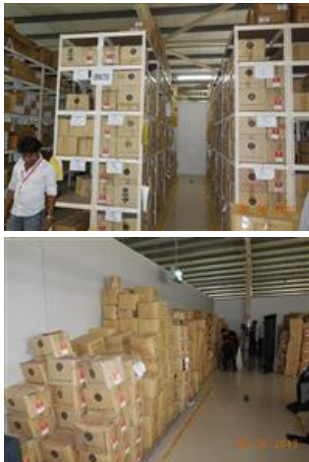
| Description: | On Level 4 (third floor) of the main factory building, the storage of work materials and products creates a floor loading the almost certainly exceeds the design live load capacity of the structure. Specifically, the 10 foot tall storage racks and the 6 foot tall box stacks. | |

| Suggested Plan of Action: | Have a qualified structural engineer confirm that capacity to support the load is available. Load Plans complying with Alliance Standard Part 8 Section 8.20.4.3 should also be developed. | |
