INITIAL STRUCTURAL INTEGRITY ASSESSMENT REPORT (SIAR)

Factory Name: **MAHDEEN SWEATERS LTD**

Assessor: **Bureau Veritas**

Date: **09 Jun 2014**

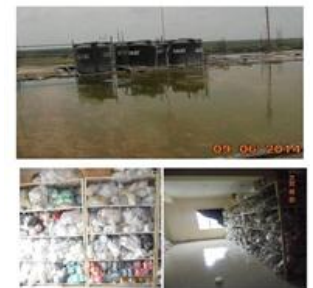
Question:	Are all non-structural elements suspended from, attached to, or resting atop the structure adequately anchored and braced to resist earthquake forces?
Priority Level:	Medium
Non-Compliance Level:	1
Description:	In the store room, there are racks which are not braced for earthquake force. Also, there are 12 plastic water tanks with considerable height, which are not braced adequately to resist earthquake forces.
Source of Findings:	Visual Assessment: Visual inspection conducted.
Suggested Plan of Action:	Adequately anchor and brace all non-structural elements to resist earthquake forces to comply with the BNBC and Alliance Standard.
Suggested Deadline Date:	15 Sep 2014
Standard:	Alliance Standards Part 8 Section 8.18 Seismic Bracing of Key Non-Structural Elements and 2006 BNBC Part 6
