# INITIAL ELECTRICAL ASSESSMENT REPORT (EAR)

Factory Name: **Brandix Casual Wear Ltd**  
Address: **Plot No 61-71+85 Comilla EPZ Comilla Chittagong  
Bangladesh**  
Assessor: **Bureau Veritas**  
Date: **07 Jun 2014**

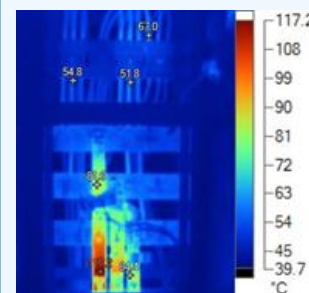
| Description: | Electrical cables are not sized according to capacity of circuit breakers. Location: DB-Finishing-Shed-2, DB-Washing-1-Washing-Shed-2, DB-Compressor-Compressor Room-Utility, MDB-2-Fabric Store-Shed-1, MDB-Pump-Pump Room, DB-Washing-1-Washing-Shed-2, DB-Washing-2-Washing-Shed-2, DB-PDB-1-Sewing-Shed-1, DB-PDB-2-Sewing-Shed-1, DB-L3-Sewing-Shed-1. |

| Source of Findings: | Photograph: Higher rated circuit breakers with lower rated wiring. | |

| Suggested Plan of Action: | Consult with a qualified Electrical Engineer and ensure electrical wiring and cables are sized according to capacity of circuit breakers. | |
