# INITIAL STRUCTURAL INTEGRITY ASSESSMENT REPORT (SIAR)

Factory Name: **Ratul Knitwear**  
Address: **CS, SA-41, Zirabo, Ashulia, Savar Ashulia, Savar  
Dhaka Bangladesh**  
Assessor: **EIMS**  
Date: **23 Apr 2014**

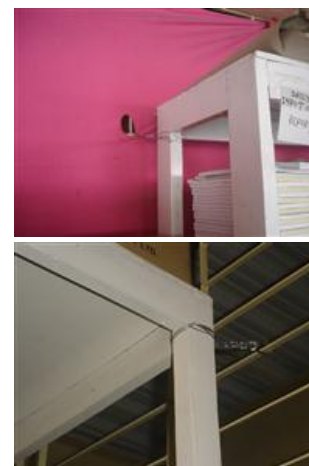
Question:	Are all non-structural elements suspended from, attached to, or resting atop the structure adequately anchored and braced to resist earthquake forces?
Priority Level:	Medium
Non-Compliance Level:	1
Description:	We found un-braced rack in first floor of the main building during inspection. However, racks were already anchored (photograph attached). Review the observed correction by an engineer.
Source of Findings:	Photograph: Photograph of anchored non-structural elements, Visual Assessment: Factory visited on April 23, 2014
Suggested Plan of Action:	Have an engineer review the observed correction.
Suggested Deadline Date:	17 Jun 2014
Standard:	Alliance Standards Part 8 Section 8.18 Seismic Bracing of Key Non-Structural Elements and 2006 BNBC Part 6
