Islam Knit Designs Ltd. (Unit-2)

301 NOYAPARA, KASHIMPUR, GAZIPUR
(23.989034N, 90.318997E)
23rd May 2017

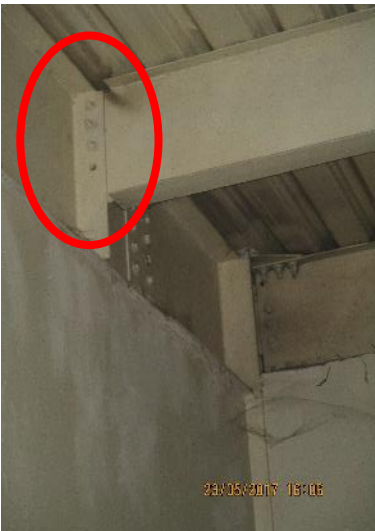
Bolt missing between the connection of sub beam and main beam

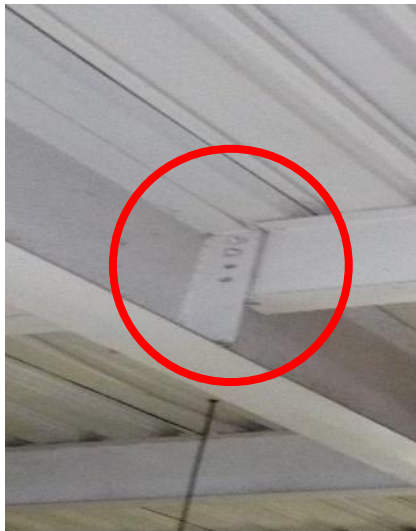
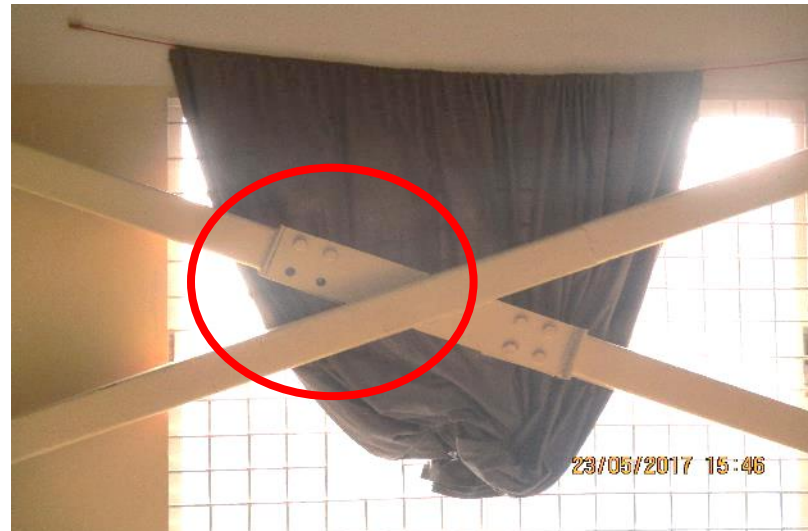
Bolt missing of bracing at 4th floor

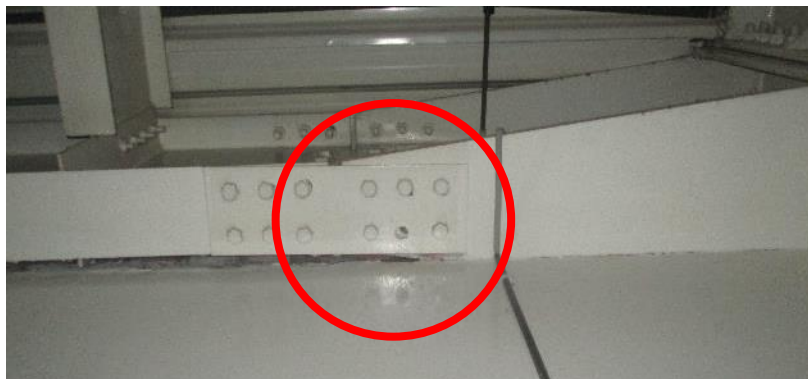
Bolt missing at joint of Main Beam

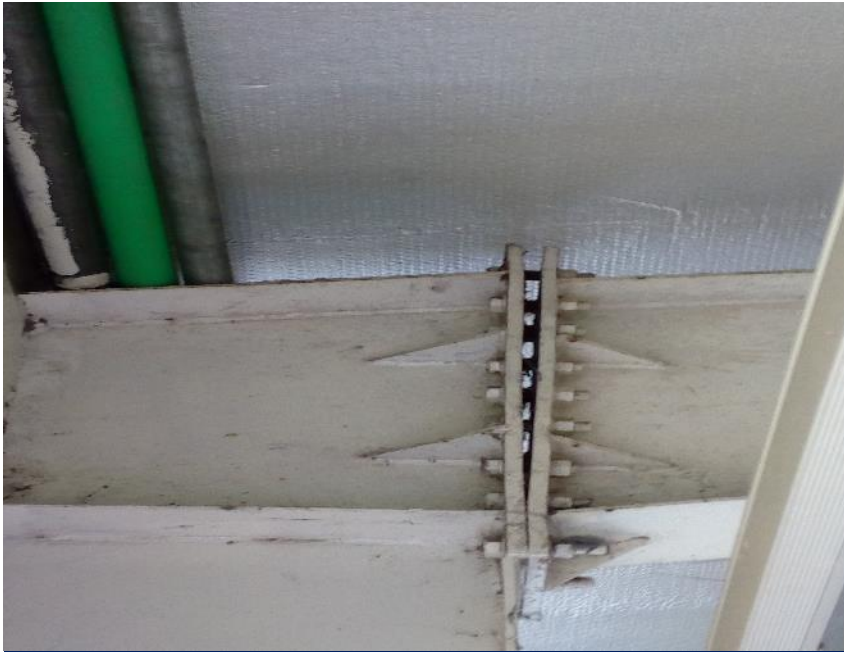
Loose connection between rafters

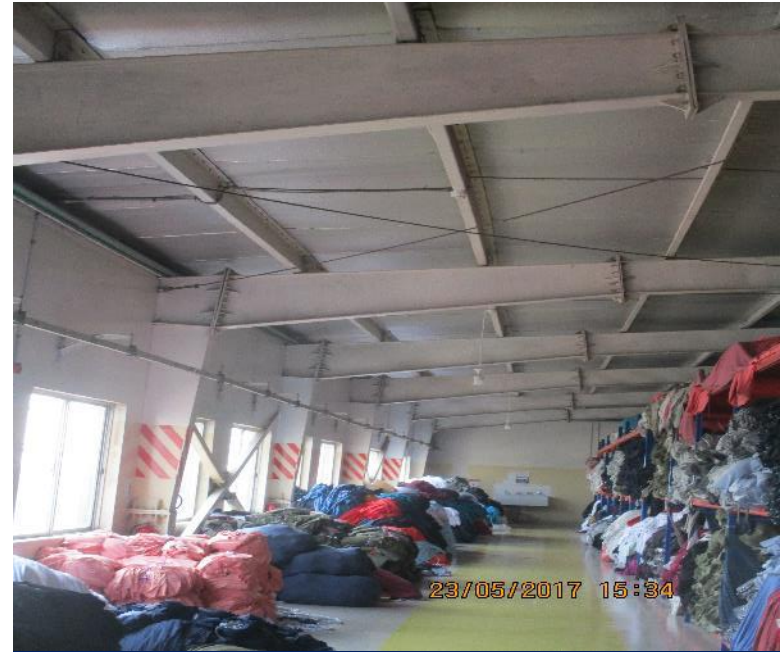
Loose horizontal bracing observed at roof shed of the factory building

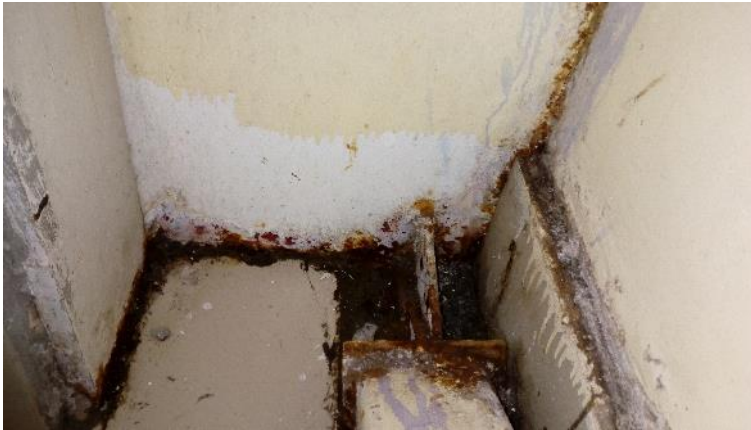
Corrosion observed at steel sections

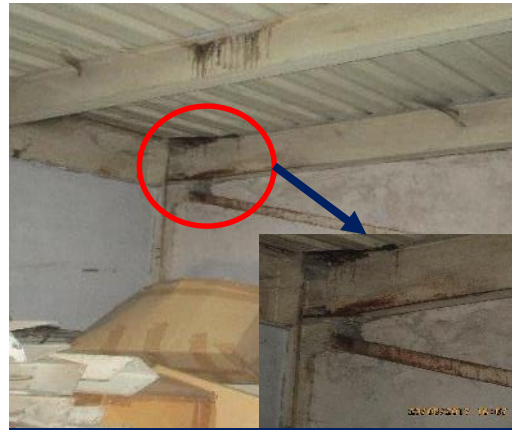
Corrosion observed at ground floor

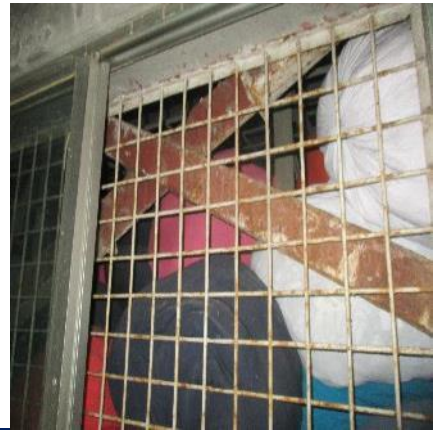
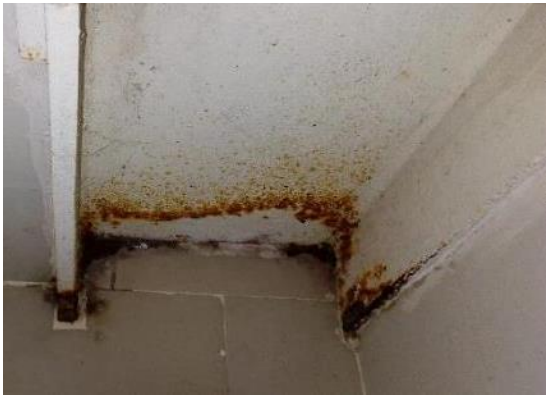
Corrosion at steel column

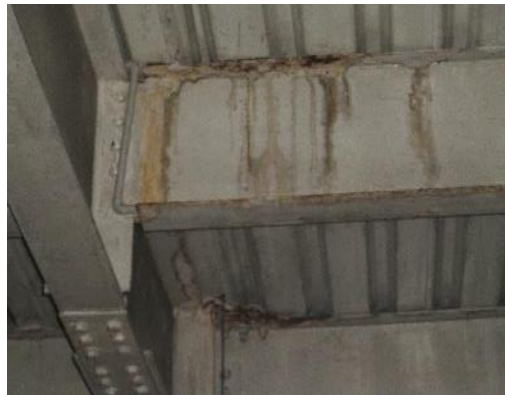
Corrosion at Sub Beam

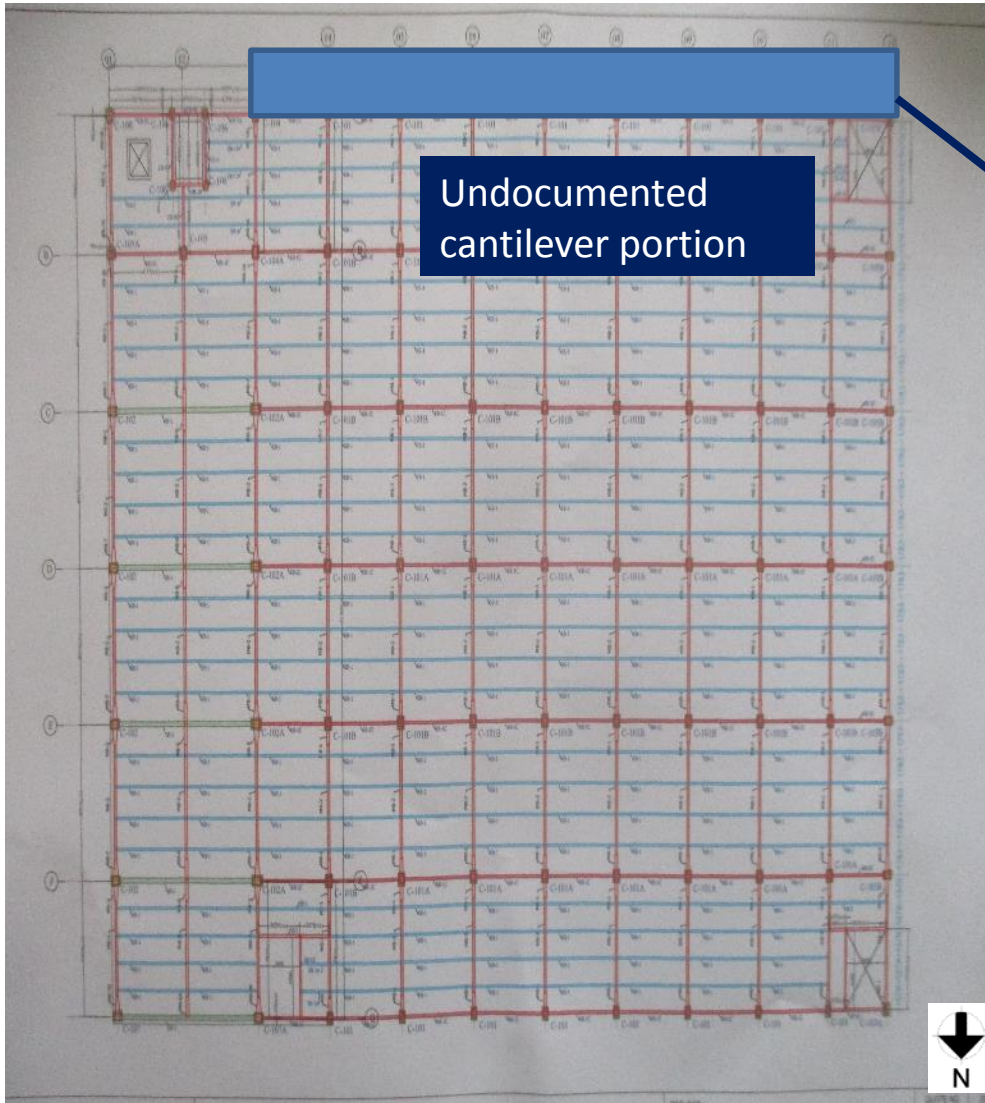
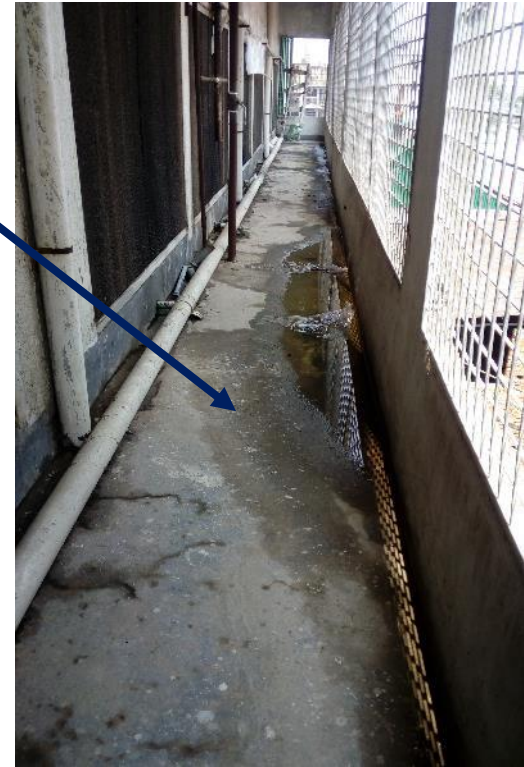
During inspection, a undocumented cantilever portion was observed. Building Engineer is required to update as built drawing including this.

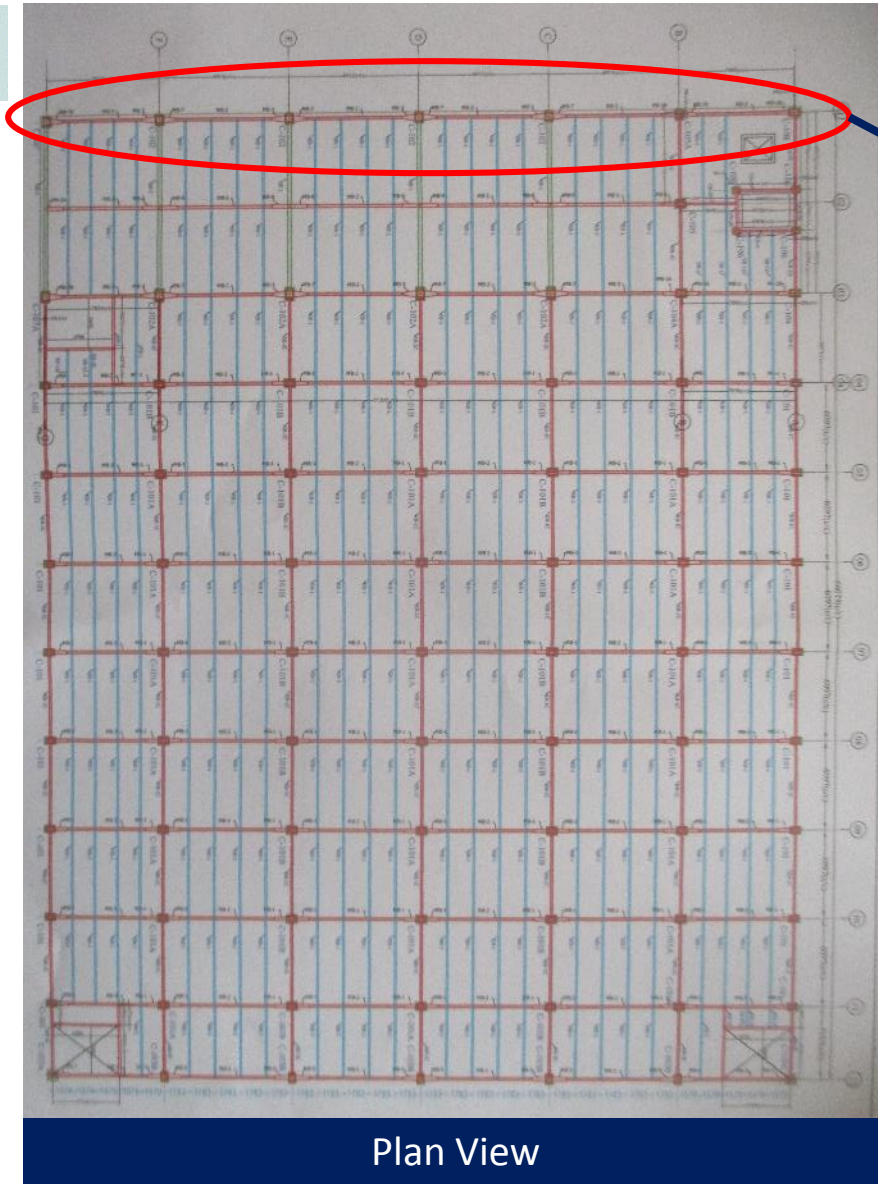
Discrepancy observed in construction drawings and site condition

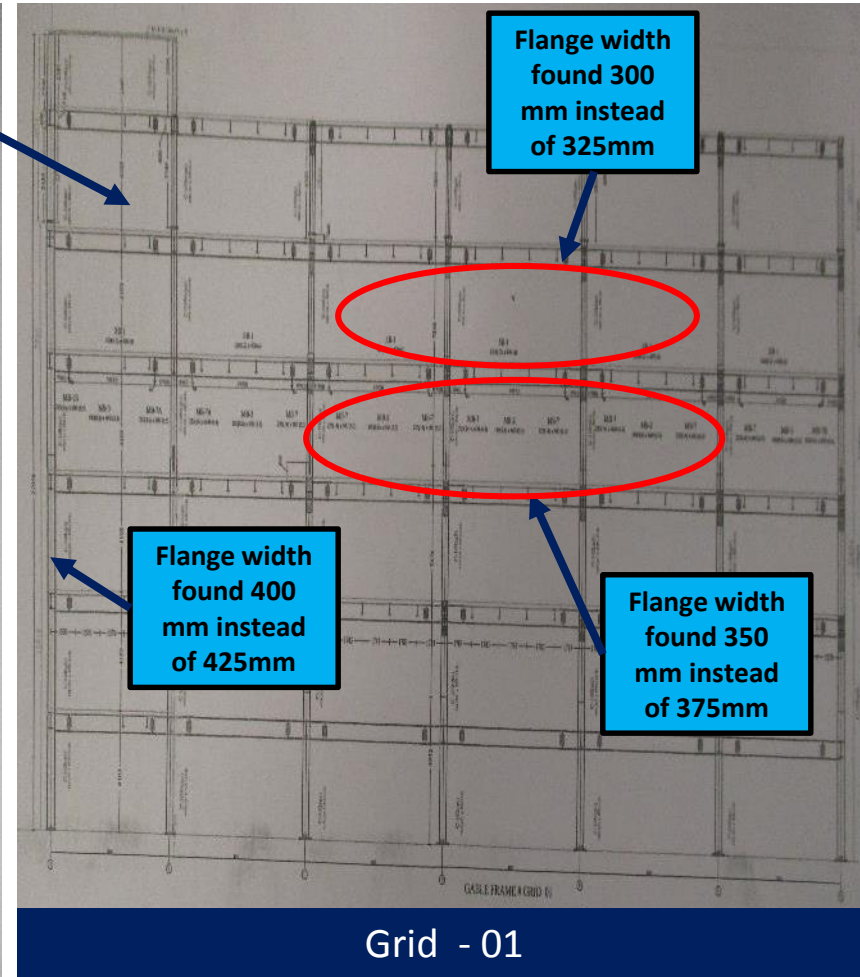
During inspection, the flange width found less than provided drawing. Building Engineer required to prepare As Built drawing.
