FIRE SAFETY INSPECTION REPORT

T Design Knitwear Ltd.

ACCORD ID: 12898

Date: 13 August 2017

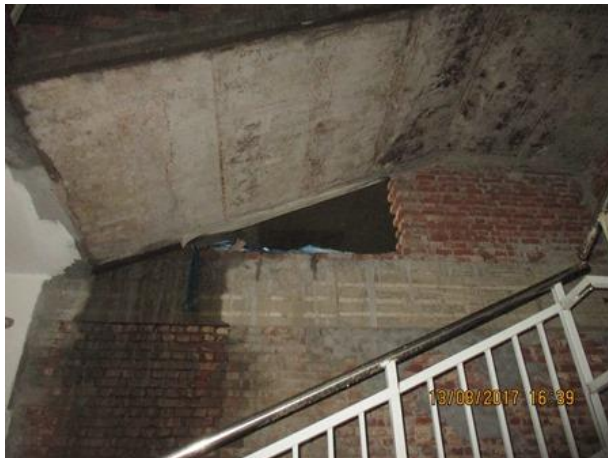
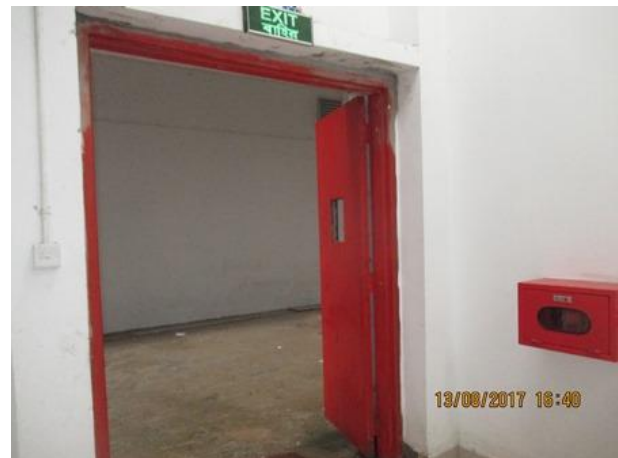
| No. | Category | Finding | Recommendation | Remediation Timeframe |
|---|---|---|--|---|
| F-1 | Fire Rated Construction | <p>Exit stairs are not separated from work areas & other spaces on each floor by fire-rated construction due to unprotected openings and penetrations.</p> <p>Location: Utility Building where top floors are construction and fire door installation is not completed in rest of the floors.</p> | <p>Separate the exit stairs from work areas and other building spaces on all floor levels by minimum 2- hr fire-rated construction. Provide minimum 1.5- hr fire rated doors and seal all unprotected openings and penetrations to maintain the fire separation.</p> <p>Ensure that all fire doors are self-closing and positive latching, and are provided with fire exit (panic) hardware where serving production floors or assembly occupancies.</p> <p>If fire doors are required to be held open for functional reasons, provide automatic-closing devices tied to the fire alarm system.</p> <p>Once fire doors are installed, every door in a stair enclosure serving more than 5 stories shall be provided with re-entry unless it meets ACCORD standard 6.8.3.1.</p> | Within 3 months |

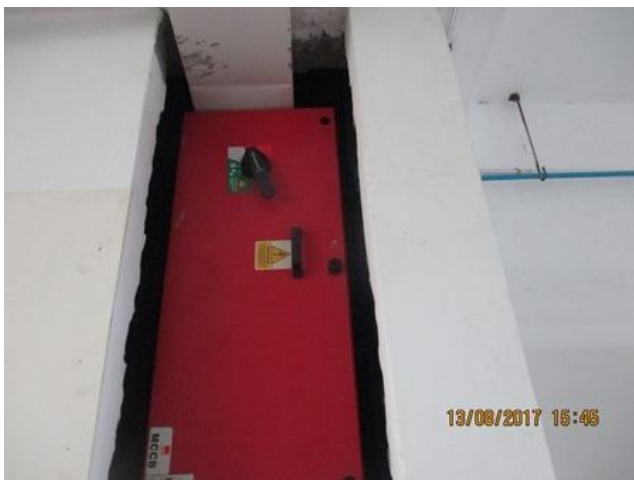
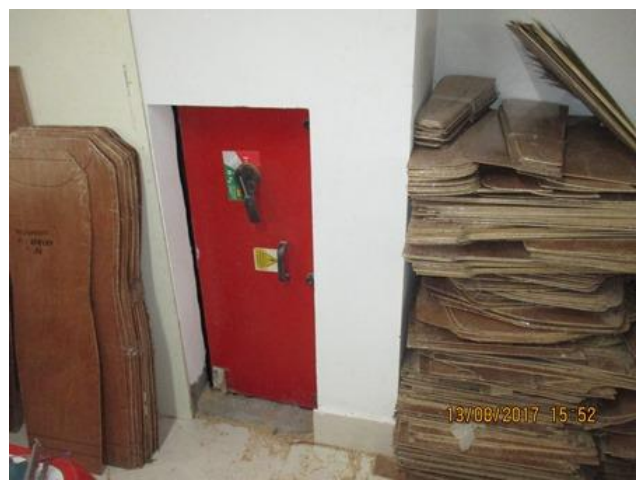
F-2 Fire Rated Construction

Unsealed electrical shafts are located in the fire-rated floor/ceiling assemblies.

Location: Main building.

Provide a minimum 2-hr fire-rated shafts to separate the utility risers from each floor level and seal all penetrations in floor/ceiling assemblies to maintain the fire separation.

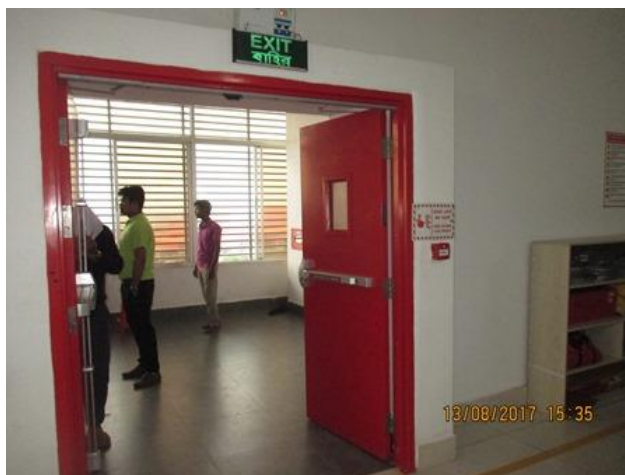
| F-3 | Fire Rated Construction | Fire doors are kept open by external objects without interfacing with fire alarm system. | Provide automatic door-closing devices tied to the fire alarm system, if fire doors are required to be held open for functional reasons. | Within 3 months |

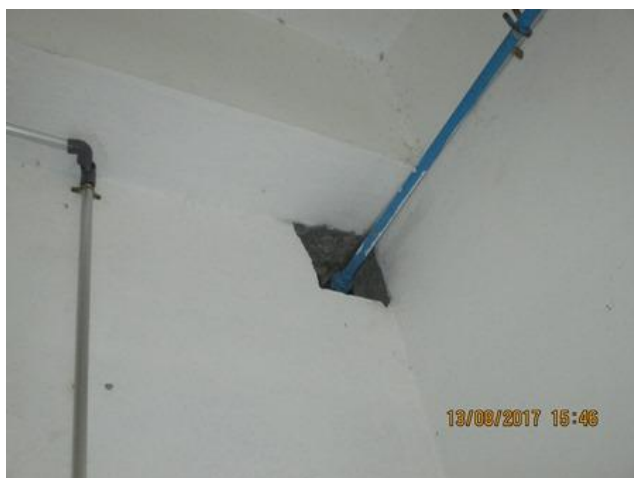
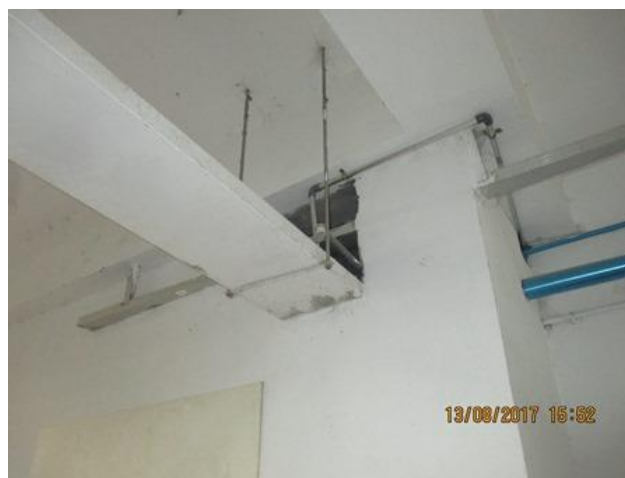
| F-4 | Fire Rated Construction | Unsealed penetrations and openings are located in the fire-rated walls and ceilings. | Seal all penetrations and openings in the fire rated walls and ceilings to maintain the required fire separation. | Within 3 months |

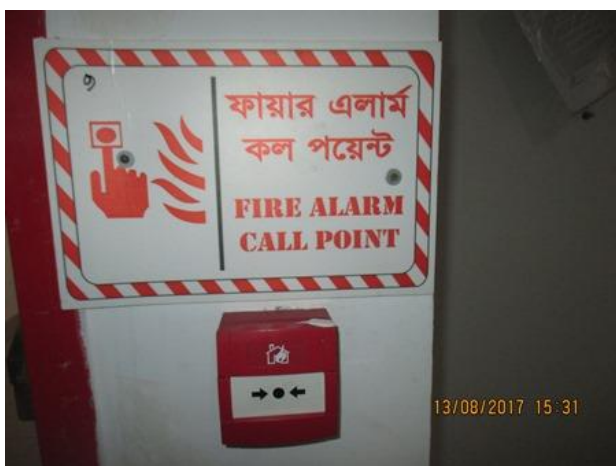
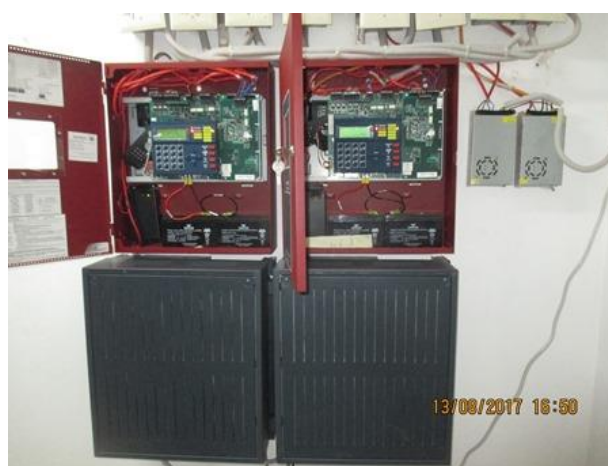
| F-5 | Fire Protection | The fire alarm system installation was almost completed which requires detailed design review to confirm compliance with NFPA 72 and Accord standard. | Submit as-built drawings, testing records, equipment certification and other relevant documentation to the ACCORD for review and approval then complete installation work as per reviewed design and in accordance with NFPA 72. | Design Within 2 Months Installation Within 6 months |

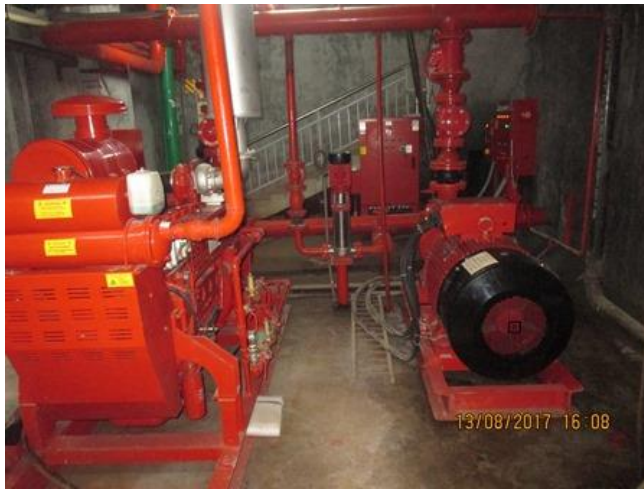
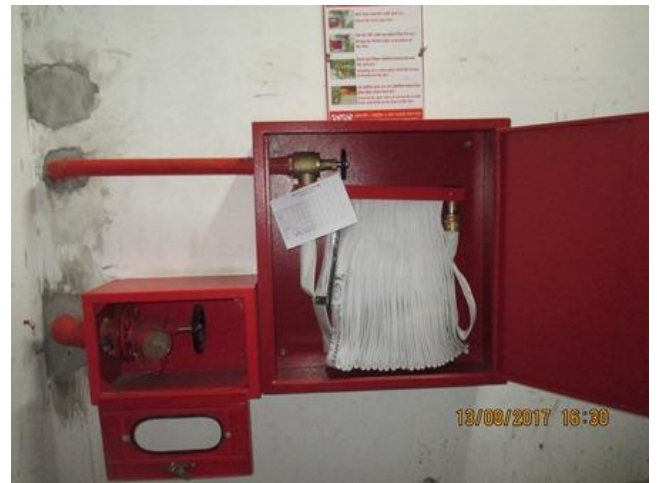
| F-6 | Fire Protection | Both the building has an occupied floor greater than 10 m (33 ft) and requires standpipe system in accordance with NFPA 14 and fire pump as per NFPA 20. Note: Installation is almost completed without design review. | Submit as-built drawings, testing records, equipment certification and other relevant documentation to the ACCORD for review and approval complete installation work in accordance with NFPA 14 and NFPA 20. | Design Within 2 Months Installation Within 6 months |

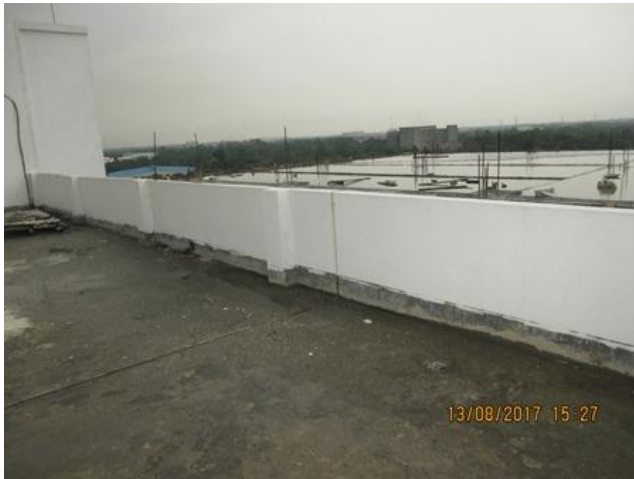
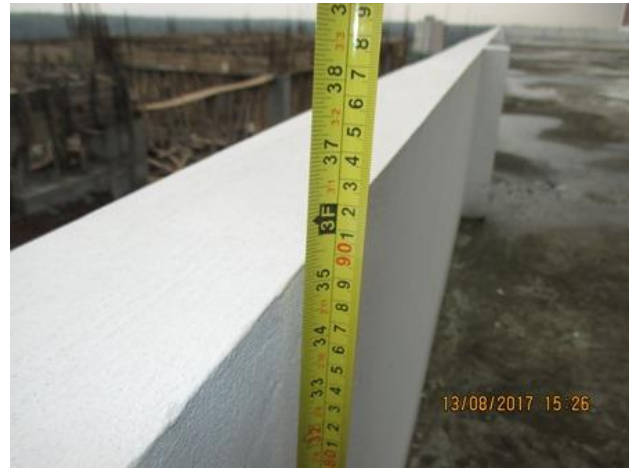
F-8 Egress

Occupiable roof is not provided with an adequate parapet / guard rail.

All occupiable roofs shall be provided with parapets or guards with a minimum height of 1067 mm (42 in.)

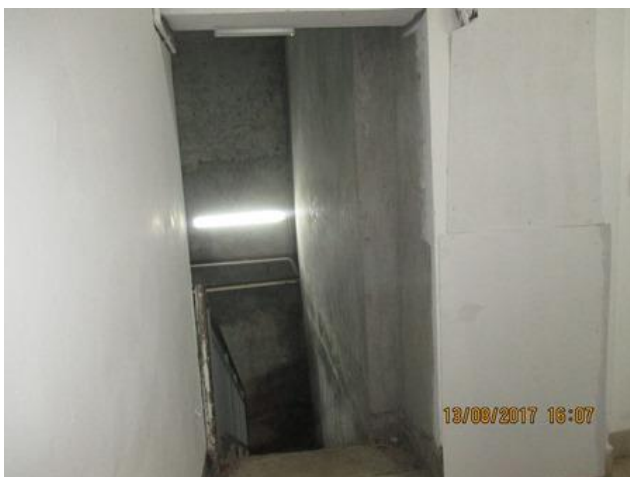
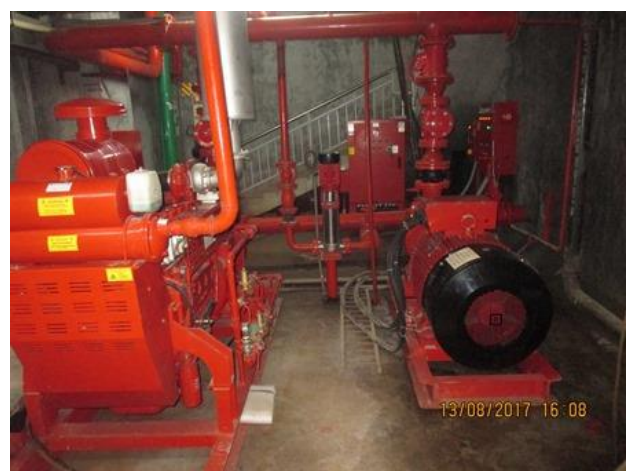
| F-9 | Fire Rated Construction | The fire pump room is at main building, not provided with adequate fire separation. | Provide fire pump room with 2 hr rated fire separation when not sprinklered and 1 hr rated fire separation when provided with automatic sprinklers, in accordance with NFPA 20. | Within 3 months |

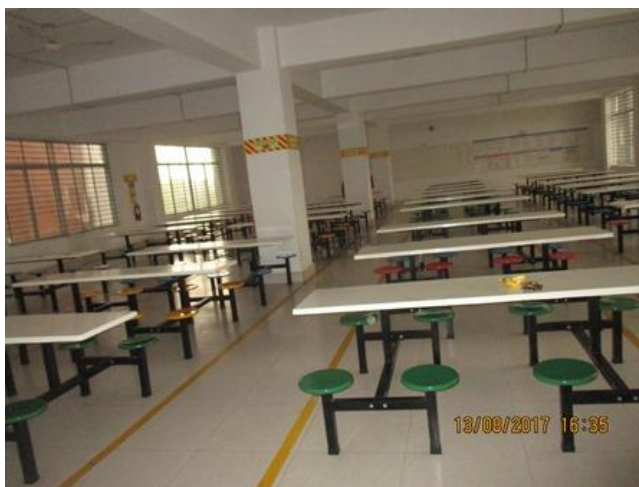
| F-10 | Egress | Exit capacity is not adequate for the occupant load. Utility building 2nd floor dining, available capacity is 475 and occupant load is 640. | Reduce occupant load immediately to not more than available exit capacity (475). Provide additional exits in the future to increase exit capacity. | Immediately |

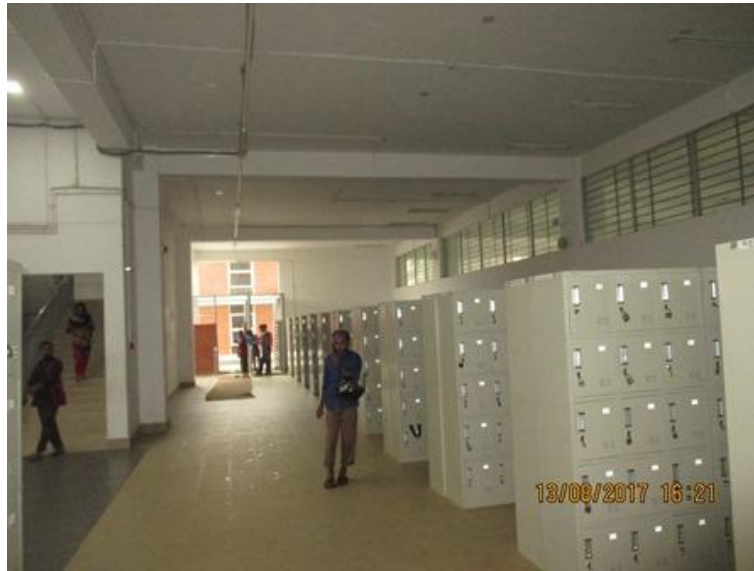
| F-11 | Fire Rated Construction | South-west stairwell stair discharge directly inside the building at ground floor and not separated from building interior. | Modify stair to discharge directly outside of the building and shall have to be safe egress path. Or Provide sprinkler protection for discharge floor in accordance with NFPA 13. | Within 3 months |
