## **R. B. Knitwears**

65/11, Nayamati, Narayangonj. (23.61205N, 90.50308E) 01 March 2015

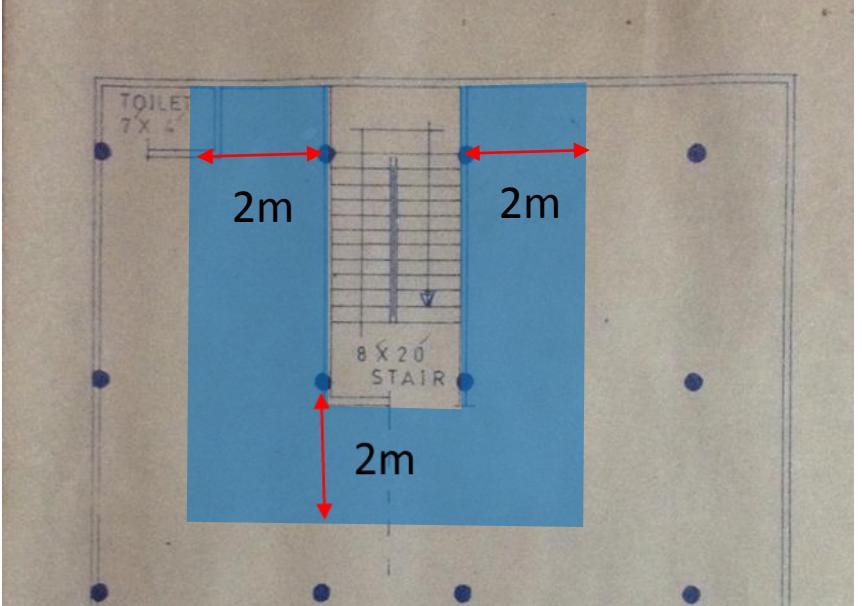
We have important and urgent concerns in relation to the column stresses in the building. Columns appear to be stressed to levels that require <u>immediate</u> actions, as follows:

If the building owners are not in a position to carry out these actions immediately, the building should be classified as Category Red and evacuated.

- Pending outcome of the Detail engineering Assessment, the area (denoted in blue) must be vacated at 3 suspended floors and the water tank must be emptied (access permitted to stairs)
- In all other areas, Live loads are to be limited to
  **1,5 kPa** pending the outcome of a Detail
  Engineering Assessment.
- A Detail Engineering Assessment is required for the Buildings, as outlined at the end of this report. No further vertical or horizontal extension to the building shall take place without having been fully considered and justified in the Detail Engineering Assessment.

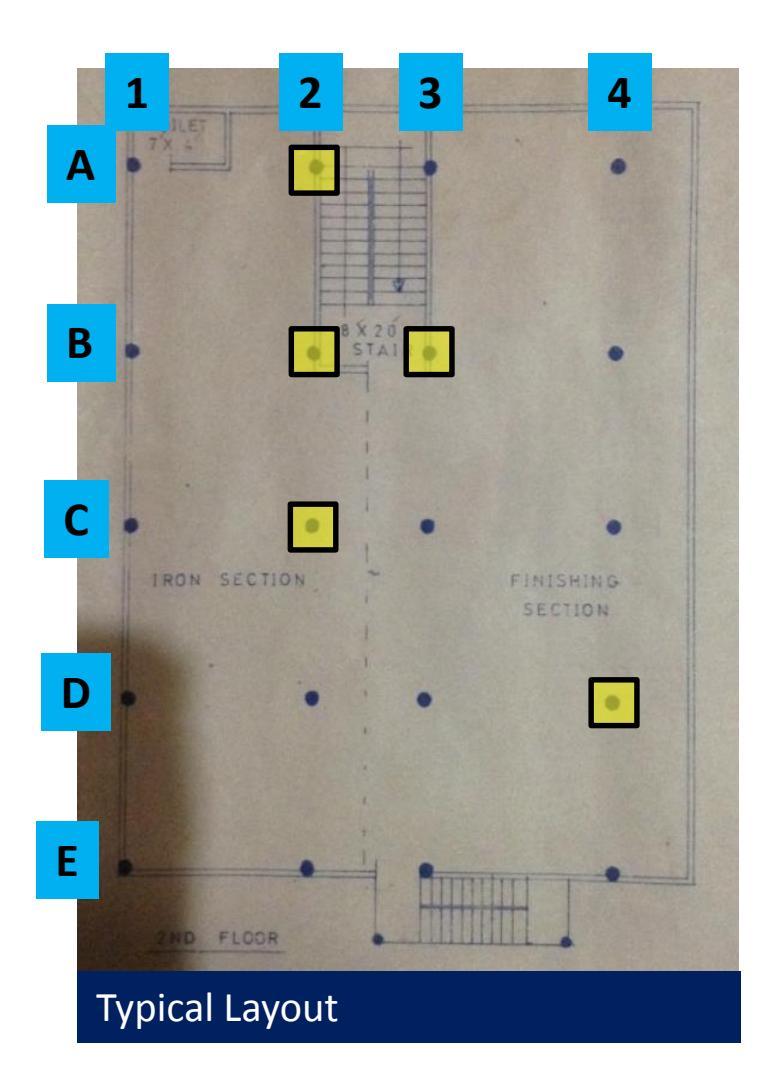
#### High stress levels in the columns

ltem No.	Observation	Recommended Action Plan	Recommended Timeline
1	High stress levels in the columns	Area around staircase to be emptied at 3 floors and water tank at roof to be empited – see page 3 for details.	Immediate - Now
2	High stress levels in the columns	Live load to be limited to 1.5kPa elsewhere, pending outcome of Detail Engineering Assessment.	Immediate - Now
3	High stress levels in the columns	Building Engineer to review design, loads and column stresses in all columns.	Immediate - Now
4	High stress levels in the columns	Verify in-situ concrete stresses by 100mm dia. cores from 4 min. columns.	Immediate - Now
5	High stress levels in the columns	A Detail Engineering Assessment of both Buildings to be commenced, see attached Scope.	Immediate - Now
6	High stress levels in the columns	Detail Engineering Assessment to be completed	6-weeks
7	High stress levels in the columns	Produce and actively manage a loading plan for all floor plates within the Building, giving consideration to floor capacity and column capacity.	6-weeks

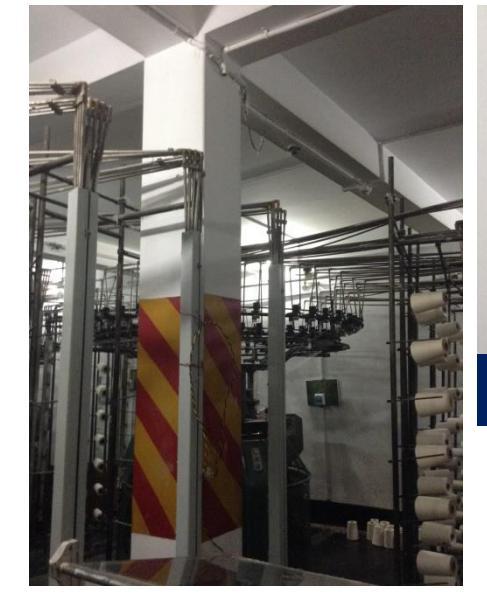
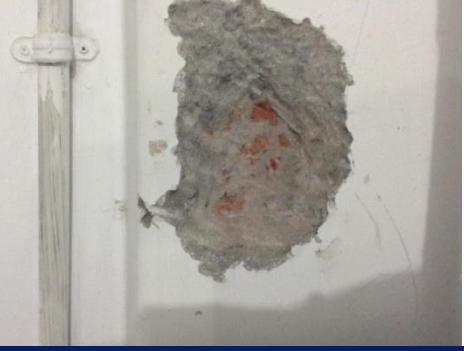
#### Calculated columns

Cursory calculations indicate column working stress is at high risk level.

Brick aggregate

8	High stress levels in the columns	Actions identified in the Detail Engineering Assessment to be implemented.	6-months
9	High stress levels in the columns	Continue to implement the load management plan.	6-months

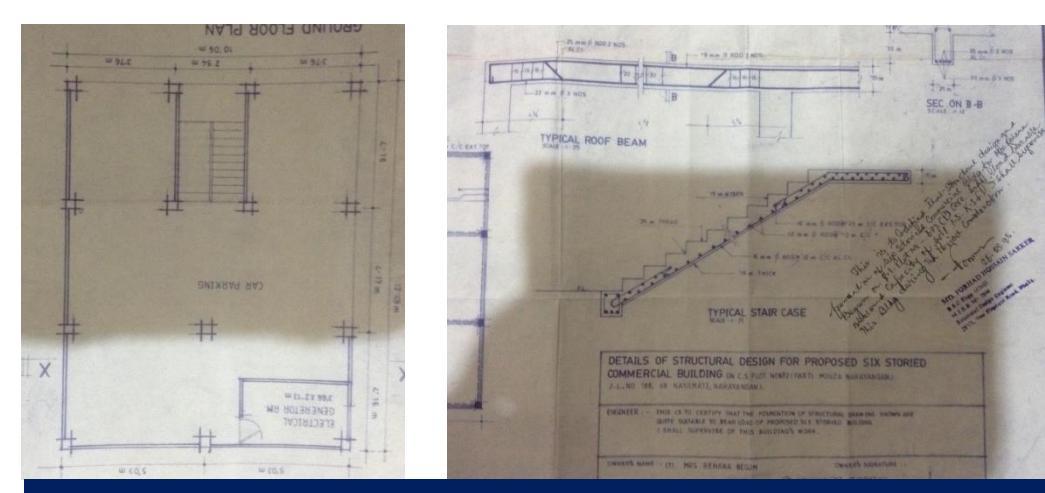
Presented permit drawing do not match the building layout and address .

Item No.	Observation	Recommended Action Plan	Recommended Timeline
10	Discrepancies between drawings, As-built structure and the construction of 3 additional floors	As part of the Detail Engineering Assessment (see Item 1), Building Engineer to survey the as-built structure, including as-built roof structures and floor finishes thickness. The engineering robustness and stability of the additional extensions to be investigated as well their effect on the supporting structures.	6-weeks
11	Discrepancies between drawings, As-built structure and the construction of 3 additional floors	Building Engineer to produce accurate as-built drawings.	6-months
12	Discrepancies between drawings, As-built structure and the construction of 3 additional floors	Repair or remove the additional rooftop structures as directed by the Building Engineer.	6-months
13	Discrepancies between drawings, As-built structure and the construction of 3 additional floors	Carry out any structural works as required.	6-months

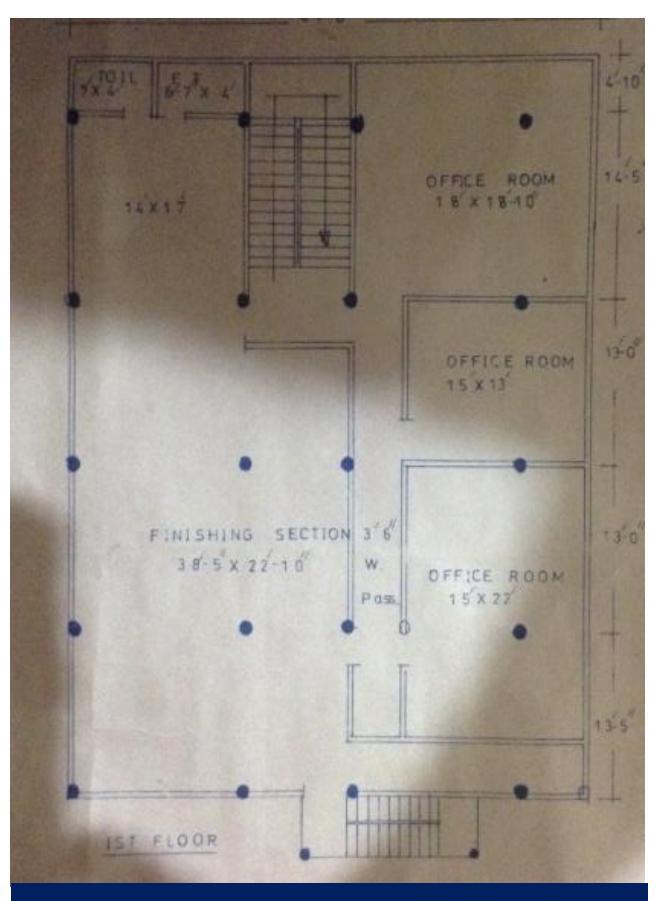
Presented As-Built architectural drawing which matches with the existing building layout.

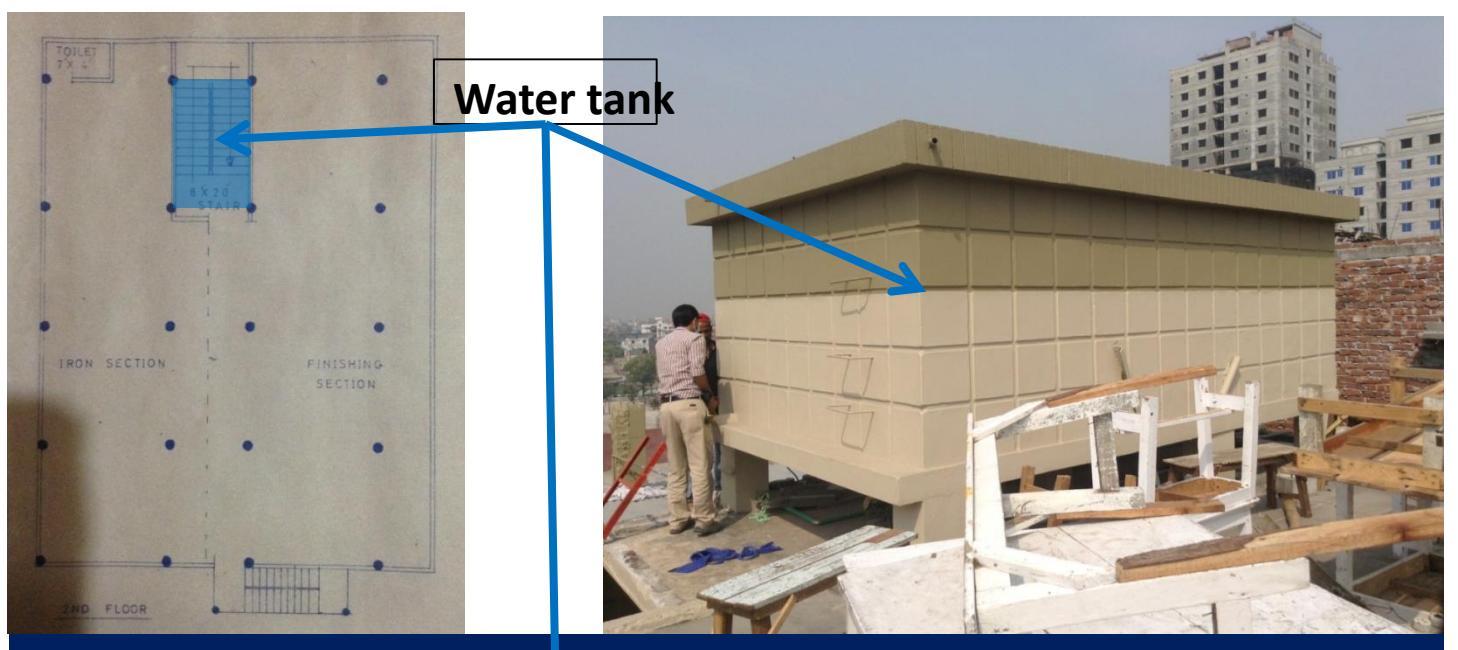
#### **Uncontrolled storage and heavy loading**

Roof – concrete water tank 15 000L capacity on top of the stairs case

14	Uncontrolled storage and heavy loading	Pending the outcome of the Detail Engineering Assessment, live loads to be removed or reduced as noted in Item 1	Immediate - Now
15	Uncontrolled storage and heavy loading	As part of the Detail Engineering Assessment (see Item 1), Building Engineer to confirm design loading of slabs and incorporate it into the loading plan for all floor plates within the Building.	6-weeks
16	Uncontrolled storage and heavy loading	Continue to implement the load management plan	6-months

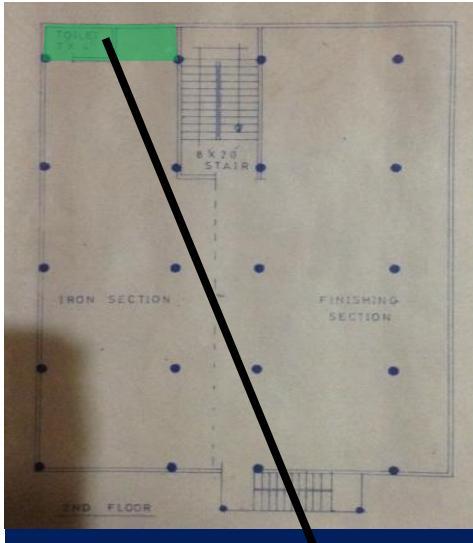
6<sup>th</sup> floor - Toilet build up 200mm

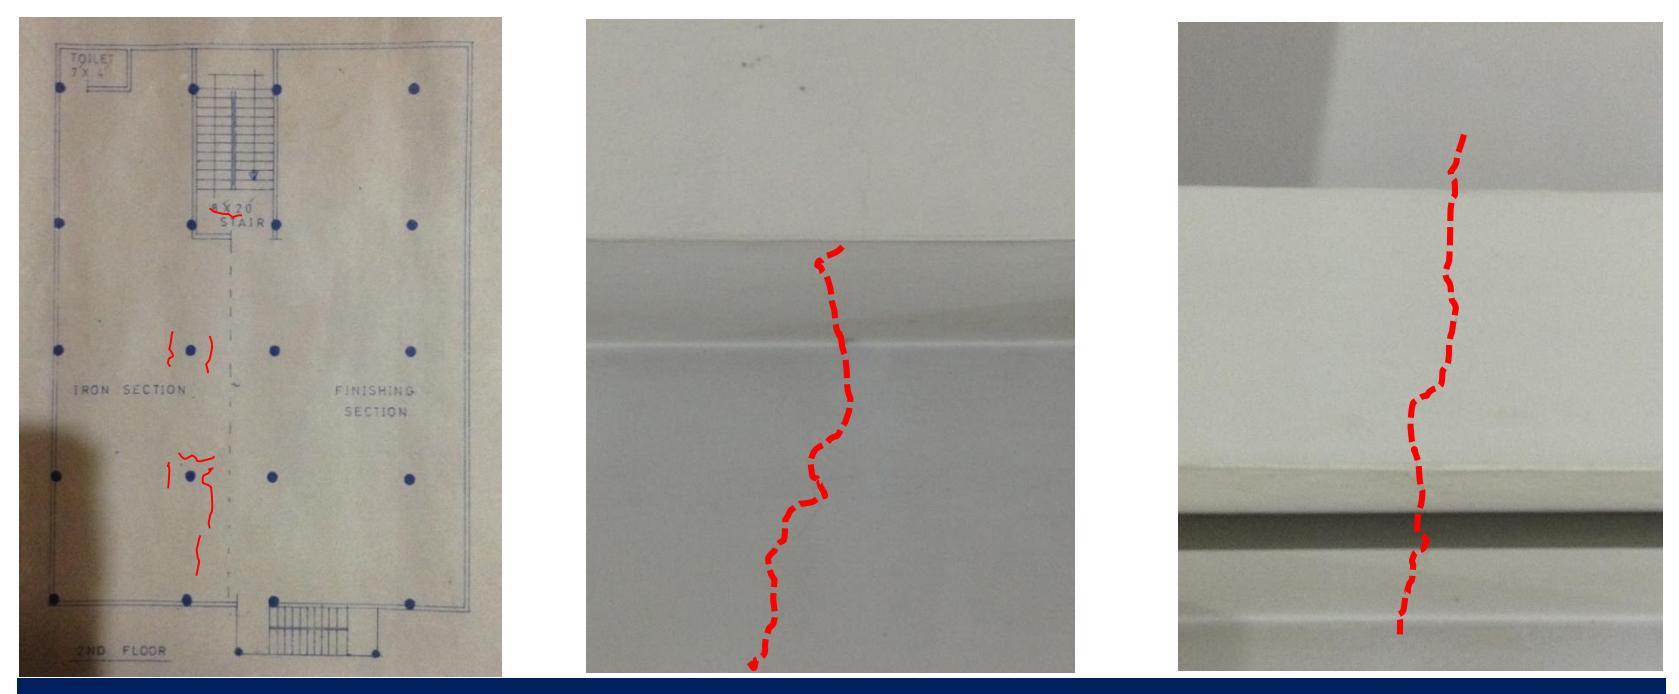
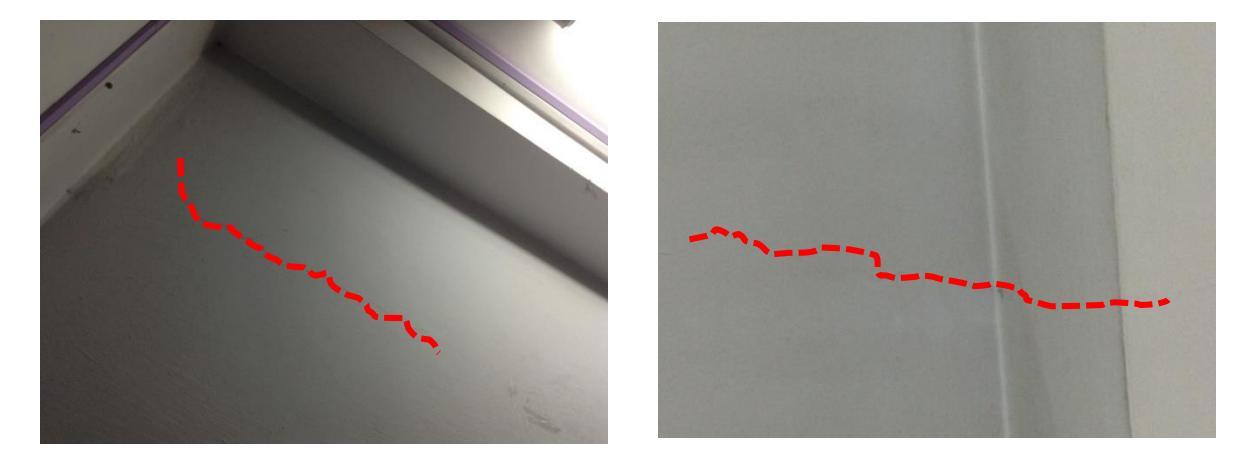
#### **Cracks in beams and slab**

#### 6<sup>th</sup> floor - Hair line crack found on beam and slabs

ltem No.	Observation	Recommended Action Plan	Recommended Timeline
17	Cracks in the building	Building Engineer to investigate damage to beam and cracking, and determine cause.	6-weeks
18	Cracks in the building	As part of the Detail Engineering Assessment (see Item 1), Building Engineer to carry out full design check of all floor slabs and beams to confirm their load capacity, taking into account the cracking.	6-weeks
19	Cracks in the building	Carry out any structural repairs as necessary to beams and slabs.	6-months
20	Possible modifications of structural elements on the 3rd floor	As part of the Detail Engineering Assessment (see Item 1), Building Engineer to carry out investigation of these enlargements and to define the reasons and the status of the structure inside.	6-weeks
21	Possible modifications of structural elements on the 3rd floor	Reconstruct or/and repair the highlighted structures to ensure their adequacy.	6-months

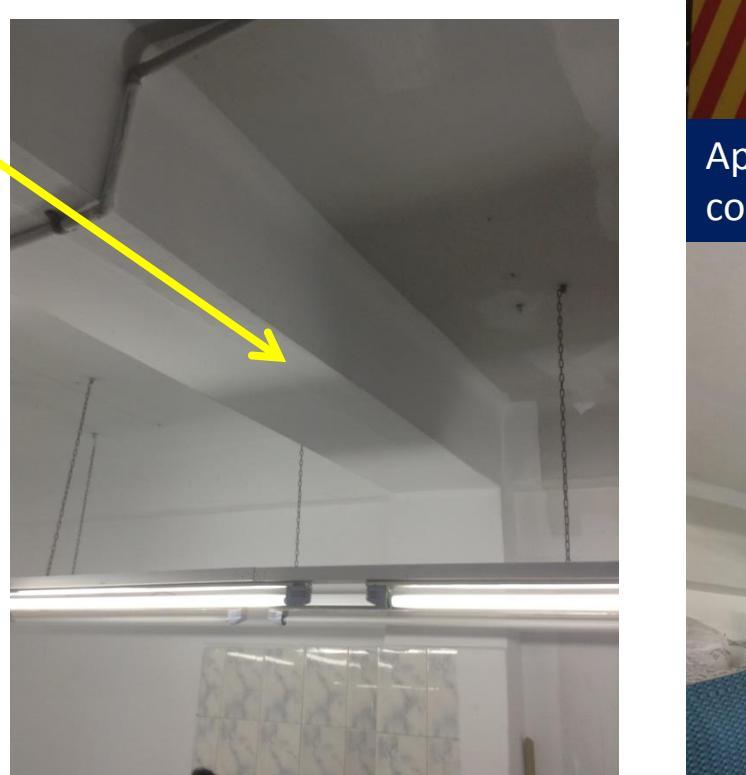
# Possible modifications to structural elements on the 3rd floor

Some of the structural elements have possibly been modified - these could indicate issues with the existing structure.

Larger beam then others

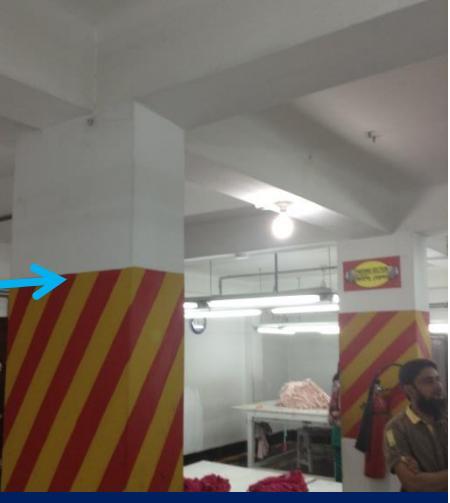
Apparently larger column

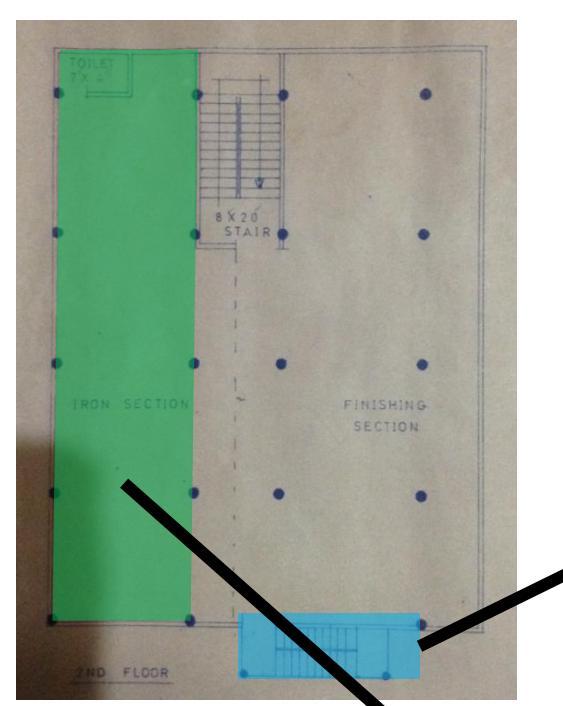
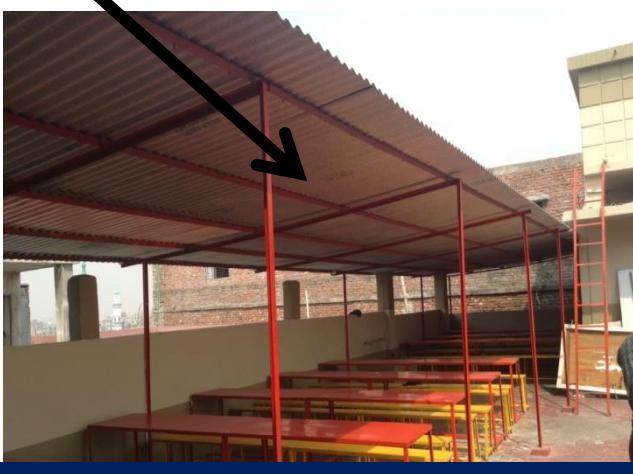
# Apparently non-engineered lightweight steel roof structures and steel stairs

Non-engineered light weight steel roof structure Observations

22	Apparently non-engineered lightweight steel stair structures	As part of the Detail Engineering Assessment (see Item 1), Building Engineer to carry out full design check on lightweight steel stairs and the support and connections to the main building structure.	6-weeks
23	Apparently non-engineered lightweight steel stair structures	Reconstruct or repair lightweight steel stairs as necessary to ensure adequacy to withstand code vertical and wind loads.	6-months

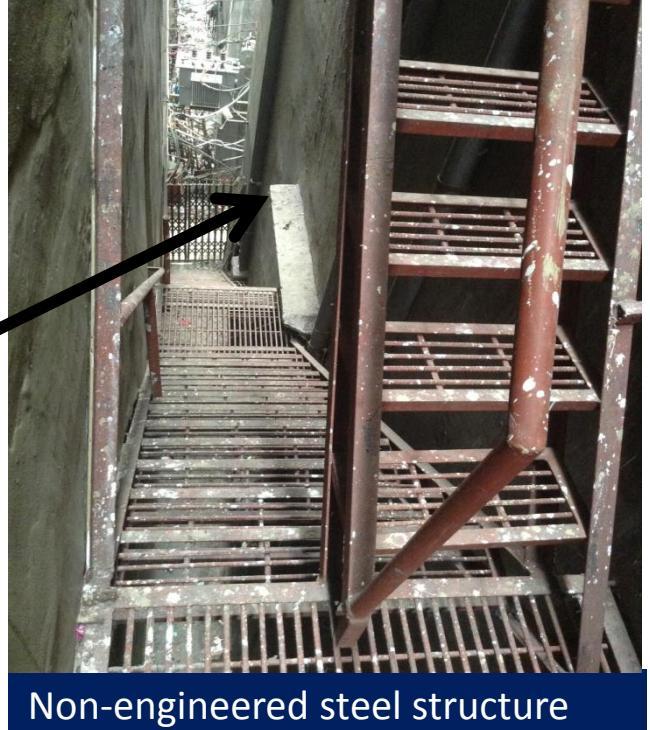
stair
