Anupam Sweaters Ltd

11 March 2015

Observations

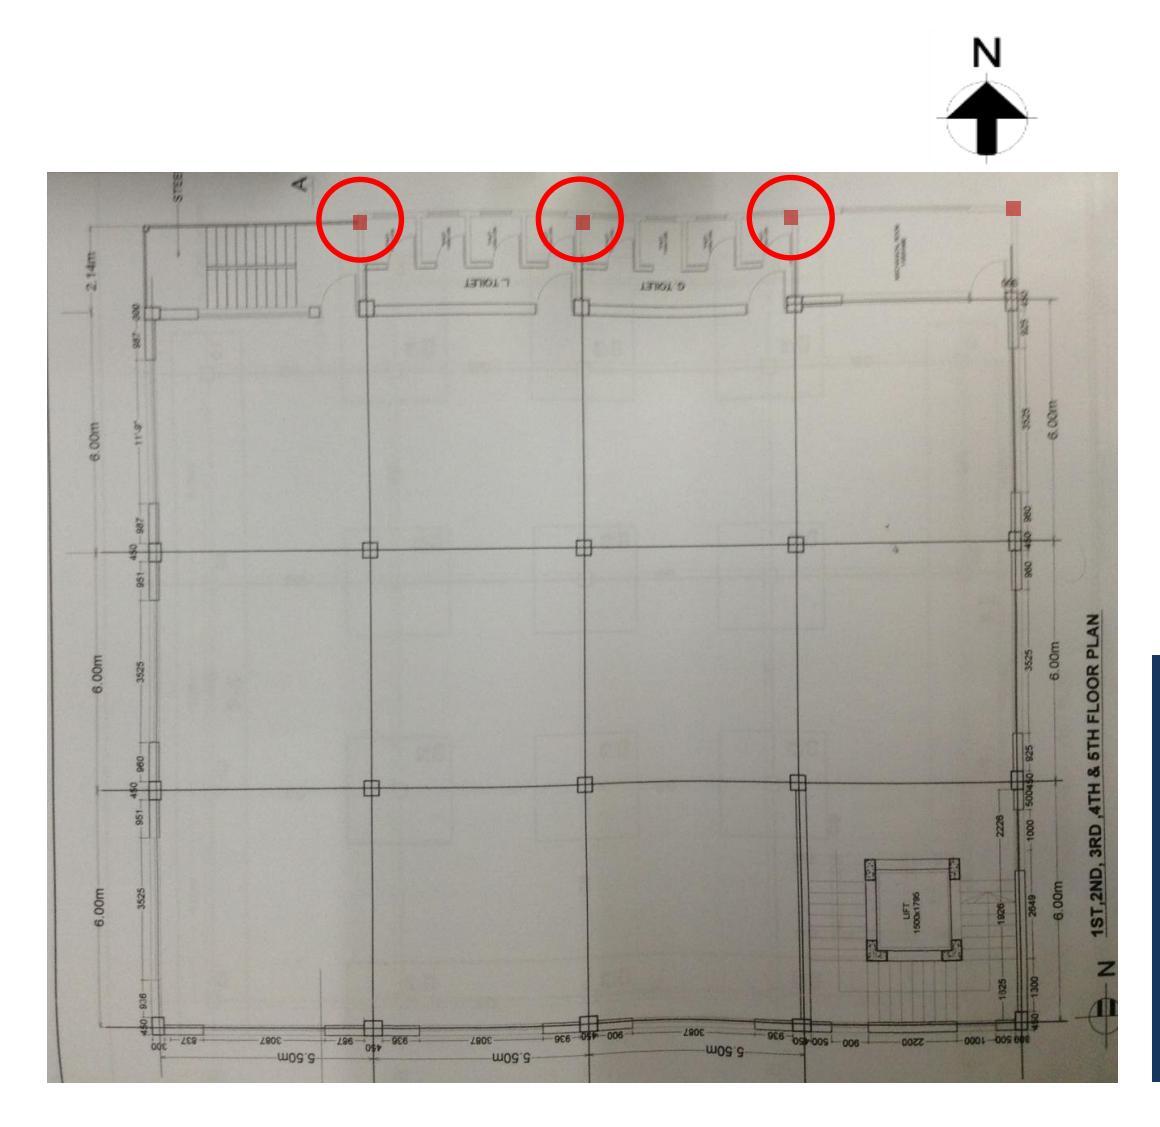
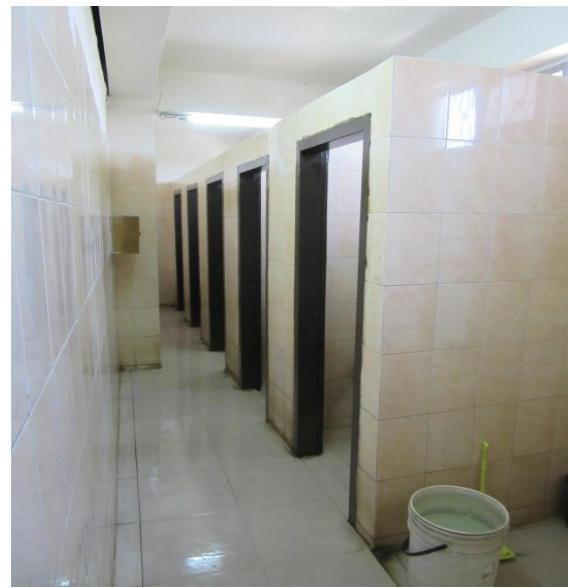
- Initial calculations indicate that the highlighted columns appear to be stressed in excess of normal design limits.
- Heavy loads from façade, toilet floor and toilet walls.

ltem No.	Observation	Recommended Action Plan	Recommended Timeline
1	Building 1 - Stress in façade columns in toilet area	Building Engineer to review design, loads and column stresses in area identified above.	6-weeks
2	Building 1 - Stress in façade columns in toilet area	Verify in-situ concrete strength by 100mm dia. cores from min. 4 no. ground floor columns.	6-weeks
3	Building 1 - Stress in façade columns in toilet area	Produce and actively manage a loading plan for all floor plates within the factory, giving consideration to floor capacity and column capacity.	6-months
4	Building 1 - Stress in façade columns in toilet area	Implement any remedial measures recommended by Building Engineer.	6-months
5	Building 3 - Cracking in cantilever slab with no backspan	Provide temporary propping to suitable strong point as identified by Building Engineer.	6-weeks
6	Building 3 - Cracking in cantilever slab with no backspan	Building Engineer to review cantilever design and develop permanent solution.	6-weeks

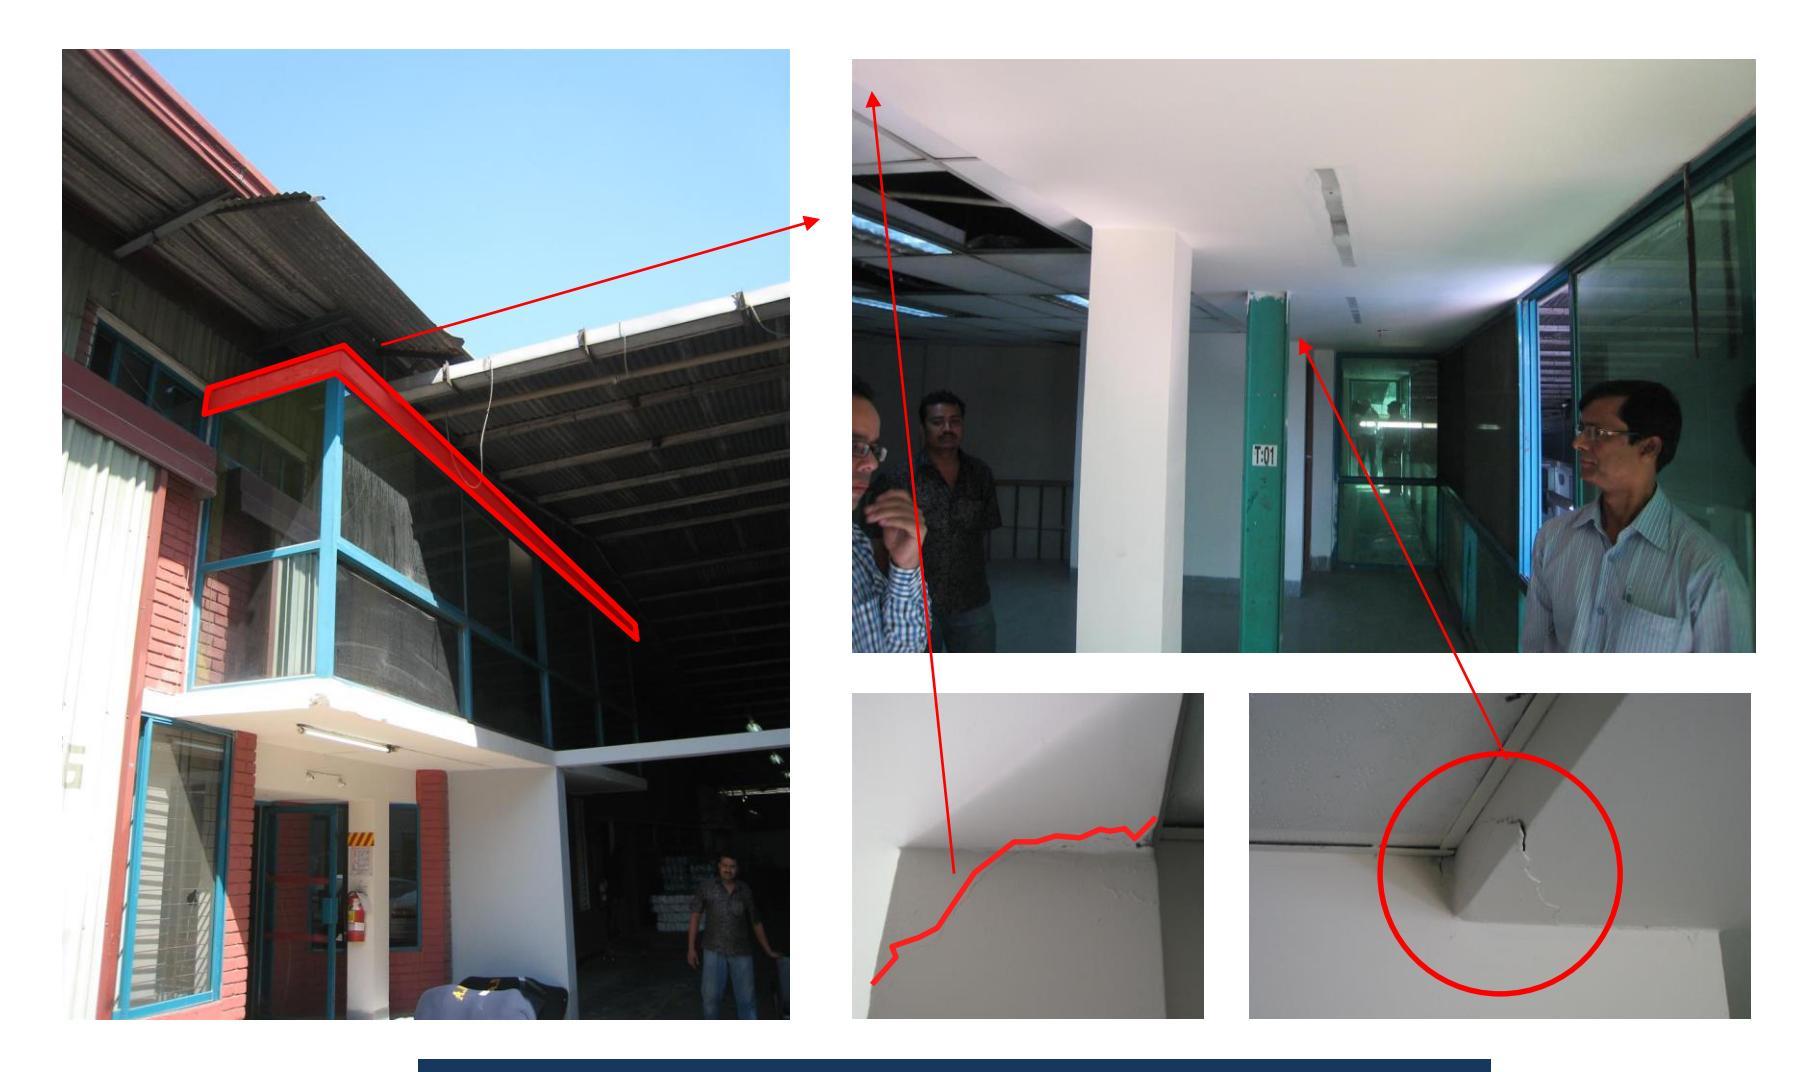
Cantilever roof slab appears to have no backspan. Cracking and distress visible at column connections.

7	Building 3 - Cracking in cantilever slab with no backspan	Implement remedial measures recommended by Building Engineer.	6-months

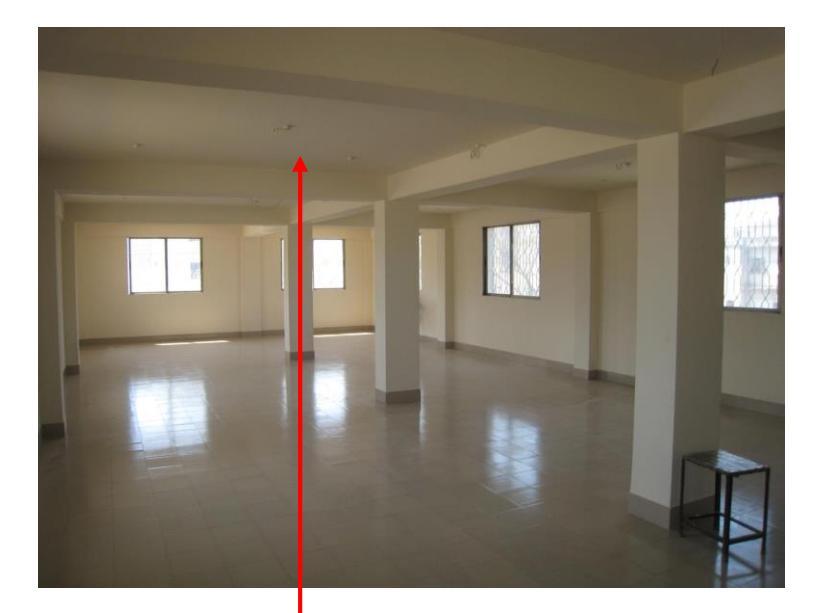
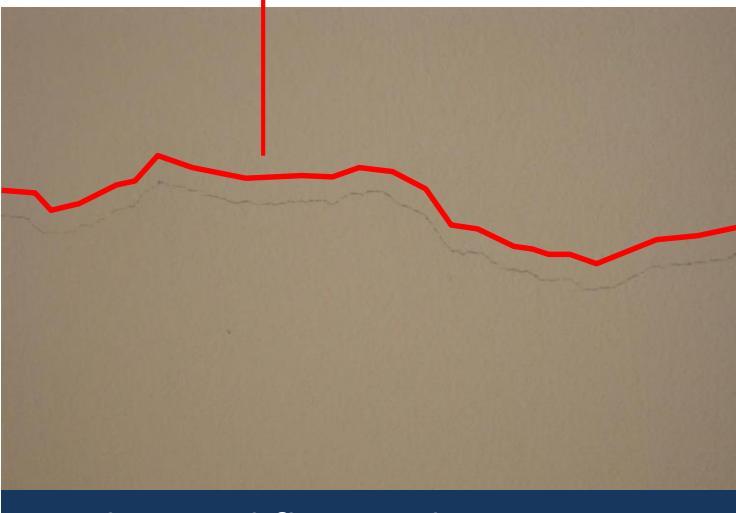
Crack in 2nd floor ceiling

Minor cracking in slabs appear to be bending cracks, possibly induced by loading on floors above.

ltem No.	Observation	Recommended Action Plan	Recommended Timeline
8	Building 2 - Cracking to the underside of slabs	Building Engineer to investigate the penetration depth of cracks in slabs.	6-weeks
9	Building 2 - Cracking to the underside of slabs	Building Engineer to review design, loads and slab stresses, paying particular attention to weight of brickwork walls on slabs.	6-weeks
10	Building 2 - Cracking to the underside of slabs	Implement any structural remedial or strengthening works arising from Building Engineer's review.	6-months
11	Building 2 - Cracking to the underside of slabs	Produce and actively manage a loading plan for all floor plates within the building, giving consideration to floor capacity and column capacity	6-months
12	Building 1 - Lightweight staircase with non-engineered connections	Building engineer to check load capacity of fully loaded staircase, paying particular attention to: column buckling, connections to concrete structure, ability of concrete structure to carry applied loads.	6-weeks

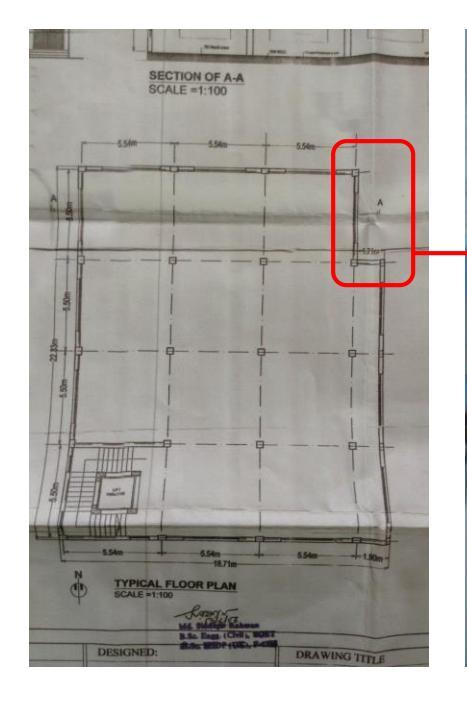
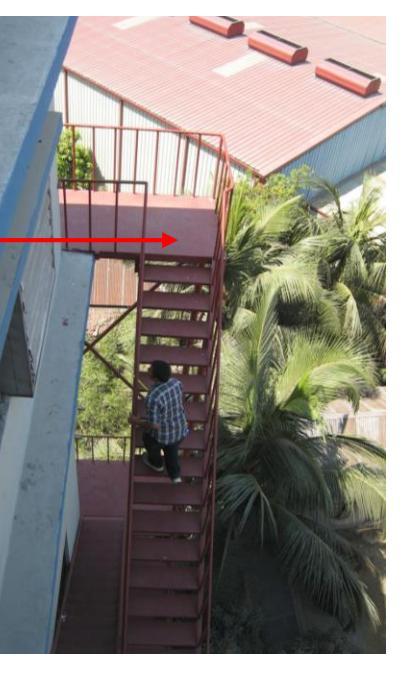
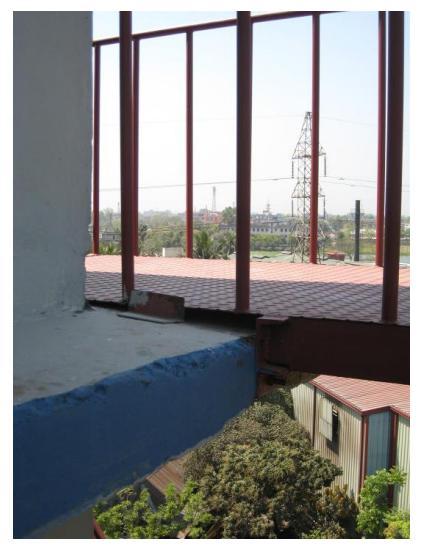
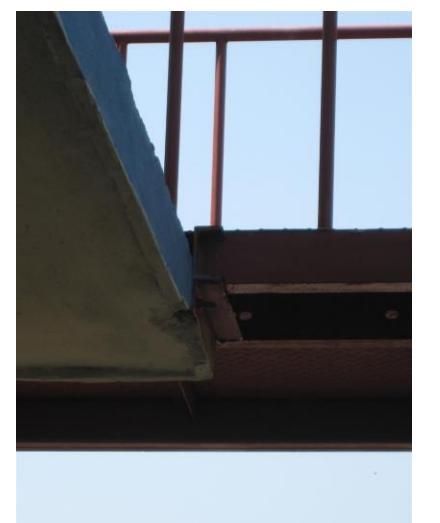
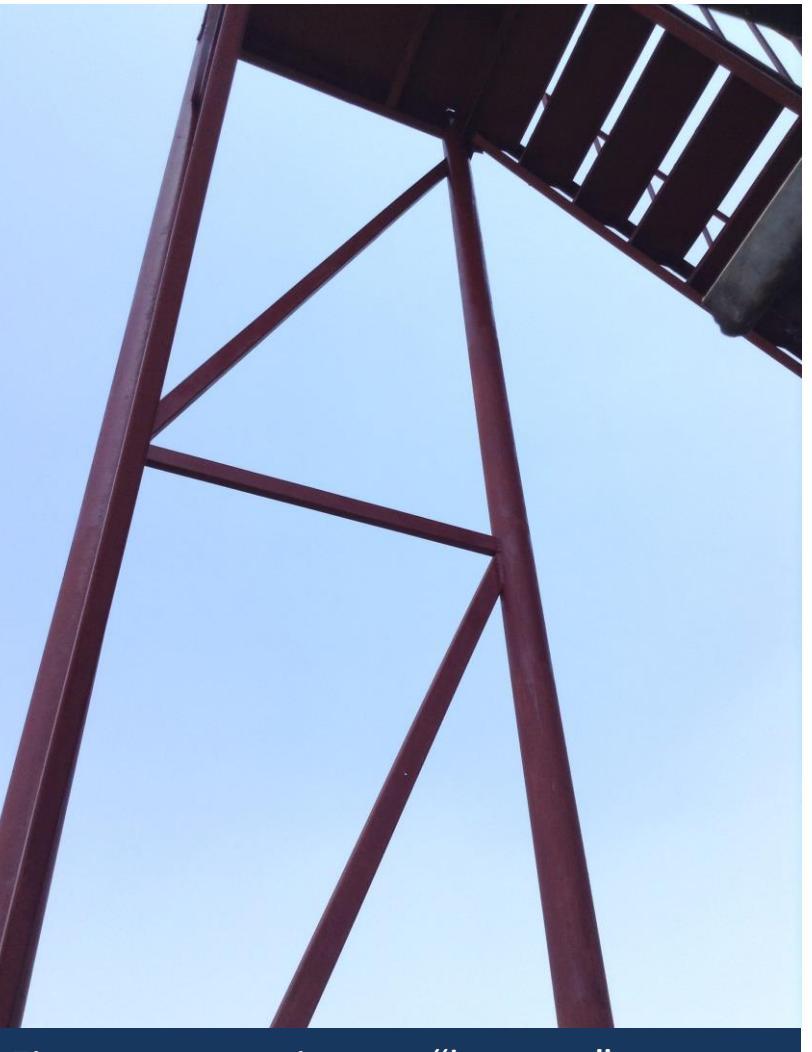
Fire escape stair very "bouncy", columns appear slender and some connections appear non-engineered.

13	Building 1 - Lightweight staircase with non-engineered connections	Implement any remedial measures recommended by Building Engineer.	6-months
14	Building 4 - Stability system not apparent	Building Engineer to carry out a stability analysis and determine additional stability structure required to meet building code.	6-months
15	Building 4 - Stability system not apparent	Implement remedial measures recommended by Building Engineer.	6-months
16	Building 5 - Lightweight non- engineered shed	Building engineer to carry out a stability analysis and review element capacities and connection design.	6-months
17	Building 5 - Lightweight non- engineered shed	Implement remedial measures recommended by Building Engineer, or consider replacing with a new shed meeting the requirements of the current building code.	6-months

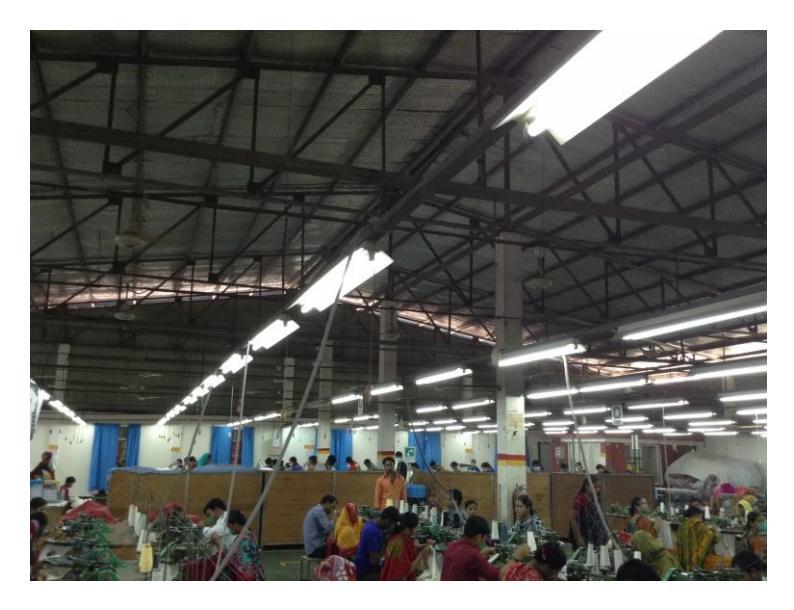
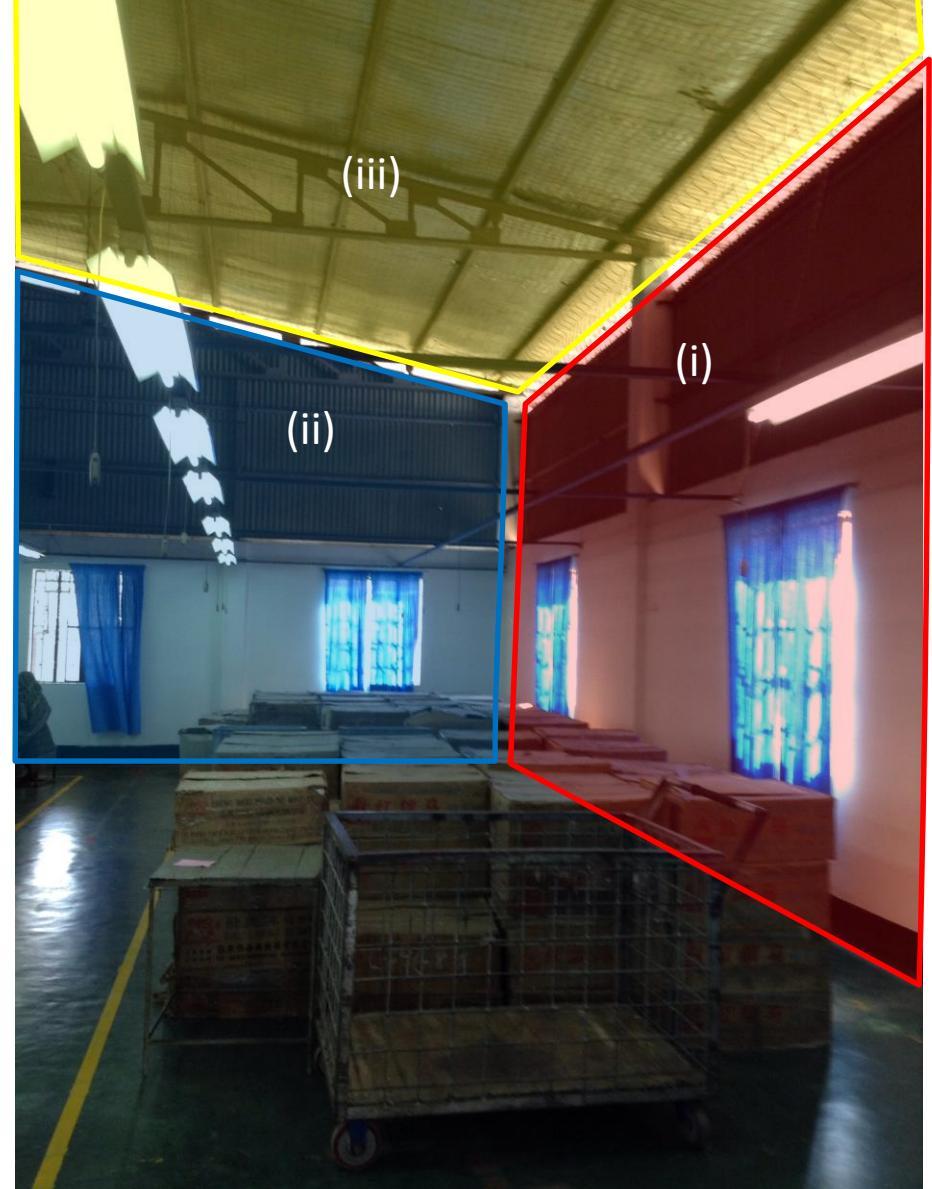
Building 4 - Stability system not apparent

- Stability system is required in all three planes: (i) N/S walls, (ii) E/W walls and (iii) roof.
- Concrete columns may provide <u>some</u> stability in wall plane but there is no apparent continuation of the stability system into the roof diaphragm.
- Nor is it apparent that the columns have sufficient strength to provide the necessary bending resistance.

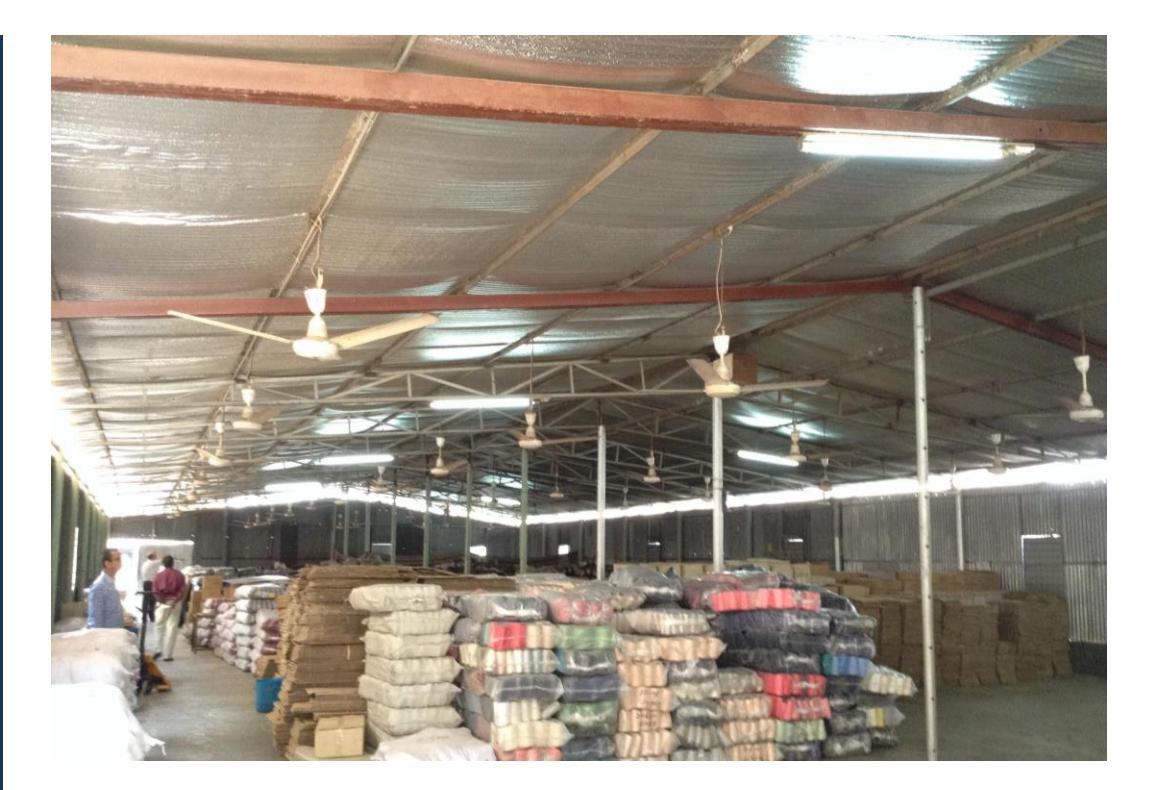
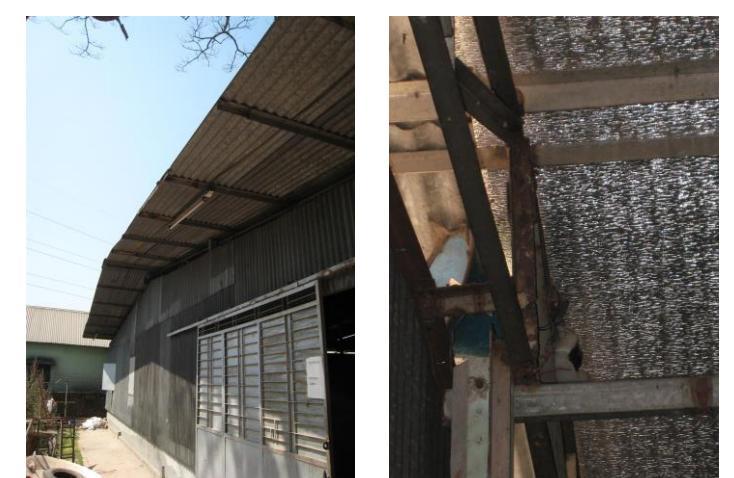
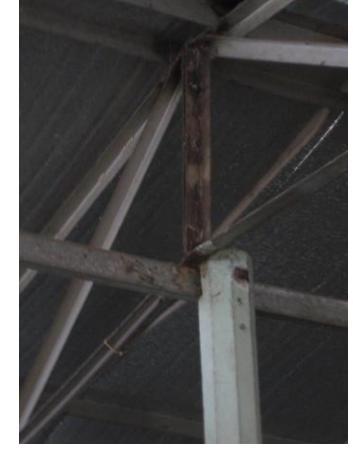
Building 5 - Lightweight non-engineered shed

- Building 5 appears susceptible to uplift and damage in strong winds It is large and lightweight and appears to have little positive tying back to a solid foundation structure.
- There is no clear stability system and no apparent crossbracing in any of the walls or in the roof.
- Typically the connections appear to be non-engineered.
- The non-engineered canopy structure at the south end of the shed appears to be particularly susceptible to uplift in strong winds.
