# Peak Apparels Ltd.

242, Sharifpur, National University, Joydevpur, Gazipur.

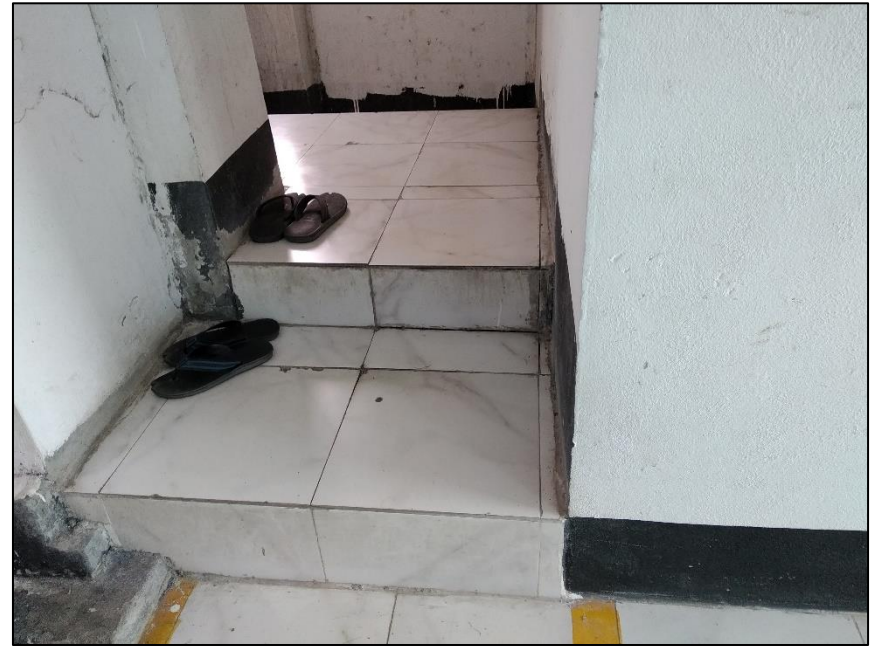
Build-up in toilet area

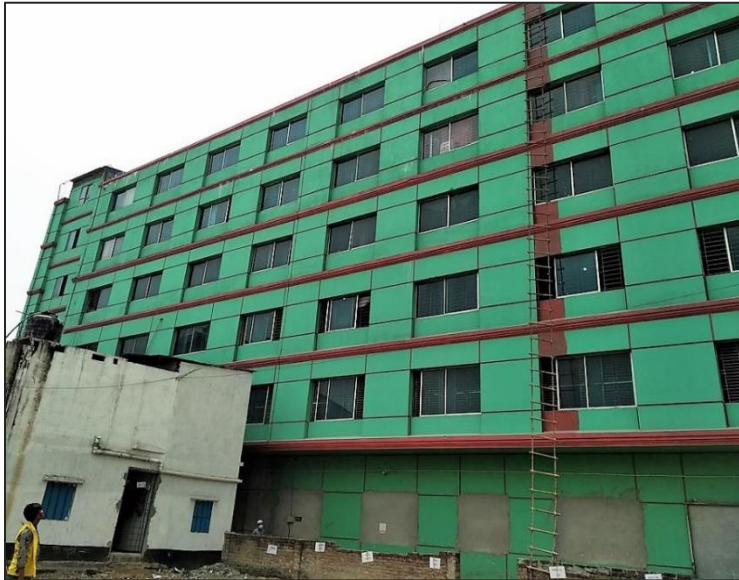
As per BNBC every building or structure designed shall have its design documents prepared in accordance with the provision of Section 1.9.1. The design document shall include a design report, and a set of structural drawings, which shall be prepared in compliance with section 1.9.1.1 and section 1.9.1.2 as per BNBC. During the inspection, the drawings were found incomplete which is required to be prepared in compliance with section 1.9.1.2 (Part-6, BNBC 2006).

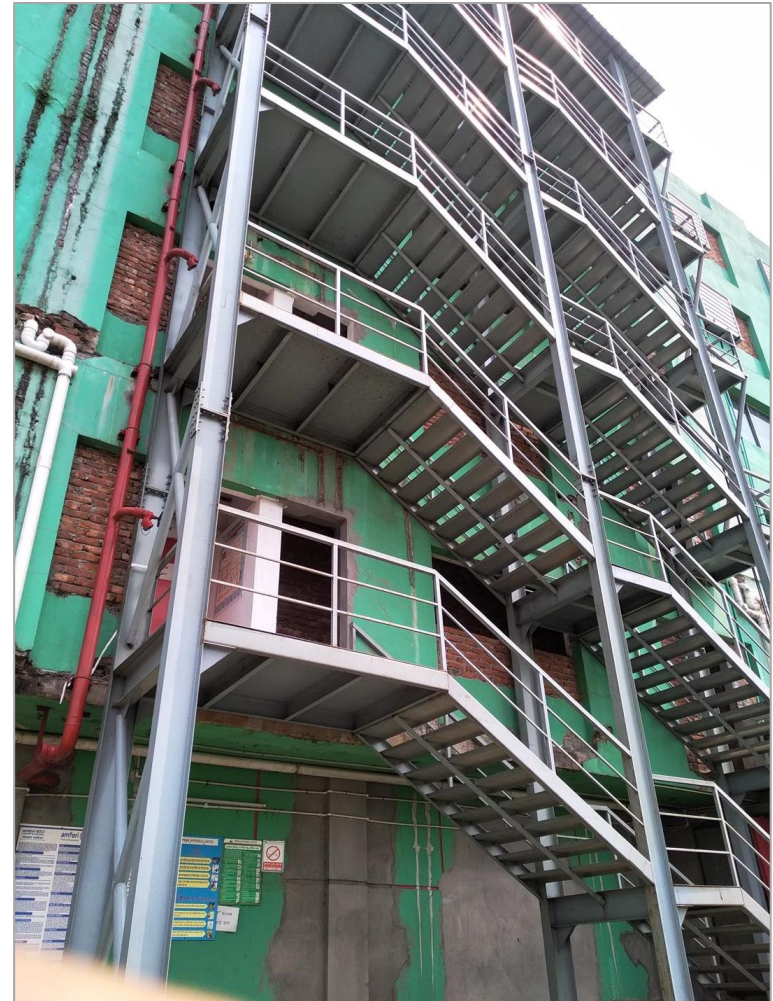
Lack of lateral stability was found against lateral load and poor connection was observed.

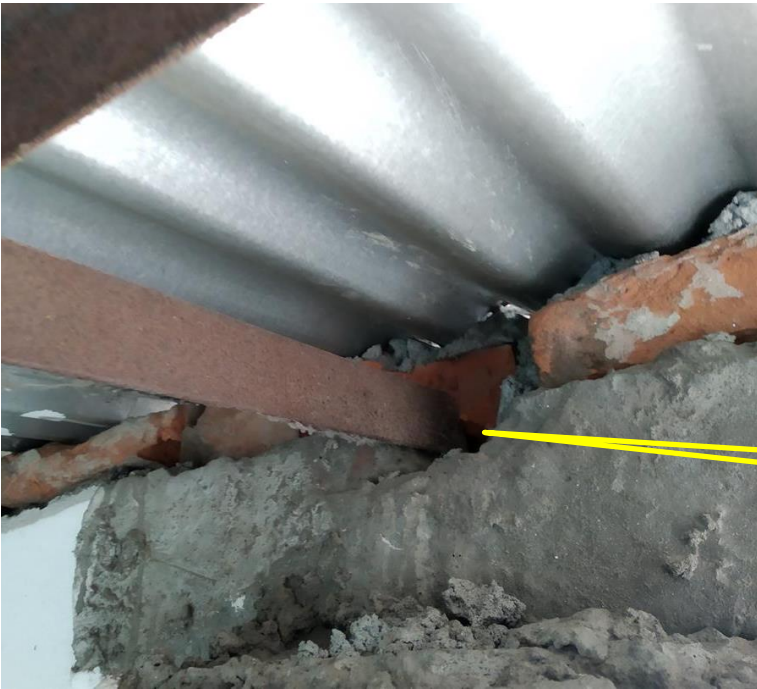
Poor connection details

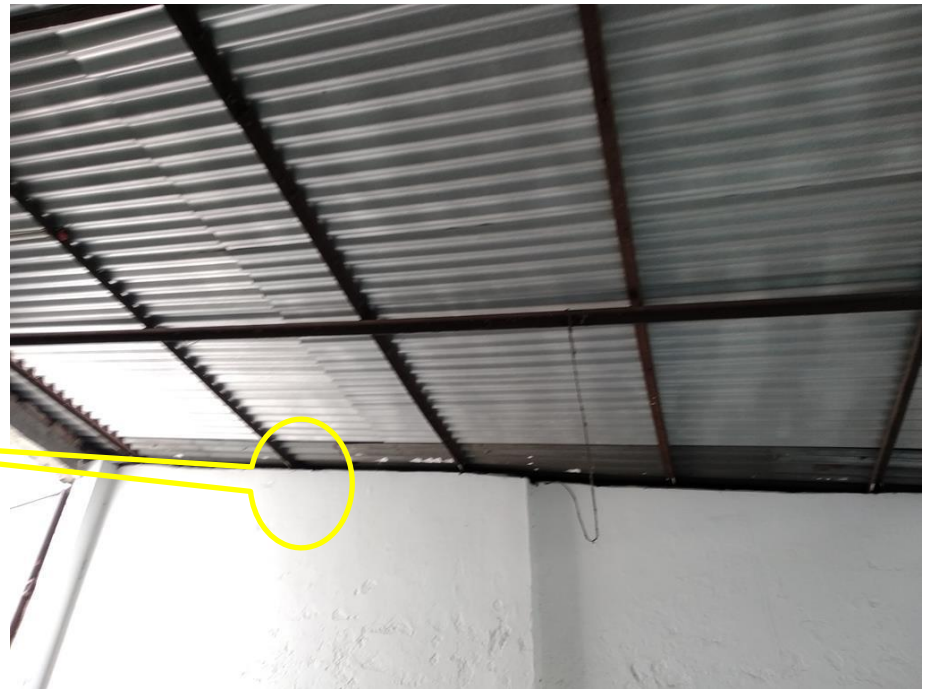
Inadequate structural members

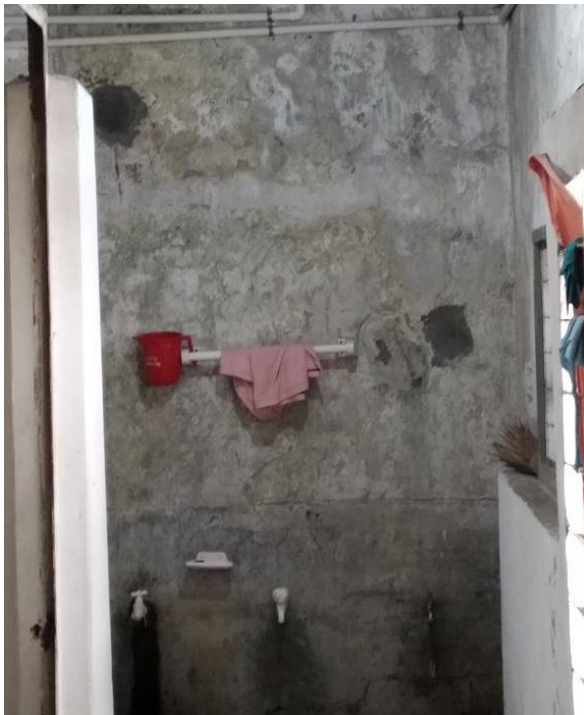
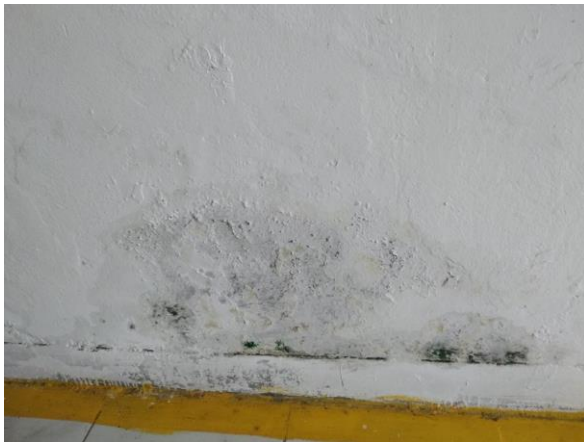
Dampness was found on the wall of toilet zone.

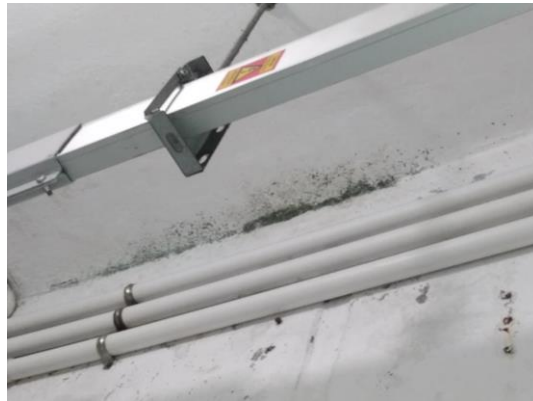
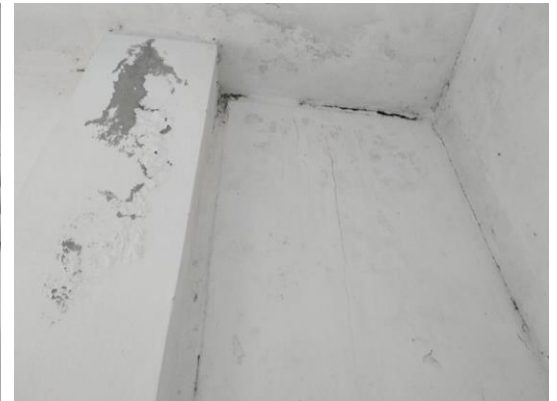
Dampness was found on roof slab soffit at several locations.

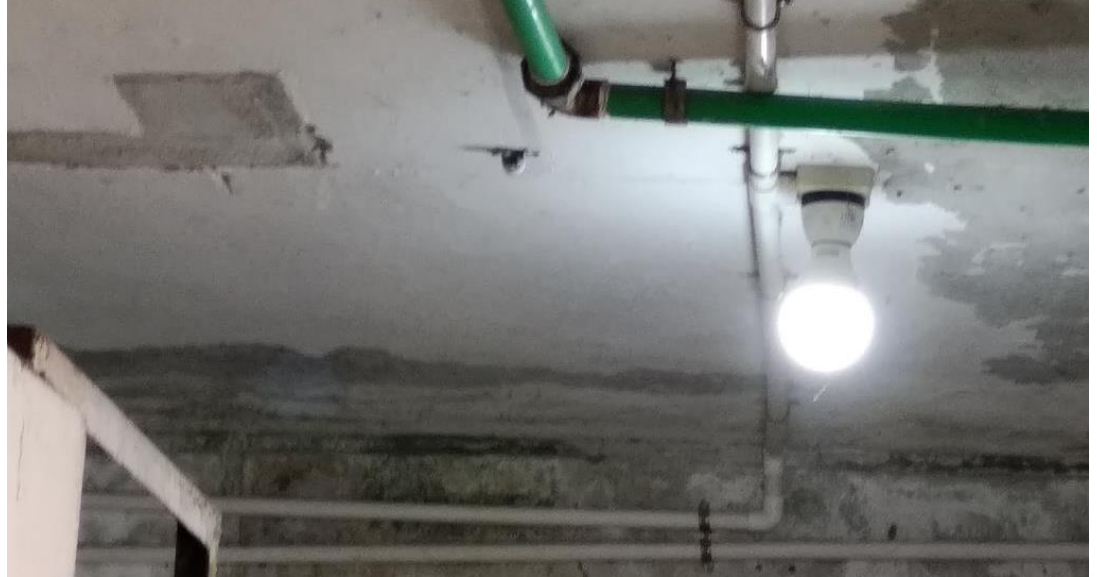
Dampness was found on slab at several locations.
