# Indochine Apparel (Bangladesh) Limited, Plot 54-56 (Previously Baxter Brenton (BD) Clothing Manufacturing Co. Ltd (Extension)

Plot-54-56, DEPZ (Old Zone), Ganakbari, Ashulia, Savar, Dhaka

9 September 2025

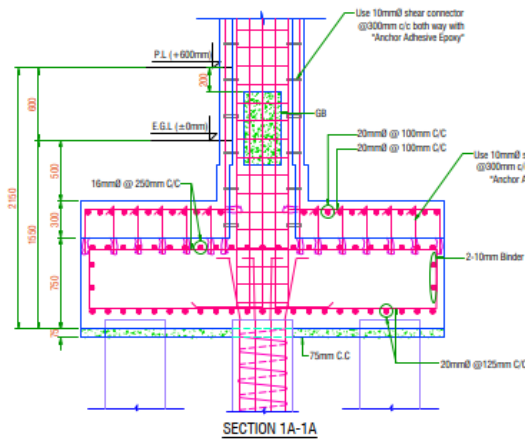
Pile cap retrofitting

**Observation-1:** Substructure retrofitting works need to be verified & assessed (Building-1)

**Description:** Several pile caps and grade beams are shown as retrofitted in the as-built drawings; however, the factory could not provide pictorial evidence, QC certifications, or adequate test reports for the works, except for one verified pile cap of five piles. The Building Engineer is required to verify all substructure retrofitting works.

| Item No. | Observation | Action Plan | Timeline |
|---|---|---|---|
| 1. | Substructure retrofitting works need to be verified & assessed (Building-1) | Verify retrofitting works of substructure | within 6 weeks |

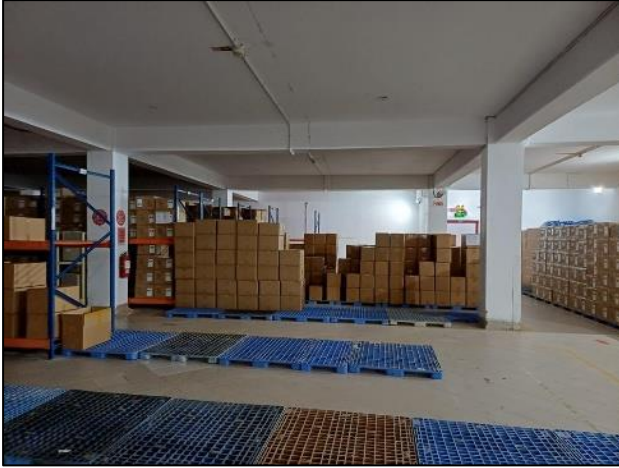
Building 1

**Observation 03: Lack of load management plan. (Building-1, 5)**

**Description:** At the time of inspection, the load plan was found posted on all floors of Building-1; however, no load height marking or load management program was observed for the building. Additionally, the load plan was not posted for Building 5. The Building Engineer is required to post the load plan for Building-5, provide load height markings, and maintain the loading accordingly.

| Item No. | Observation | Action Plan | Timeline |
|---|---|---|---|
| 4. | Lack of load management plan. (Building-1) | Implement load management plan (allowable live load plan posting, storage area and height marking, load maintaining). | within 6 weeks |

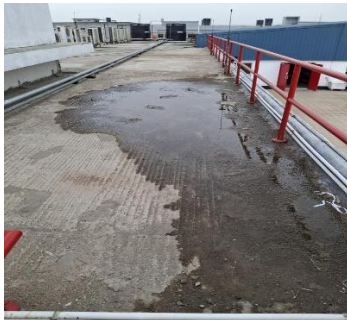
Building 1

**Observation 04: Improper roof drainage system. (Building-1, 4, 5)**

**Description:** During inspection, the roof drainage system was found to be inadequate. Also, no proper sloping was found to drain rainwater. The building engineer is required to improve the drainage system on the roof with an adequate slope.

| Item No. | Observation | Action Plan | Timeline |
|---|---|---|---|
| 5. | Improper roof drainage system. (Building-1) | The building engineer is required to improve the drainage system on the roof with an adequate slope. | within 6 months |

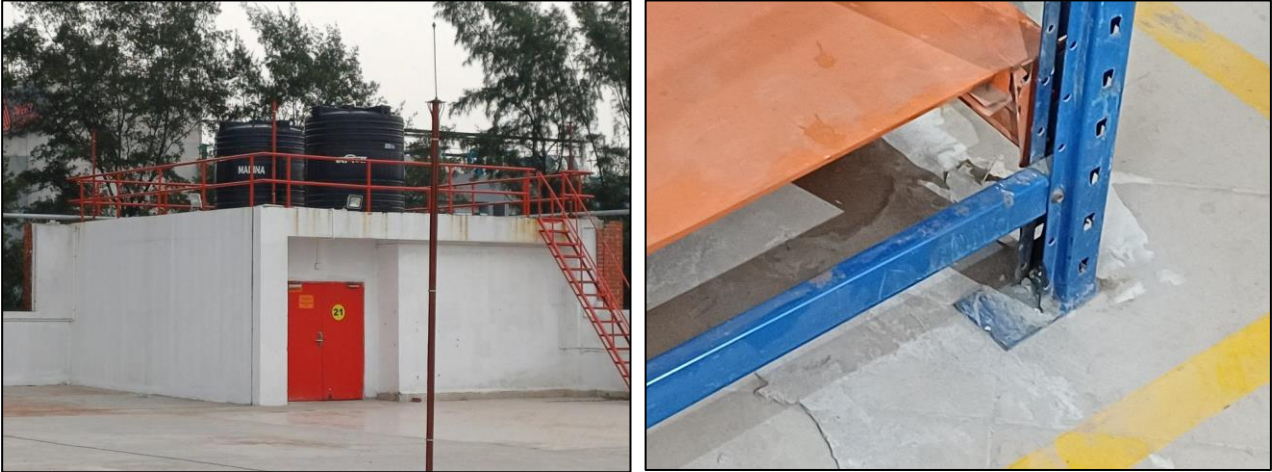
**Observation 05:** Non-structural elements were found not anchored or braced. (Building-1)

**Description:** During inspection, non-structural elements like the plastic water tank on the stair roof and storage racks on several floors were found not anchored or braced. The building engineer is required to anchor or brace all non-structural elements.

| Item No. | Observation | Action Plan | Timeline |
|---|---|---|---|
| 6. | Non-structural elements were found not anchored or braced. (Building-1) | The building engineer is required to anchor or brace all non-structural elements. | within 6 months |

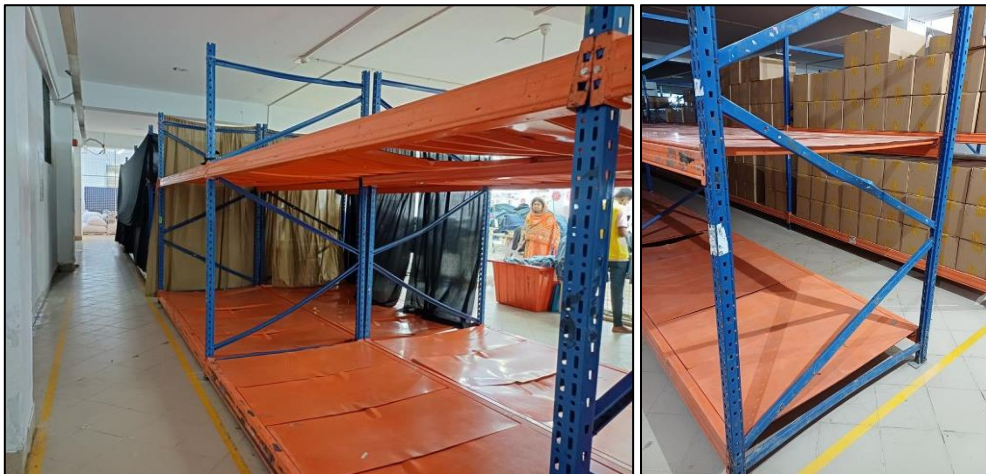
**Observation 06:** Distorted brace of storage racks. (Building-1)

**Description:** During inspection, distorted brace elements were found in storage racks on several floors. The building engineer is required to identify the distorted bracing members and replace them accordingly.

| Item No. | Observation | Action Plan | Timeline |
|---|---|---|---|
| 7. | Distorted brace of storage racks. (Building-1) | The building engineer is required to identify the distorted bracing members and replace them accordingly. | within 6 weeks |

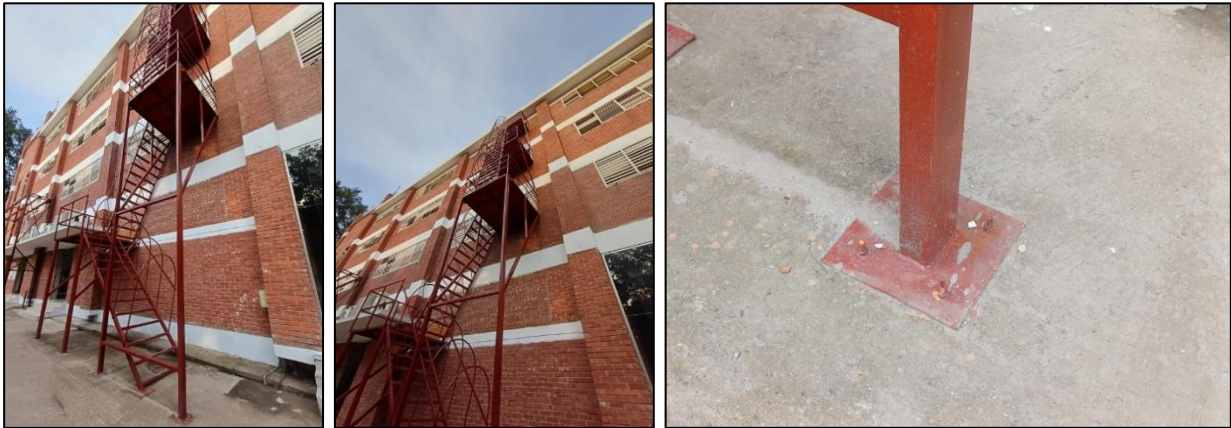
**Observation 07:** Inadequate connection and member size of the external steel stair. (Building-1)

**Description:** During inspection, two external emergency steel stairs were found on the west side of Building 1. The connection & member size were found to be inadequate. The building engineer is required to check the connection & member adequacy and suggest remedial works.

| Item No. | Observation | Action Plan | Timeline |
|---|---|---|---|
| 8. | Inadequate connection and member size of the external steel stair. (Building-1) | The building engineer is required to check the connection, member adequacy and prepare design documents for lateral & gravity forces. Otherwise, replace the steel stairs with proper engineered structures. | within 6 weeks |
| 9. | | Carry out suggested remedial works. | within 6 months |

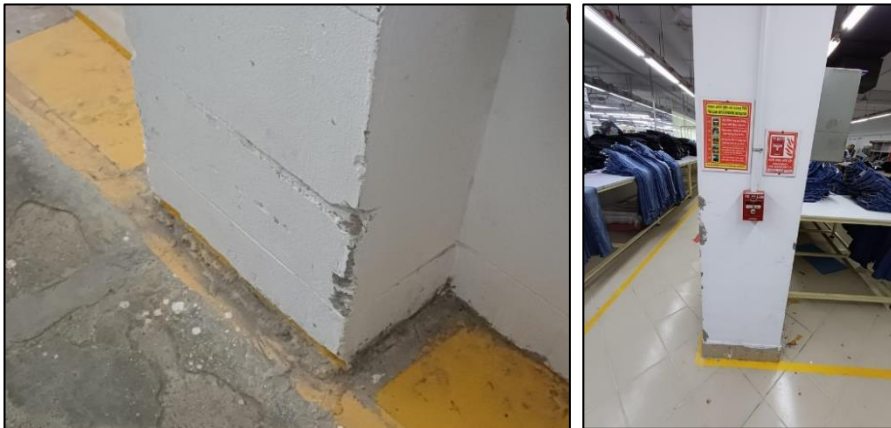
**Observation 08:** Trolley impact on column. (Building-1)

**Description:** During inspection, trolley impact was found on the column at several locations. The building engineer is required to identify the column and provide column guard to avoid trolley impact.

| Item No. | Observation | Action Plan | Timeline |
|---|---|---|---|
| 10. | Trolley impact on columns. (Building-1) | The building engineer is required to identify the damaged column and provide a column guard to avoid trolley impact. | within 6 weeks |

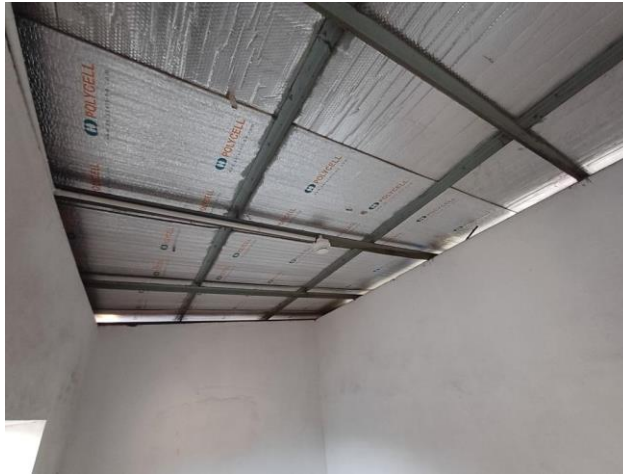
**Observation 10:** Lack of anchorage of roof shed against wind uplift (Building-7)

**Description:** The roof shed was found without sufficient anchorage to resist uplift forces induced by wind loading. The building engineer is required to ensure proper anchorage to prevent potential uplift failure.

| <b>21.</b> | Lack of anchorage of roof shed against wind uplift (Building-7) | The building engineer is required to ensure proper anchorage to prevent potential uplift failure and update as-built drawings accordingly. | within 6 weeks |
