FIRE SAFETY INSPECTION REPORT

**INTERFAB SHIRT MFG CO.
302 / 547 GASA UNION RD, GAZIPUR**

ACCORD
on Fire and Building Safety in Bangladesh

April 3, 2014

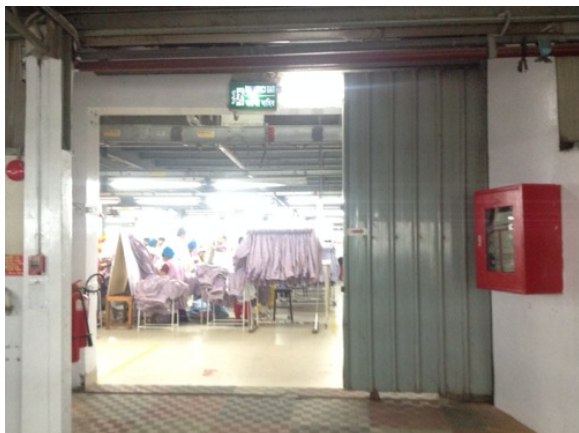
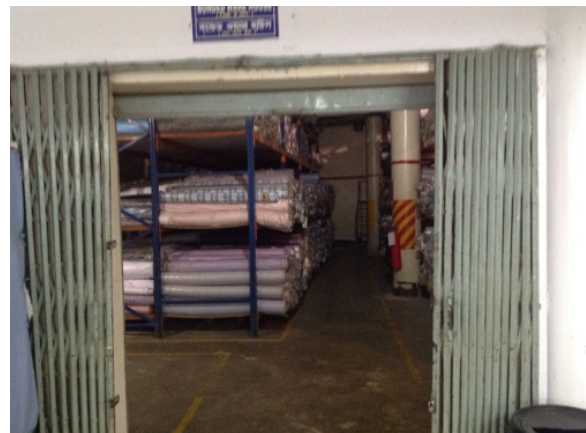
No.	Category	Finding	Recommendation	Remediation Timeframe
F-1	Egress	Egress doors / gates with locking features are provided at building exits and exit discharge.	Remove locking features from all egress doors / gates. If locks are required for security reasons, utilize special door locking features complying with NFPA 101.	Immediate
F-2	Egress	Collapsible gates / sliding doors are provided at building exits, exit discharges throughout the factory.	Replace all gates / sliding doors along the means of egress with side-hinged, swinging egress doors. If locks are required for security reasons, utilize special door locking features complying with NFPA 101.	Within 1 month

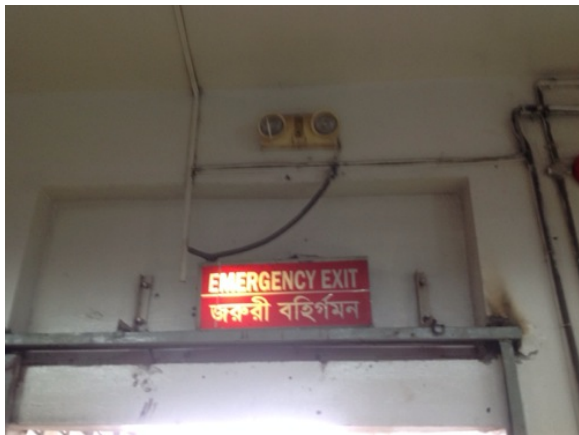
F-3	Fire Protection	Inspection, testing, and maintenance of the fire alarm system is not in accordance with NFPA 72.	Inspect, test and maintain the fire alarm system, and keep written records on-site, in accordance with NFPA 72.	Within 3 months
F-4	Egress Lighting	Based on the number and location of emergency lights observed, adequate illumination levels are not anticipated along egress routes on ground or first floor.	Test the emergency lighting system on each floor and provide additional emergency fixtures to provide adequate illumination along the means of egress. Provide a minimum illumination of 10 lux at the floor level within exit stairs and exit discharge paths and minimum 2.5 lux along exit access aisles.	Within 3 months

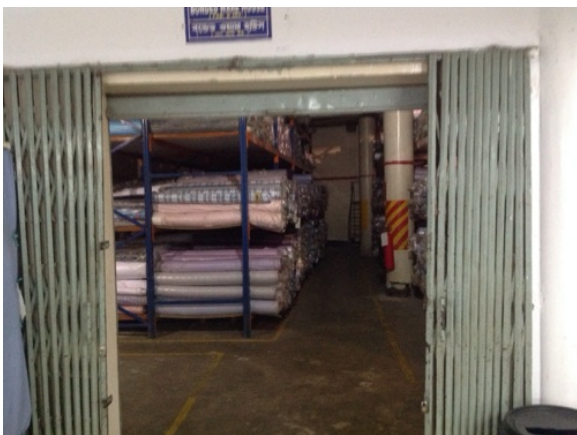
No.	Category	Finding	Recommendation	Remediation Timeframe
F-1	Fire Rated Construction	The exit stairs are not separated from work areas on each floor by fire-rated construction.	<p>Provide minimum 1.5-hr fire rated doors and seal all unprotected openings to separate the exit stairs from work areas and other building spaces on all floor levels. Ensure that the fire doors are self-closing and positive latching and that they are provided with fire exit (panic) hardware where serving production floors.</p> <p>If fire doors are required to be held open for functional reasons, provide automatic-closing devices tied to the fire alarm system.</p>	Within 3 months

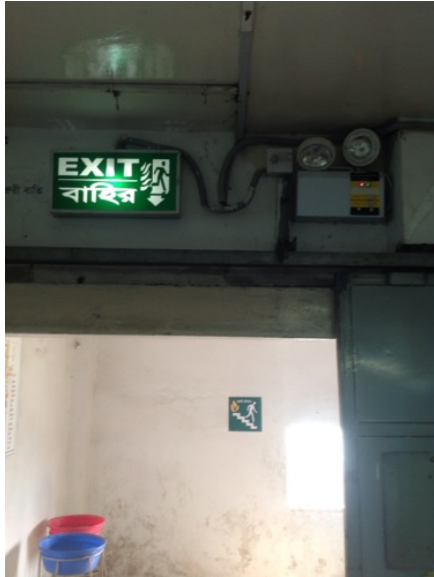
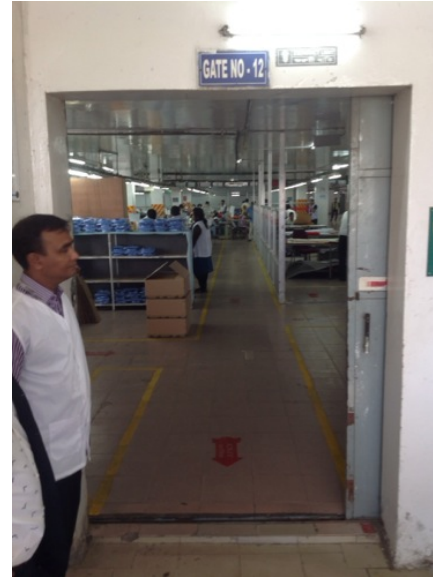
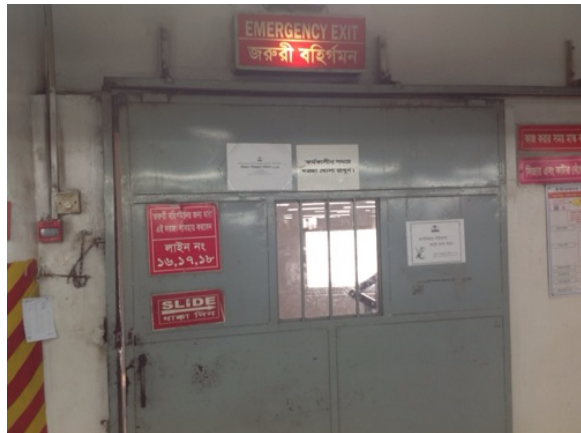
F-2	Egress	Egress doors / gates with locking features are provided at building exits, exit stairs, along egress routes, exit discharge all exits.	Remove locking features from all egress doors / gates. If locks are required for security reasons, utilize special door locking features complying with NFPA 101.	Immediate
-----	--------	--	--	-----------

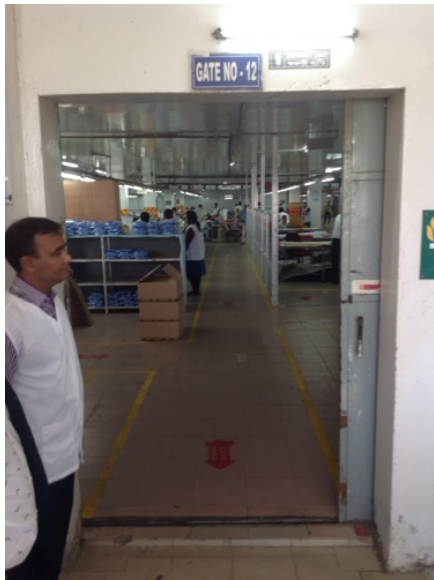
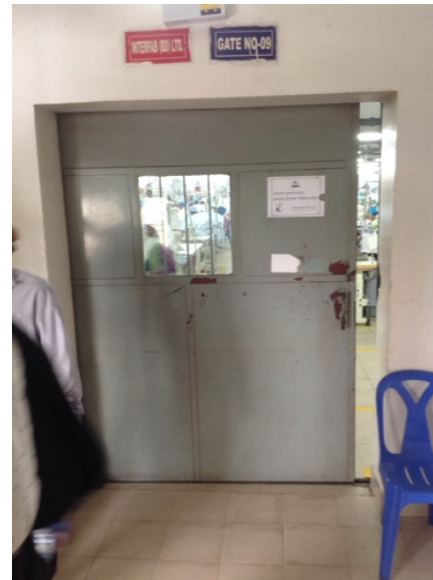
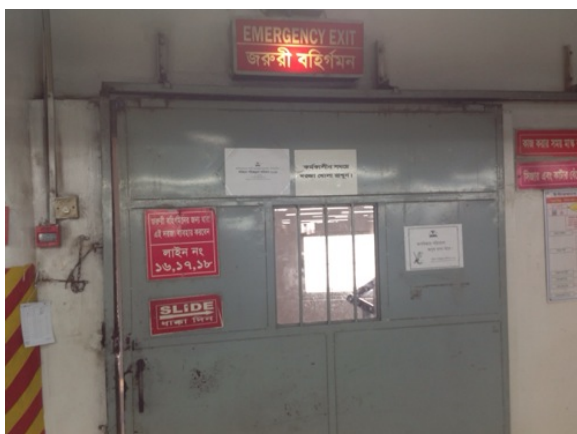
F-3	Egress	Collapsible gates / sliding doors are provided at building exits, exit stairs, along egress routes, exit discharge throughout the entire facility.	Replace all gates / sliding doors along the means of egress with side-hinged, swinging egress doors. If locks are required for security reasons, utilize special door locking features complying with NFPA 101.	Within 1 month
-----	--------	--	--	----------------

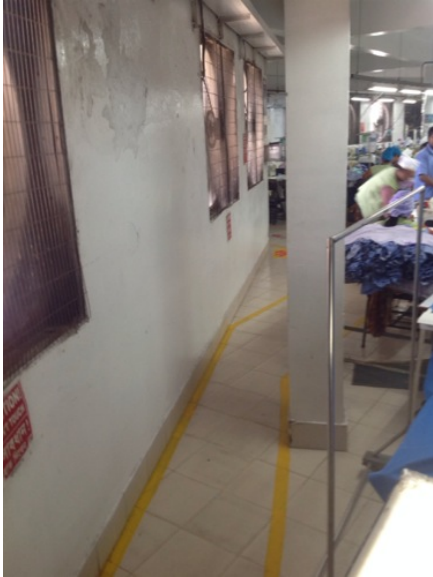
F-4	Egress	The width of egress aisles is less than 36-in along south wall floor 3.	Provide minimum aisle widths of 36-in.	Within 3 months
-----	--------	---	--	-----------------

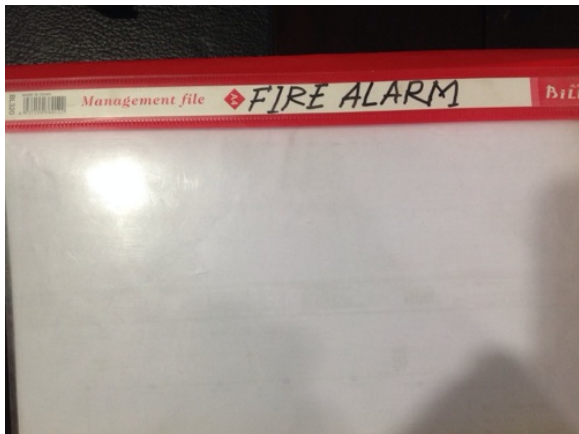
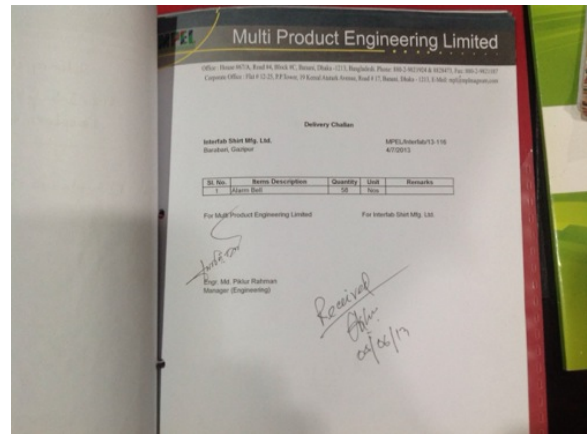
F-5	Fire Protection	Inspection, testing, and maintenance of the fire alarm system is not in accordance with NFPA 72.	Inspect, test and maintain the fire alarm system, and keep written records on-site, in accordance with NFPA 72.	Within 3 months
-----	-----------------	--	---	-----------------

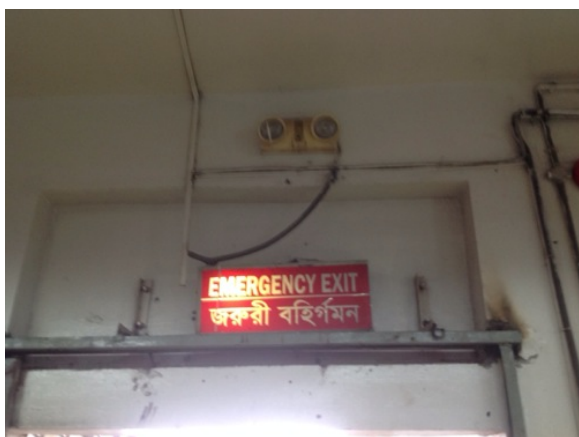
F-6 Egress Lighting Based on the number and location of emergency lights observed, adequate illumination levels are not anticipated along egress routes throughout the factory. Test the emergency lighting system on each floor and provide additional emergency fixtures to provide adequate illumination along the means of egress. Provide a minimum illumination of 10 lux at the floor level within exit stairs and exit discharge paths and minimum 2.5 lux along exit access aisles. Within 3 months

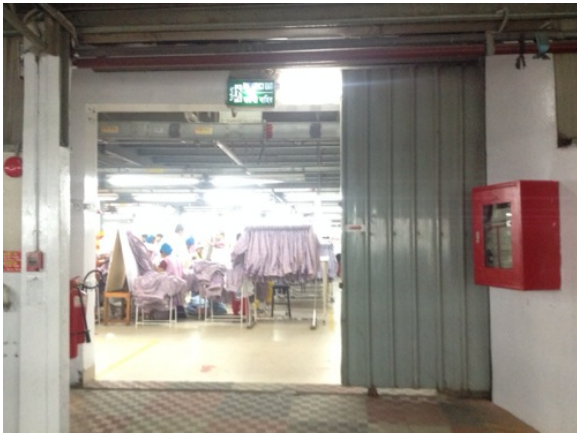
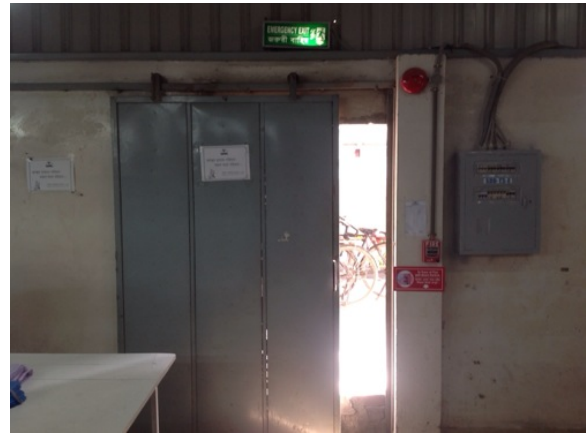
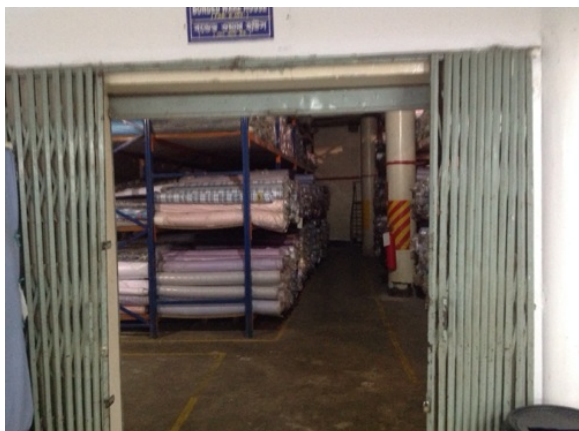
No.	Category	Finding	Recommendation	Remediation Timeframe
F-1	Egress	<p>Egress doors / gates with locking features are provided at building exits, exit stairs, along egress routes, exit discharge.</p> <p>Both sliding doors and gates are in use. One of these devices can be found on all doors in the facility.</p>	<p>Remove locking features from all egress doors / gates.</p> <p>If locks are required for security reasons, utilize special door locking features complying with NFPA 101.</p>	Immediate

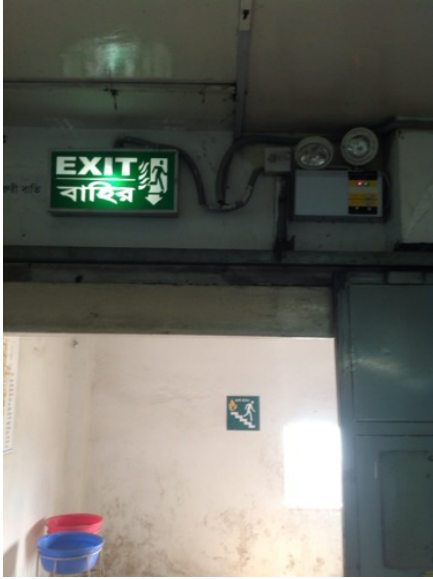
F-2	Egress	Exit stairs discharge inside the building. First floor exit discharge on working area of ground floor and not directly to the exterior of the factory.	Modify stair to discharge directly outside, or provide 2-hr fire-rated exit passageway leading directly outside.	Within 6 months
F-3	Fire Protection	Inspection, testing, and maintenance of the fire alarm system is not in accordance with NFPA 72.	Inspect, test and maintain the fire alarm system, and keep written records on-site, in accordance with NFPA 72.	Within 3 months
F-4	Egress Lighting	Based on the number and location of emergency lights observed, adequate illumination levels are not anticipated along egress routes. This condition can be found throughout the first and ground floor.	Test the emergency lighting system on each floor and provide additional emergency fixtures to provide adequate illumination along the means of egress. Provide a minimum illumination of 10 lux at the floor level within exit stairs and exit discharge paths and minimum 2.5 lux along exit access aisles.	Within 3 months
