FIRE SAFETY INSPECTION REPORT

PANDORA SWEATERS LTD
GILARCHA MASTERBARI, SREEPUR GAZIPUR

Table 1. Findings And Recommendations - Pandora Sweaters Ltd G+3 Building

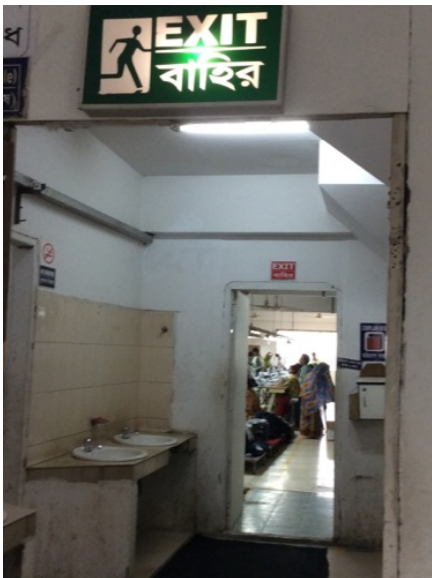
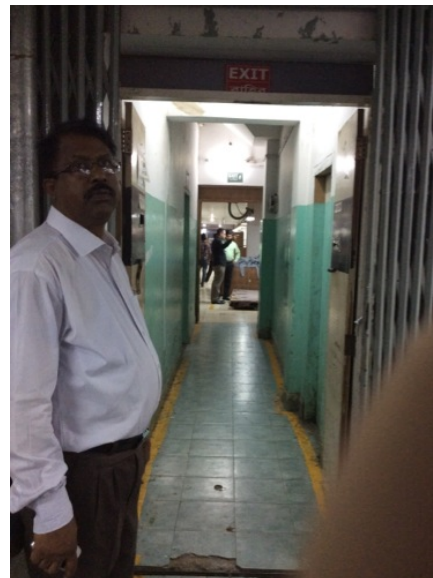
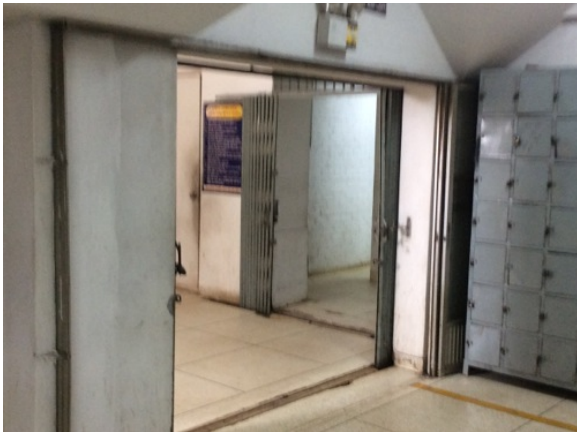
No.	Category	Finding	Recommendation	Remediation Timeframe
F-1	Fire Rated Construction	Unprotected openings at fire barrier separation between buildings were located on the ground, 1st, 2nd and 3rd floors.	<p>Provide minimum 1.5-hr fire rated doors and seal all unprotected openings to separate the two buildings on all floor levels. Ensure that the fire doors are self-closing and positive latching and that they are provided with fire exit (panic) hardware where serving production floors.</p> <p>If fire doors are required to be held open for functional reasons, provide automatic-closing devices tied to the fire alarm system.</p>	Immediate

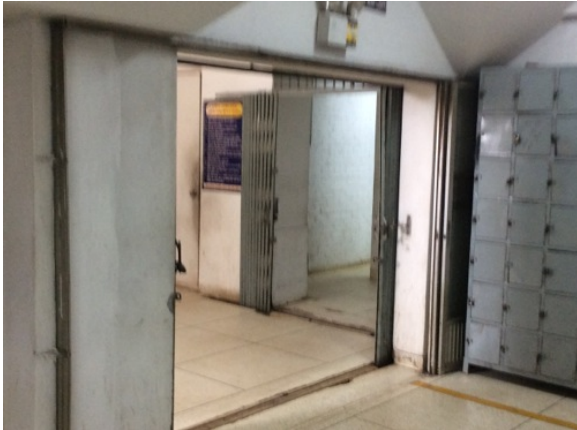
F-2	Fire Rated Construction	The exit stairs are not separated from work areas, on each floor by fire-rated construction.	<p>Provide minimum 1.5-hr fire rated doors and seal all unprotected openings to separate the exit stairs from work areas and other building spaces on all floor levels. Ensure that the fire doors are self-closing and positive latching and that they are provided with fire exit (panic) hardware where serving production floors.</p> <p>If fire doors are required to be held open for functional reasons, provide automatic-closing devices tied to the fire alarm system.</p>	Within 3 months
-----	-------------------------	--	--	-----------------

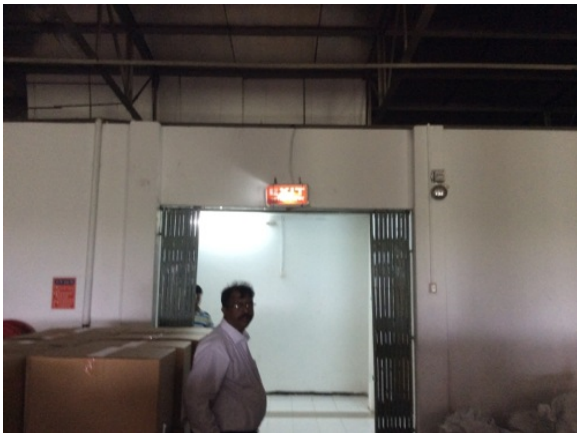
F-3	Fire Rated Construction	<p>The storage room is not separated by fire-rated construction (openings, non-rated doors, penetrations).</p> <p>Storage room is located in the 3rd floor.</p>	<p>Separate the storage room by a minimum 1-hr fire-rated construction. Seal and/or protected all openings to maintain the required fire separations.</p>	<p>Within 3 months</p>
-----	-------------------------	---	---	------------------------

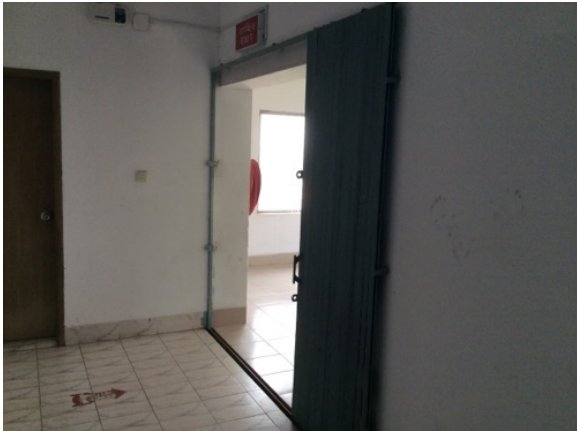
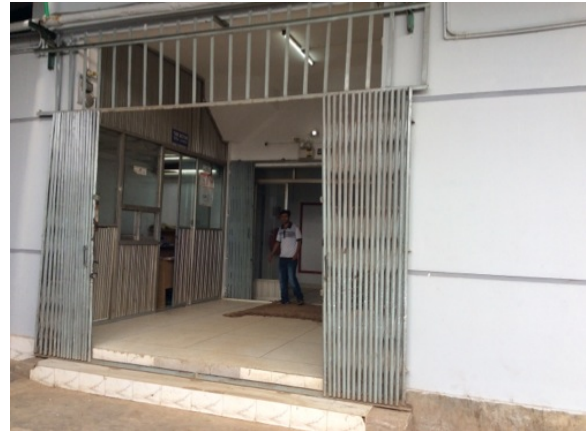
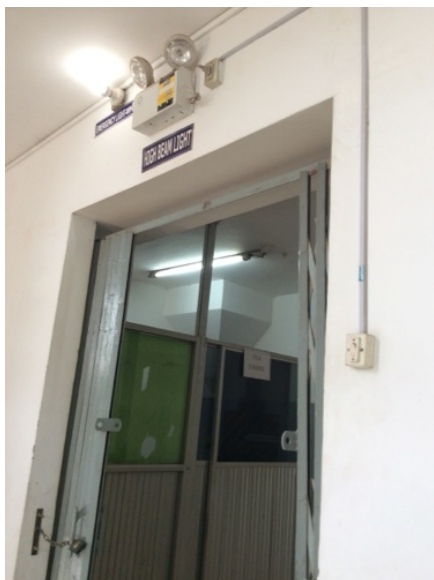
F-4	Egress	Egress doors / gates with locking features are provided at most exit stairs, some stairs have sliding glass doors.	Remove locking features from all egress doors / gates. If locks are required for security reasons, utilize special door locking features complying with NFPA 101.	Immediate
-----	--------	--	--	-----------

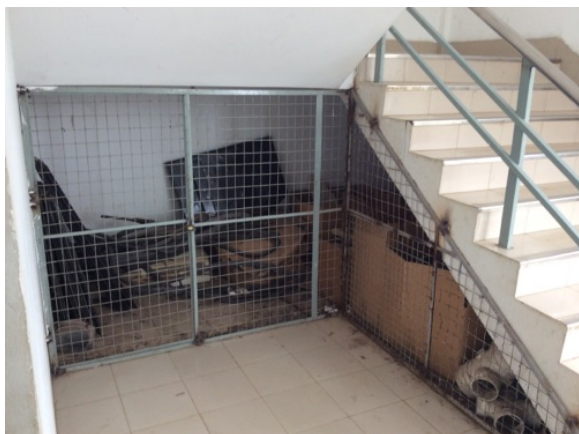
F-5	Egress	<p>Exit capacity is not adequate for the occupant load.</p> <p>2nd floor has an exit capacity of 450 occupants and an occupant load of 465.</p>	<p>Reduce occupant load to not more than available exit capacity, 450 occupants.</p> <p>In the future provide an additional horizontal exit at Southwest corner of the floor to increase occupant load.</p>	Immediate
F-6	Egress	<p>Storage was located in the exit stair.</p> <p>Combustible material was storages at the bottom of the south stair.</p>	<p>Remove all storage from exit stairs and egress paths.</p>	Immediate

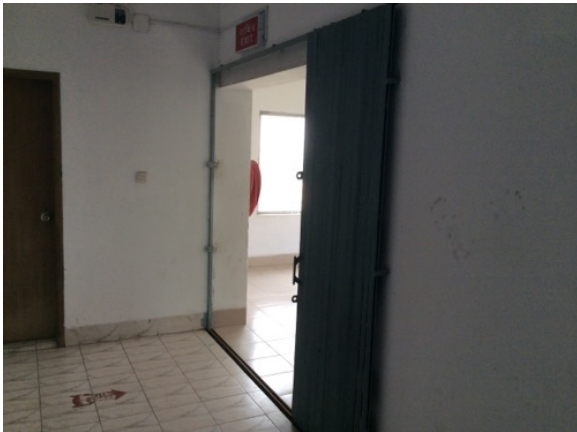
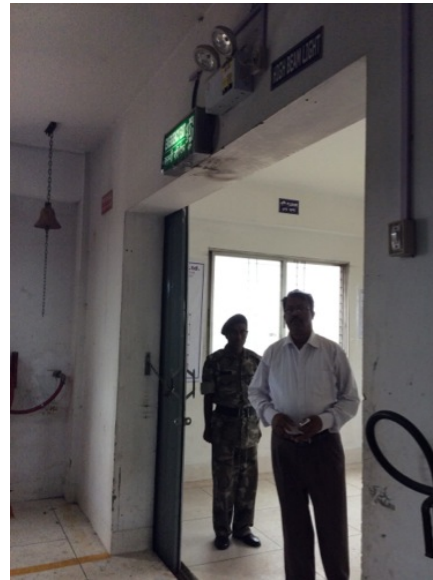
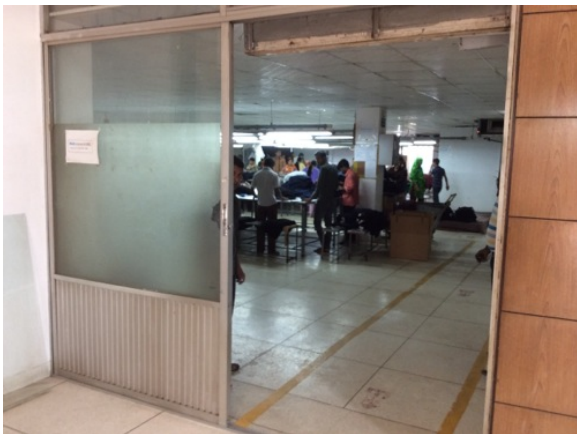
F-7	Egress	<p>Collapsible gates / sliding doors are provided at building exits, exit stairs, and exit discharge.</p> <p>Lockable sliding gates and sliding glass doors are located all along the means of the egress path of the building.</p>	<p>Replace all gates / sliding doors along the means of egress with side-hinged, swinging egress doors.</p> <p>If locks are required for security reasons, utilize special door locking features complying with NFPA 101.</p>	Within 1 month
-----	--------	---	---	----------------

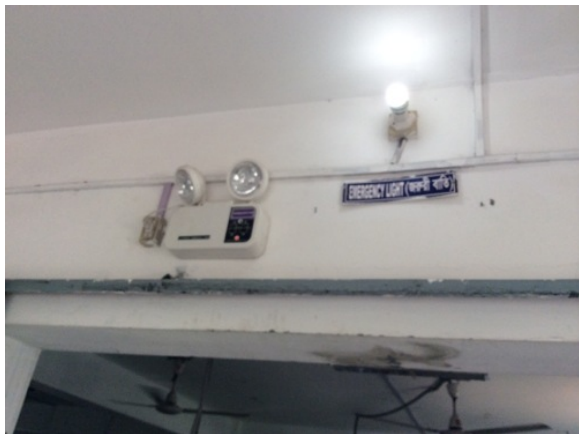
F-9	Egress Lighting	Inspection, testing, and maintenance records for the emergency lighting system were not available.	Inspect, test and maintain the emergency lighting system in accordance with The ACCORD standard. Keep written records on-site.	Within 3 months
-----	-----------------	--	--	-----------------

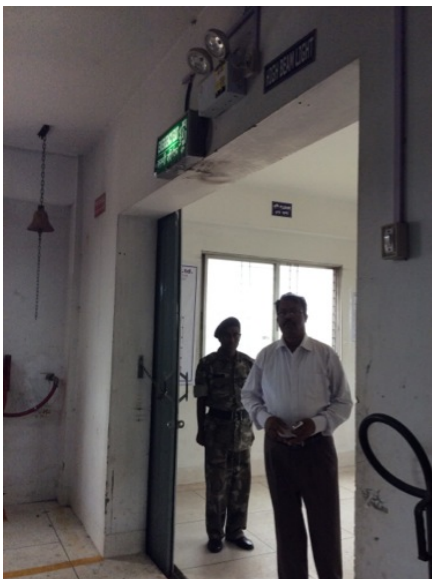
No.	Category	Finding	Recommendation	Remediation Timeframe
F-1	Fire Rated Construction	The exit stairs are not separated from work areas, on each floor by fire-rated construction.	<p>Provide minimum 1.5-hr fire rated doors and seal all unprotected openings to separate the exit stairs from work areas and other building spaces on all floor levels. Ensure that the fire doors are self-closing and positive latching and that they are provided with fire exit (panic) hardware where serving production floors.</p> <p>If fire doors are required to be held open for functional reasons, provide automatic-closing devices tied to the fire alarm system.</p>	Within 3 months

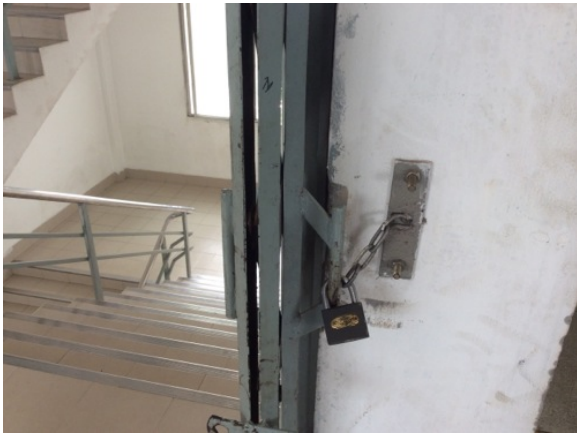
F-2	Egress	<p>Egress doors / gates with locking features are provided at building exits, exit stairs, along egress routes, and at exit discharge.</p> <p>Lockable swing gates at all exit stairs, all gates were open and unlocked during the inspection.</p>	<p>Remove locking features from all egress doors / gates.</p> <p>If locks are required for security reasons, utilize special door locking features complying with NFPA 101.</p>	Immediate
-----	--------	--	---	-----------

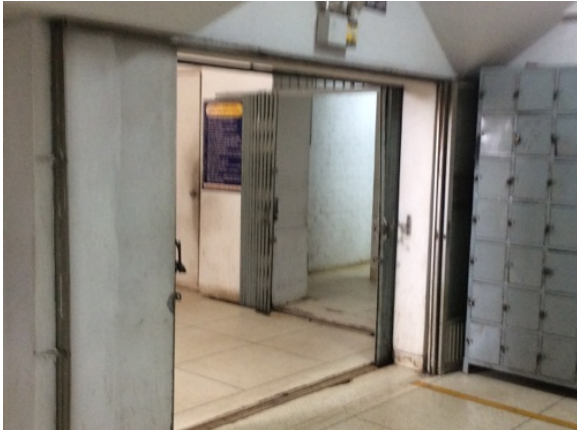
F-3	Egress	<p>Exit stair discharge into adjacent building exit enclosure stair.</p> <p>Stair on the east side discharge at the 2nd floor into adjacent building without proper fire rated separation.</p>	<p>Provide 2-hr fire-rated exit passageway leading directly into exit enclosure.</p> <p>Provide minimum 1.5 fire rated doors and seal all unprotected openings to separate the two adjacent buildings.</p>	Immediate
-----	--------	--	--	-----------

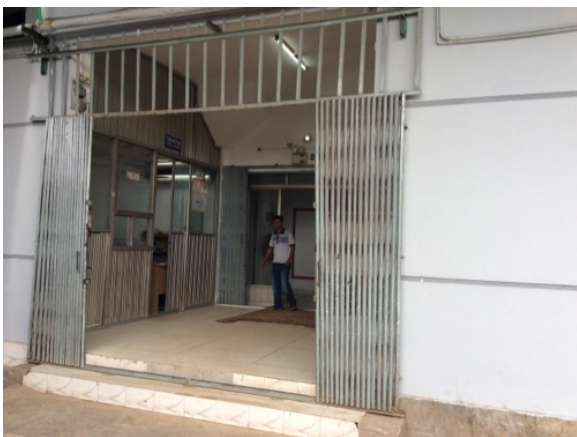
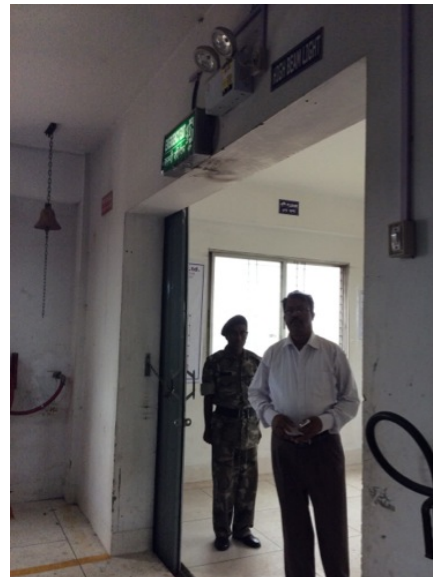
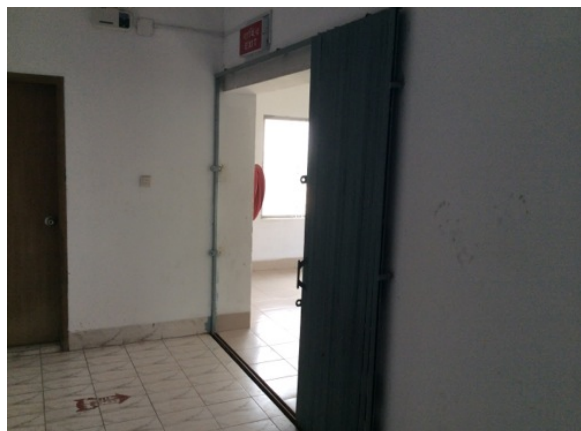
F-4 Egress

Lockable sliding gates are provided at building exits, exit stairs, along egress routes and exit discharge.

Lockable swing gates at all exit stairs, all gates were open and unlocked during the inspection.

Replace all gates / sliding doors along the means of egress with side-hinged, swinging egress doors.

If locks are required for security reasons, utilize special door locking features complying with NFPA 101.

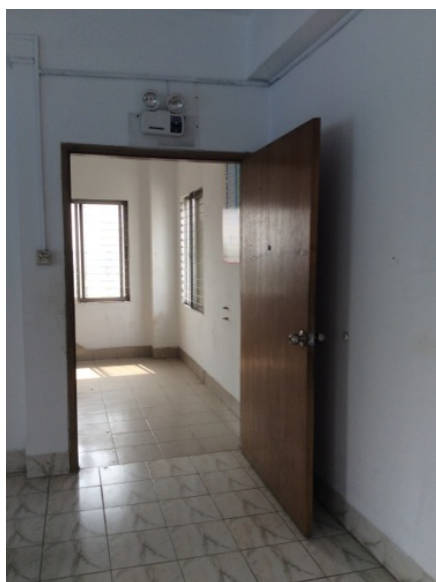
F-5	Egress	Exit stair door serving 50 or more occupants does not swing in the direction of egress travel. 5th floor into West stair.	Modify the egress door to swing in the direction of egress travel.	Within 3 months
-----	--------	--	--	-----------------

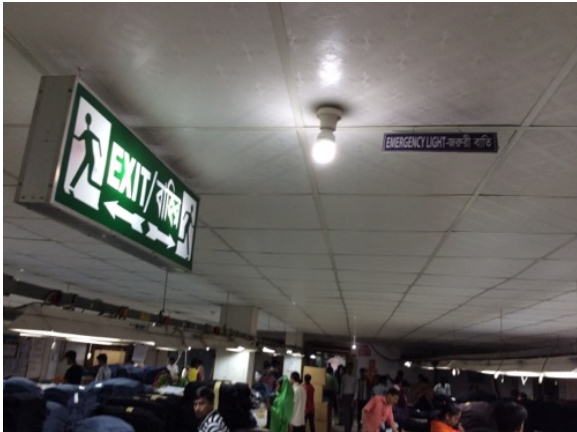
F-7	Egress Lighting	Inspection, testing, and maintenance records for the emergency lighting system were not available.	Inspect, test and maintain the emergency lighting system in accordance with The ACCORD standard. Keep written records on-site.	Within 3 months
-----	-----------------	--	--	-----------------

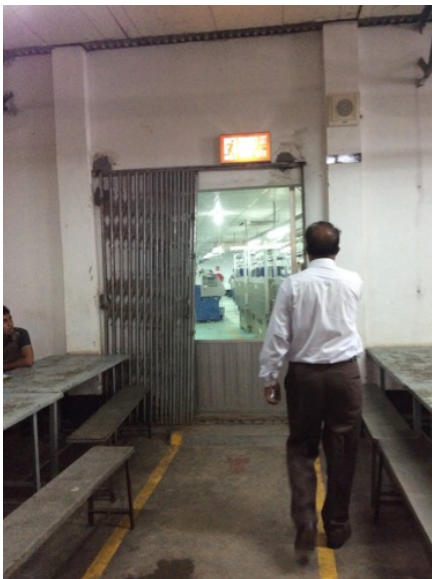
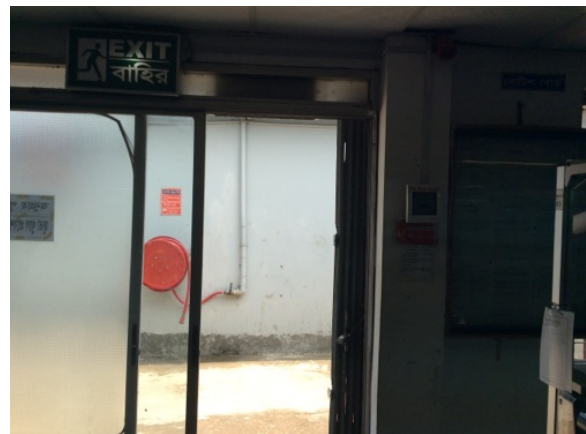
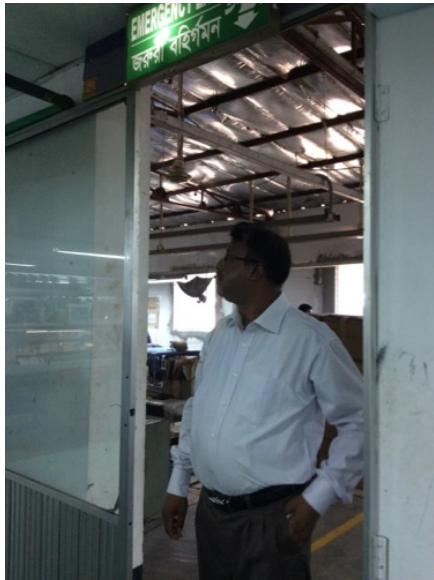
No.	Category	Finding	Recommendation	Remediation Timeframe
F-1	Egress	Collapsible gates / sliding doors are provided at building exits.	Replace all gates / sliding doors along the means of egress with side-hinged, swinging egress doors.	Within 1 month
		Lockable sliding gates and sliding glass doors thru out the building.	If locks are required for security reasons, utilize special door locking features complying with NFPA 101.

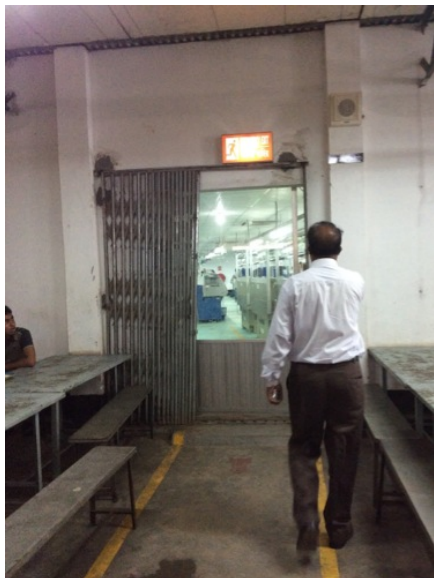
F-2 Egress

The exits are not remotely located from each other such that a single fire event could compromise both exits, in the dining area.

Modify exit arrangement or provide an additional exit or provide sprinkler protection in accordance with NFPA 13.

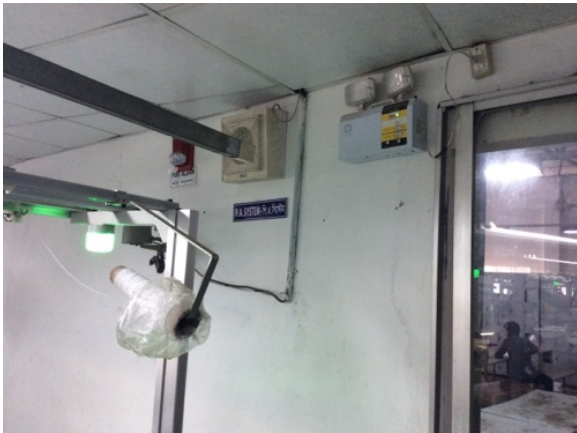
F-3	Fire Protection	Inspection, testing, and maintenance for the fire alarm system was not in accordance with NFPA 72.	Inspect, test and maintain the fire alarm system, and keep written records on-site, in accordance with NFPA 72.	Within 3 months
F-4	Egress Lighting	Inspection, testing, and maintenance records for the emergency lighting system were not available.	Inspect, test and maintain the emergency lighting system in accordance with The ACCORD standard. Keep written records on-site.	Within 3 months
