# **FIRE SAFETY INSPECTION REPORT**

**Factory Name: Divine Garments Limited**

**ACCORD ID: 12802**

**ADDRESS: Koyerpara, Chowgacha, Jessore (23.255206, 89.039256)**

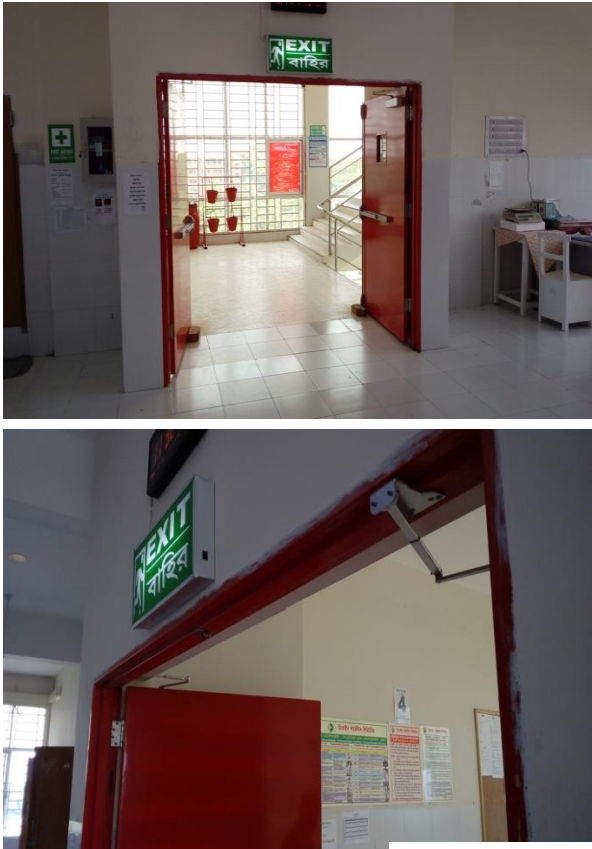
| Sl No. | Category | Findings | Required Action | Remediation Time Frame | Pictorial Evidence |
|---|---|---|---|---|---|
| 1 | Fire Rated Construction | <p>The exit stairs are not separated from [work areas, other spaces] on each floor by fire-rated construction.</p> <p>Improper assembled/missing of fire door accessories (door coordinator, vision panel etc.) have found, also kept open by using external objects.</p> | <p>Stair shall be enclosed with a minimum 2-hr fire-rated construction. Seal all unprotected openings and provide minimum 1.5-hr fire rated doors to separate the exit stairs from work areas and other building spaces on all floor levels. Ensure that the fire doors are self-closing, positive latching and that they are provided with fire exit (panic) hardware where serving production floors.</p> <p>If fire doors are required to be held open for functional reasons, provide automatic-closing devices tied to the fire alarm system.</p> <p><b>The factory shall provide listing documents of fire doors.</b></p> | Within 03 Months | |

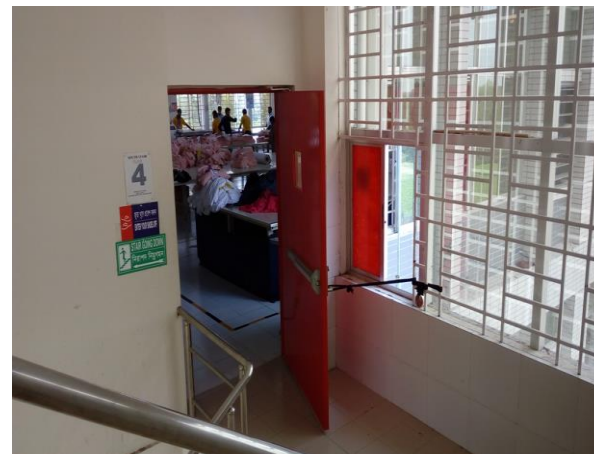
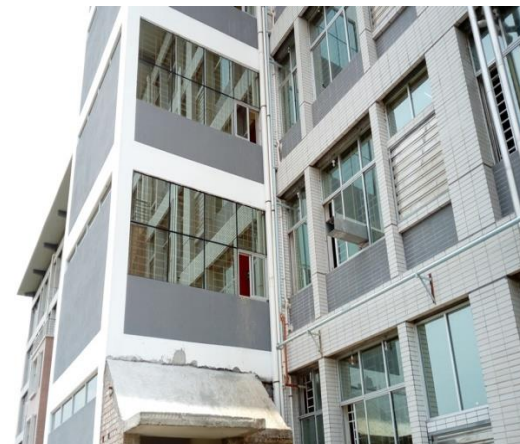
**Location: South Middle of the building**

The exterior exit stair is not separated from the building.

Exterior exit stairs shall be separated by minimum 2-hr fire-rated construction and The rating of the exterior wall shall extend 3.05 m (10 ft.) beyond the ends of the stair structure. Provide minimum 1.5-hr fire rated doors to separate the exit stairs from work areas and other building spaces on all floor levels. Ensure that the fire doors are self-closing, positive latching and that they are provided with fire exit (panic) hardware where serving production floors.

If fire doors are required to be held open for functional reasons, provide automatic-closing devices tied to the fire alarm system.

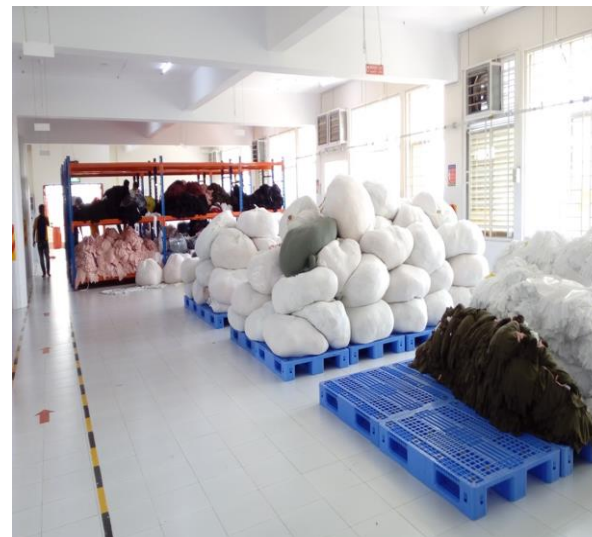
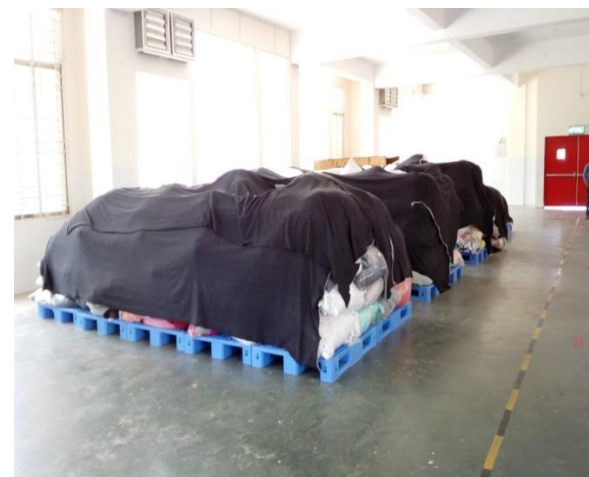
Areas used for in-process storage of combustible materials are open to the surrounding occupancy

Provide defined storage areas and limit the storage arrangement as follows:-

1. General Condition:

Maximum height of 2.4m and maximum area of 23m<sup>2</sup>.

Separate areas of unenclosed combustible storage by a minimum clear distance of 3m.

2. If sprinkler protected: maximum height of 3.66m and maximum area of 93m<sup>2</sup>. Separate areas of unenclosed combustible storage by a minimum clear distance of 3m.

or

3. Enclose the storage area from the surrounding occupancy with a minimum 1 hour construction.

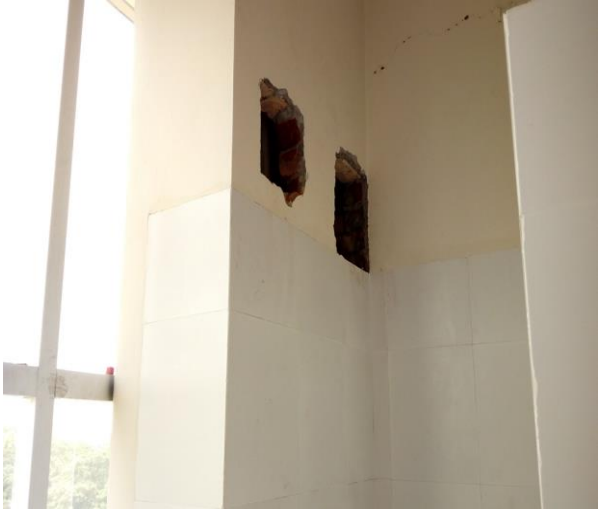
| Sl No. | Category | Findings | Required Action | Remediation Time Frame | Pictorial Evidence |
|---|---|---|---|---|---|
| 4 | Fire Rated Construction | Unsealed penetrations and openings are located in utility shaft.<br><br>Location(s): West site, Toilet Zone | Seal all penetrations and openings in floor/ceiling (full thickness of the floor/ceiling) assemblies by fire rated materials to maintain the fire resistance rating.<br><b>Or</b><br>Provide a minimum 2-hr fire rated shaft to separate the utility risers from each floor if required. | Within 03 Months | |

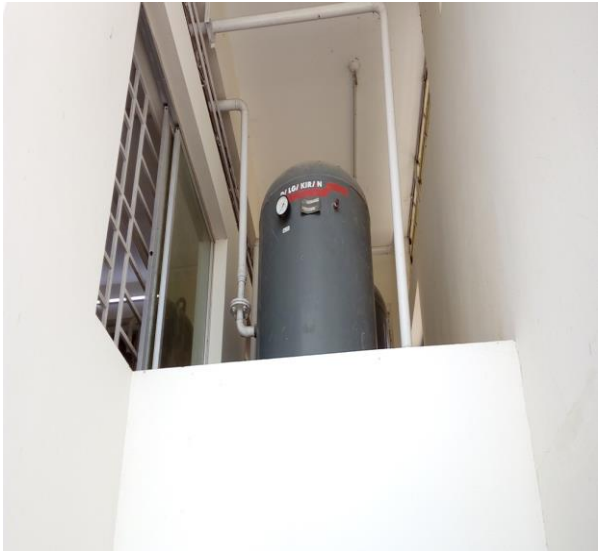
| Sl No. | Category | Findings | Required Action | Remediation Time Frame | Pictorial Evidence |
|---|---|---|---|---|---|
| 5 | Fire Rated Construction | Compressor Room is not separated properly from exit stair of utility building.<br><br>Location: 1st Floor, Utility Building | Compressor room shall be separated from other occupancies by a minimum 1-hr fire rated construction (wall, floor, slab etc.). Seal all penetrations and openings (door, window etc.) should be protected by 0.75-hr (45 min) fire rated materials to maintain the fire separation if required. All exhaust systems shall discharge to the exterior of the building in a safe location. | Within 03 Months | |

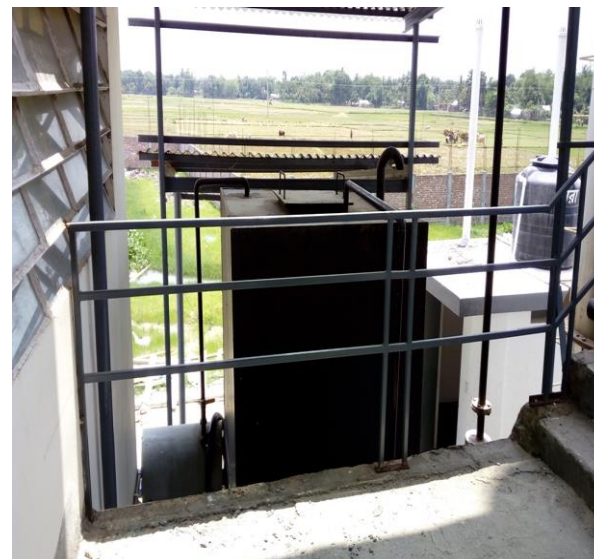
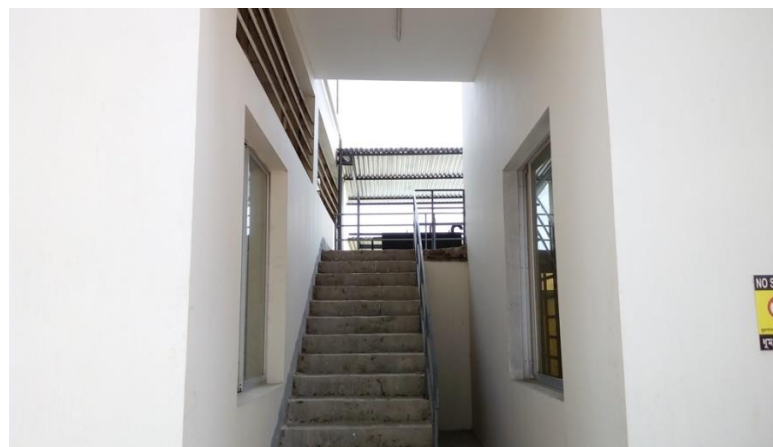
Location: Utility Building

Un protected openings have found to exit stair of utility building at ground level.

Also oil storage tank is not separated form **west side** of boiler room and **south side** of exit stair.

Stair shall be enclosed with a minimum 2-hr fire-rated construction from generator, boiler or other heat producing areas and oil storage. Penetrations and openings (door, window etc.) should be protected by 1.5-hr fire rated materials to maintain the fire separation if required. All exhaust systems shall discharge to the exterior of the building in a safe location.

Also provide a minimum 2-hr fire-rated construction between boiler room and oil stores.

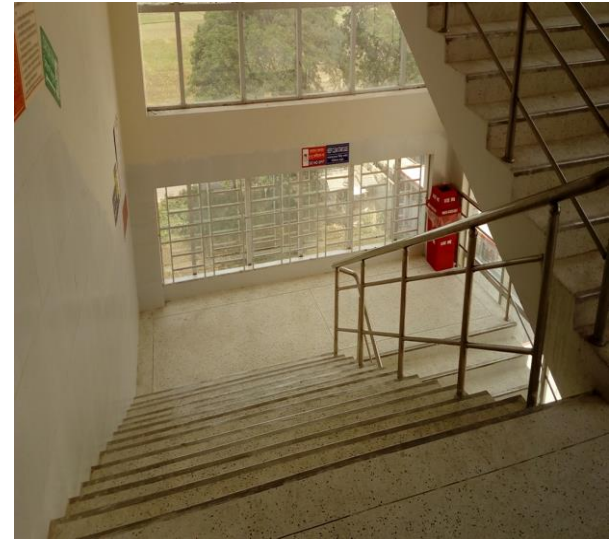
Handrails are not provided in the both side of exit stair.

Provide handrails on both side of exit stair having a minimum height 34 in. or maximum 38 in.

Intermediate handrails shall be provided when the stair width exceeds 2.2 m (87 in.)

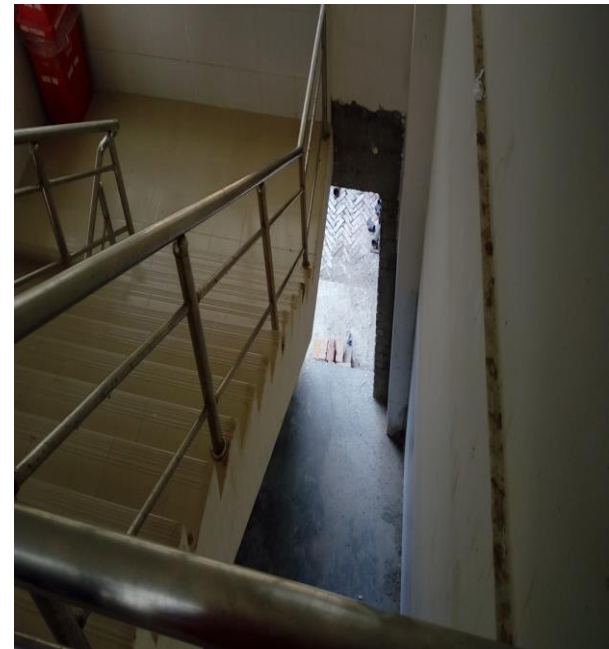
Handrail has been provided in both side of the exterior exit stair but height has found less than 34 in (actually 31 in). Moreover this handrail will be also used as guard rail because just opposite side of hand rail is like a open shaft/atrium from ground to 4th floor.

Provide handrails / guardrails on both side of exit stair having a minimum height 38 in. and maximum 42 in.

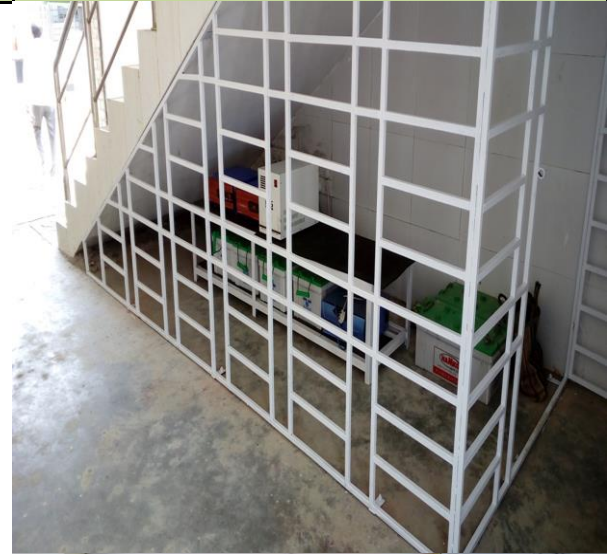
Storage was located in the exit stair.  
Location: External exit stair, South side

Remove all storage from exit stairs and egress path

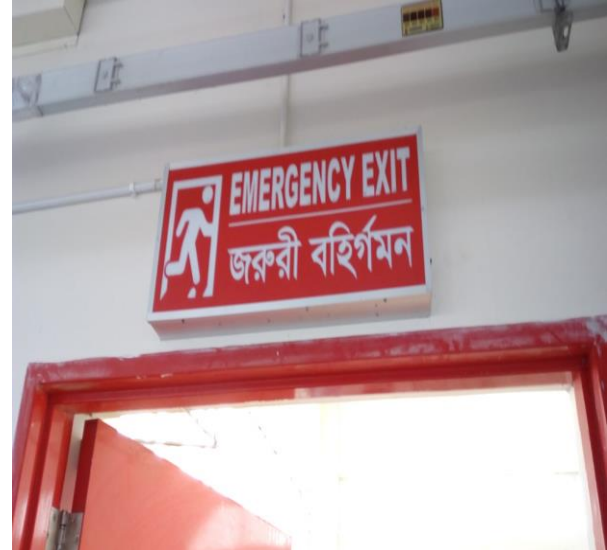
Exit signage not illuminated during inspection/testing (burned out, broken, etc.).

Regularly inspect all emergency lighting system as per Accord standard and replace/install lights as needed to illuminate signs.

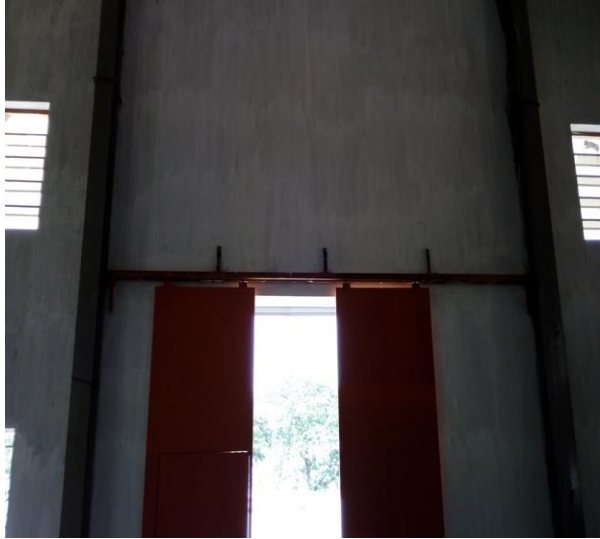
| Sl No. | Category | Findings | Required Action | Remediation Time Frame | Pictorial Evidence |
|---|---|---|---|---|---|
| 11 | Egress Lighting | Exit sign not provided at exit.<br><b>Location: Ware House</b> | Lighted exit signs shall be placed at entrance to an exit. Additional exit signs shall be placed throughout the facility anywhere the continuation of the egress is not obvious. Lighted exit signs shall be provided with either battery backup or uninterruptable power supply systems and shall be continuously illuminated. | Immediate | |

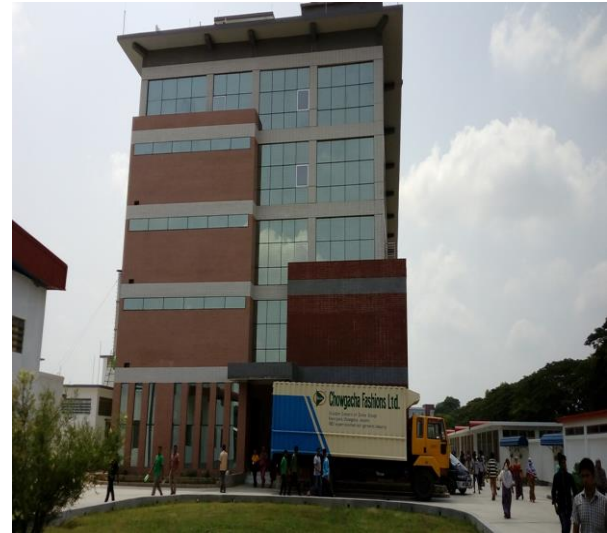
| 13 | Water Based Fire Protection System | The existing factory building with an Occupiable floor greater than 10 m (33 ft.) above the finished grade is not protected with an approved standpipe system. | <p>Provide a standpipe system throughout the building in accordance with NFPA 14.</p> <p>After complete installation, inspect, test and maintain the standpipe system, and keep written records on-site, in accordance with NFPA 25 or as per Accord standard.</p> | Design Within 02 Months & Installation within 09 Months | |
