# **FIRE SAFETY INSPECTION REPORT**

**FASHION 2000 LTD**

**367/1 SENPARA PARBOTA MIRPUR DHAKA**

April 10, 2014

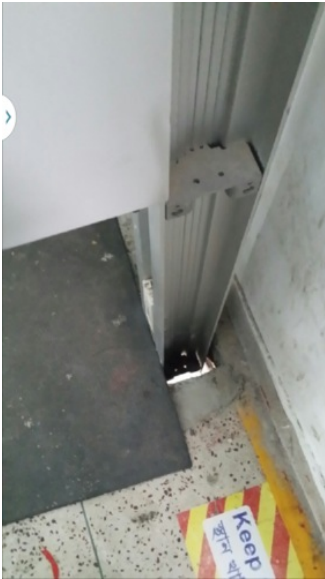
| No. | Category | Finding | Recommendation | Remediation Timeframe |
|---|---|---|---|---|
| F-1 | Fire Rated Construction | Unsealed penetrations and openings are located in the fire-rated floor/ceiling assemblies. This was reflected on all floors, penetrations were seen adjacent to the north stairwell. | Provide a minimum 2-hr fire-rated shaft to separate the utility risers from each floor level. | Within 3 months |

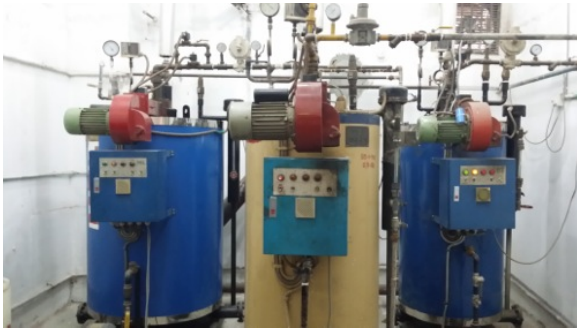
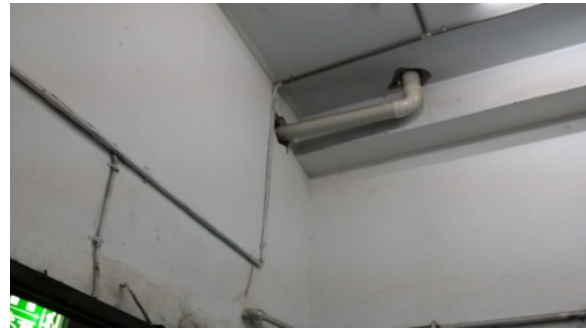
| No. | Category | Finding | Recommendation | Remediation Timeframe |
|---|---|---|---|---|
| F-2 | Fire Rated Construction | The boiler room is not separated by fire-rated construction; openings, non-rated doors, and penetrations were seen to be open to production floors, at ground level. | Separate the boiler room by a minimum 2-hr fire-rated construction. Seal and/or protected all openings to maintain the required fire separations | Within 3 months |

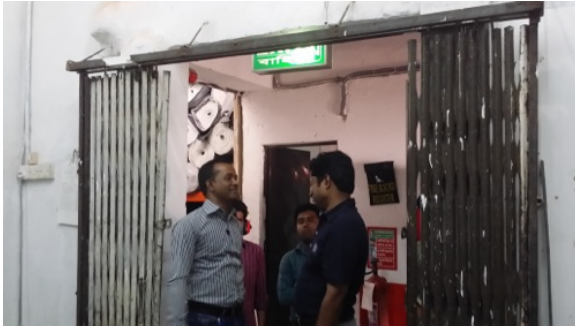
| F-3 | Fire Rated Construction | The exit stairs are not separated from work areas, on each floor by fire-rated construction. | <p>Provide minimum 1.5-hr fire rated doors and seal all unprotected openings to separate the exit stairs from work areas and other building spaces on all floor levels. Ensure that the fire doors are self-closing and positive latching and that they are provided with fire exit (panic) hardware where serving production floors.</p> <p>If fire doors are required to be held open for functional reasons, provide automatic-closing devices tied to the fire alarm system.</p> | Within 3 months |

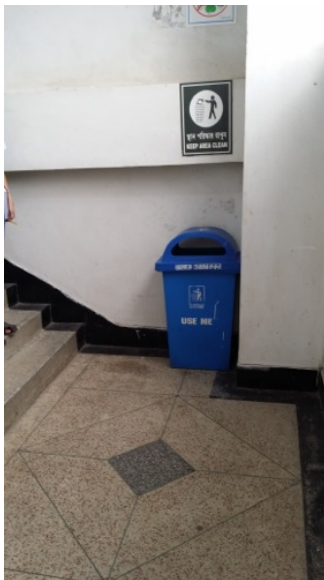
| F-4 | Egress | Storage and trash receptacles were located in all exit stairwells. | Keep egress paths and stairs clear of storage. | Immediate |

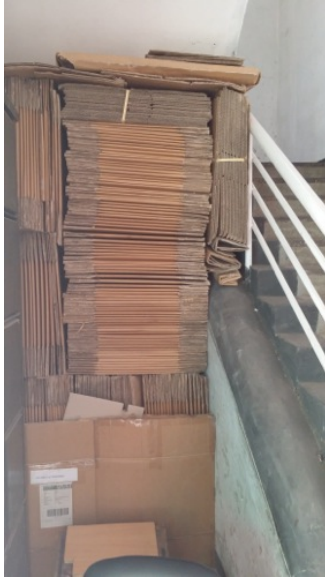
| F-5 | Egress | Ground floor west stairwell was seen to have loose boxes within the stairwell enclosures. | Remove all storage from exit stairs and egress paths. | Immediate |

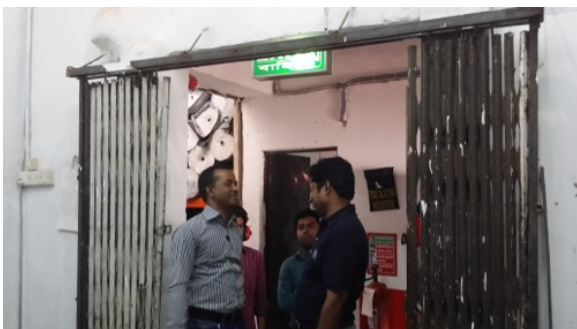
| F-6 | Egress | Egress doors / gates with locking features are provided at building exits, exit stairs, along egress routes, and exit discharge. This was reflected on all floors. | Remove locking features from all egress doors / gates.<br><br>If locks are required for security reasons, utilize special door locking features complying with NFPA 101. | Immediate |

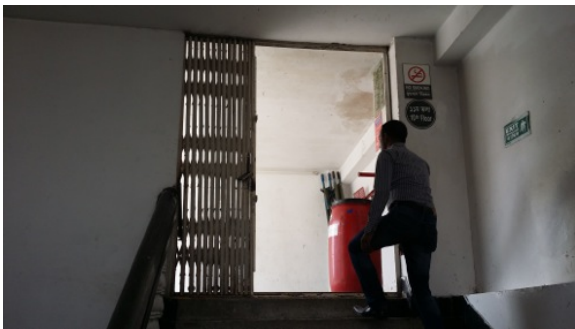
| F-7 | Egress | Collapsible gates / sliding doors are provided at building exits, exit stairs, and exit discharge. This was repeated throughout all floors. | Replace all gates / sliding doors along the means of egress with side-hinged, swinging egress doors.<br><br>If locks are required for security reasons, utilize special door locking features complying with NFPA 101. | Within 1 month |

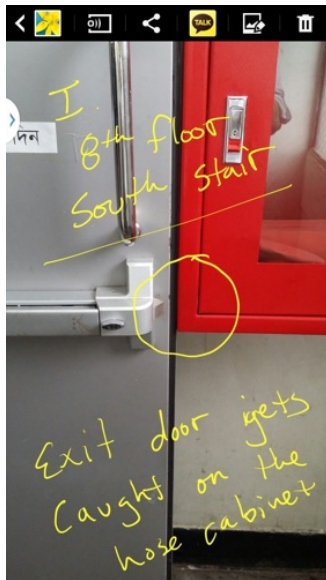
| F-8 | Egress | Located on the eighth floor south stairwell. Exit doors within exit stairwell enclosures will remain open due to the hose cabinet's close proximity to the fire door. | Relocate hose cabinet so it does not conflict with the fire rated door. | Within 1 month |

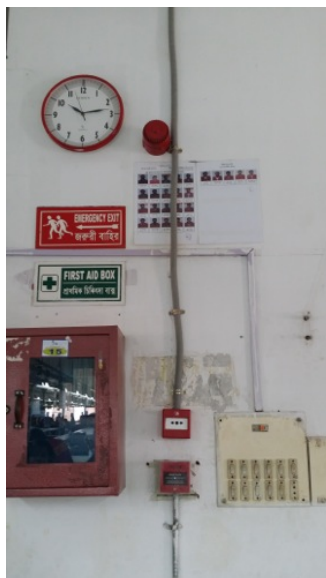
| F-9 | Fire Protection | The fire alarm system is antiquated, not a listed system, and does not provide alarm and notification features consistent with acceptable standards. | Replace the fire alarm system with a new, listed addressable fire alarm system in accordance with NFPA 72. | Design within 4 months, install within 9 months |

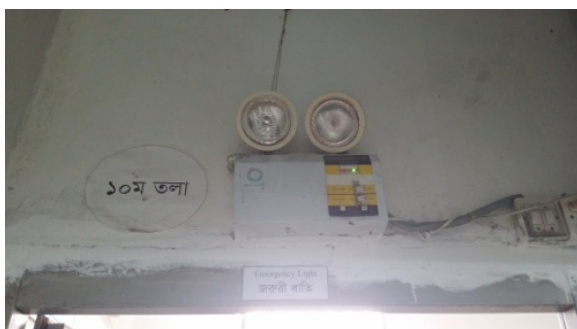
| F-12 | Egress Lighting | Emergency lighting appliances located in various areas throughout the factory were seen to have manual on/off switches. | Remove manual on/off switches from emergency lighting units to prevent them from being switched off. | Within 1 month |
