# Ever Fashions (Tongi) Ltd.

Plot # D-204,205,206,BSCIC Industrial Area, Tongi, Gazipur- 1710  
(23.892027N, 90.415737E)

25 June 2014

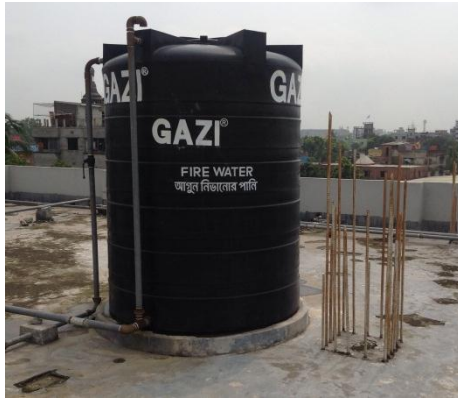
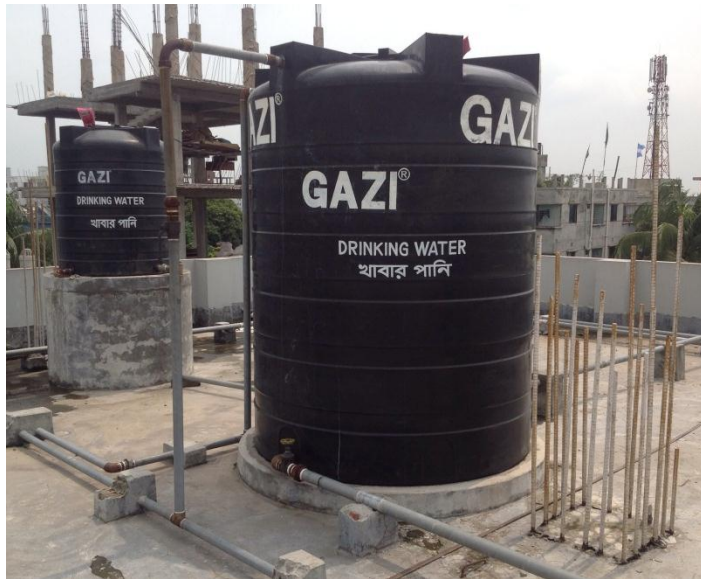
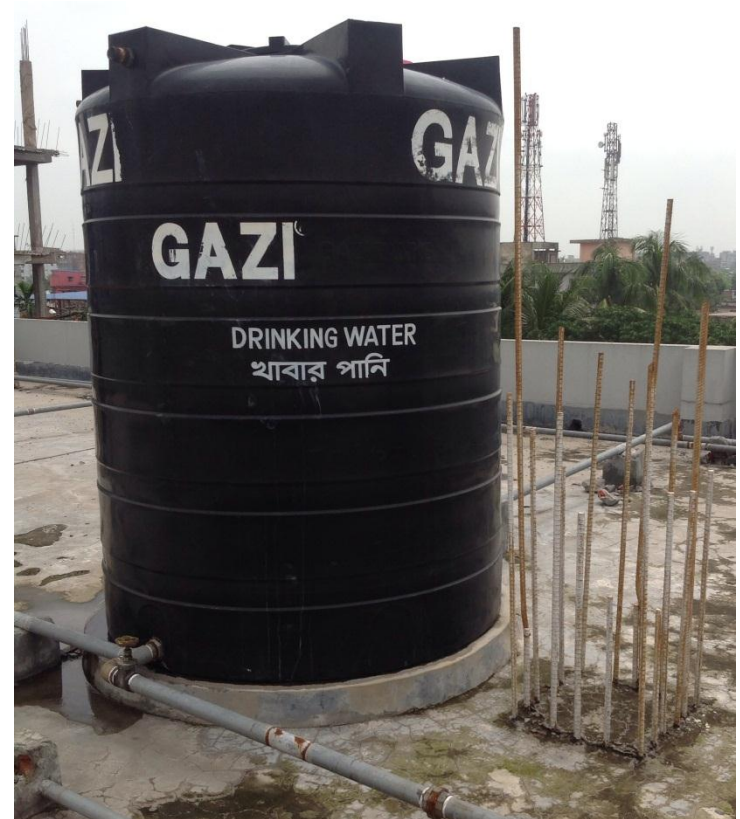
# High slab loads

Water tanks and plinths heavily loading slab to roof level.

| Item No. | Observation | Recommended Action Plan | Recommended Timeline |
|---|---|---|---|
| 1 | Check localised high loading from water tanks and storage loading | Building engineer to check that slabs and columns have sufficient capacity to locally support fully filled water tanks (inc. plinths) and storage loads. | 6-weeks |

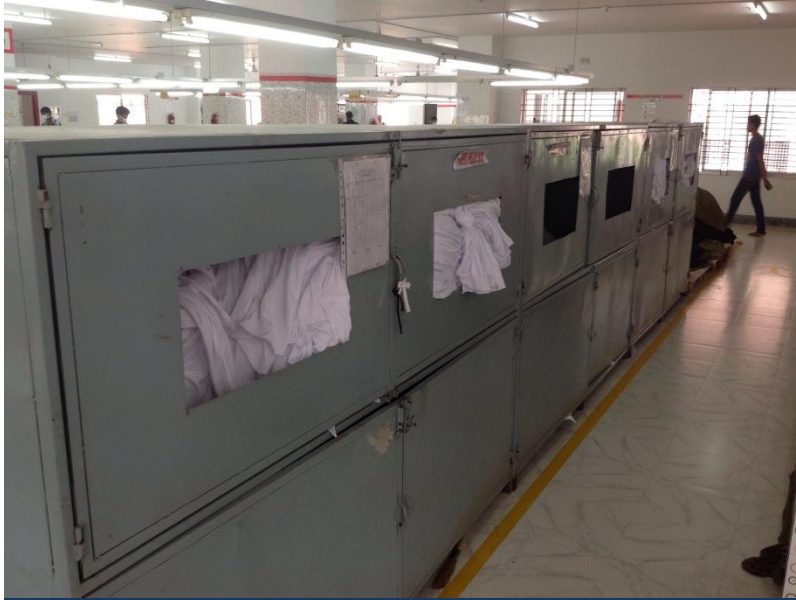
Fabric relaxation storage

Fabric waste storage and the fabric relaxing storage on the 1<sup>st</sup> floor is densely packed resulting in high areas of load.

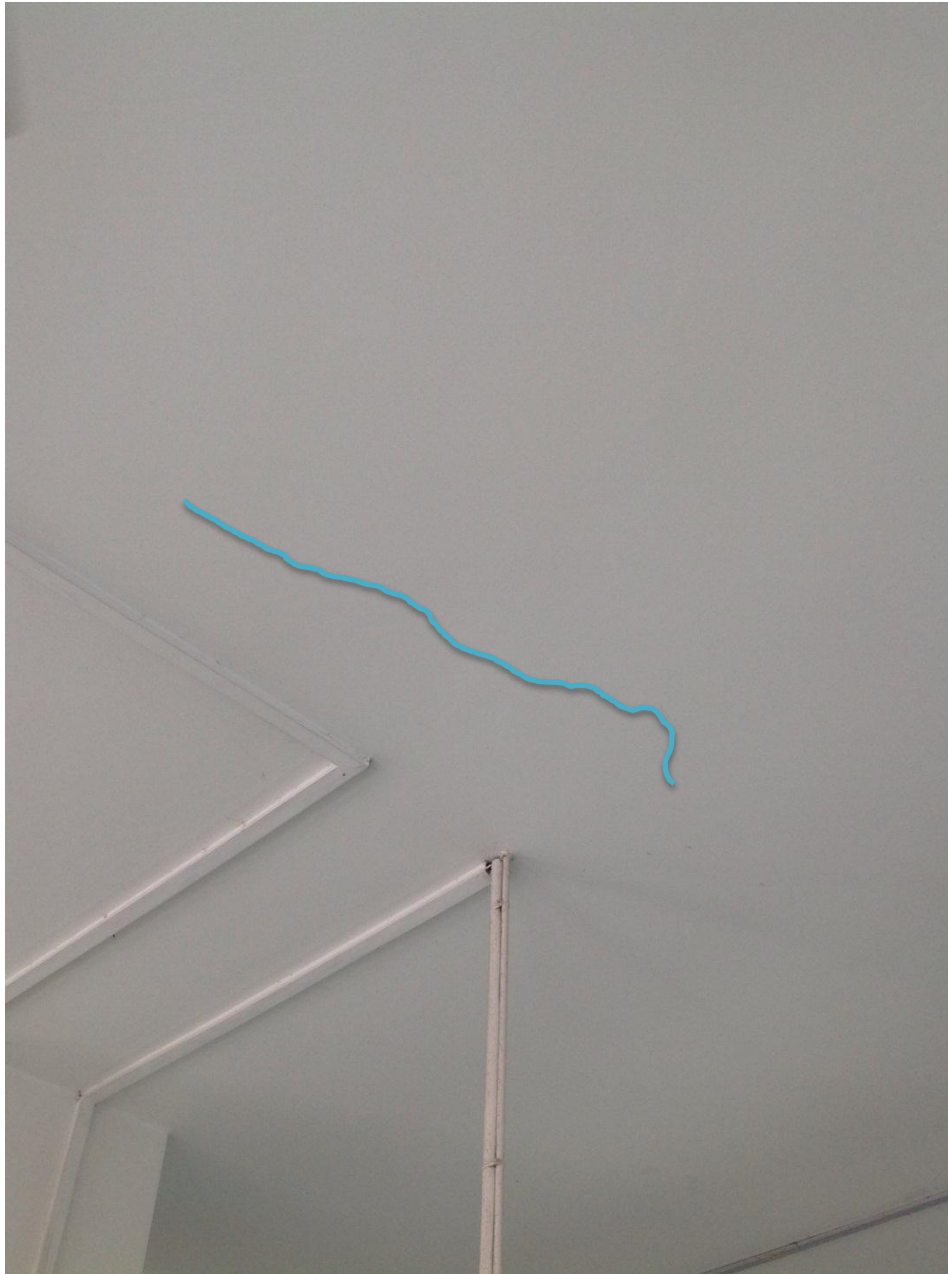
Multiple cracks on slab soffit of current roof level were observed directly below water tank position.

| Item No. | Observation | Recommended Action Plan | Recommended Timeline |
|---|---|---|---|
| 2 | Cracks to soffit of roof slab | Sections of plaster finish to be removed to investigate if cracks penetrate the building structure | 6-weeks |
| 3 | Cracks to soffit of roof slab | Engineer to carry out design check on affected areas to confirm design is adequate. | 6-months |

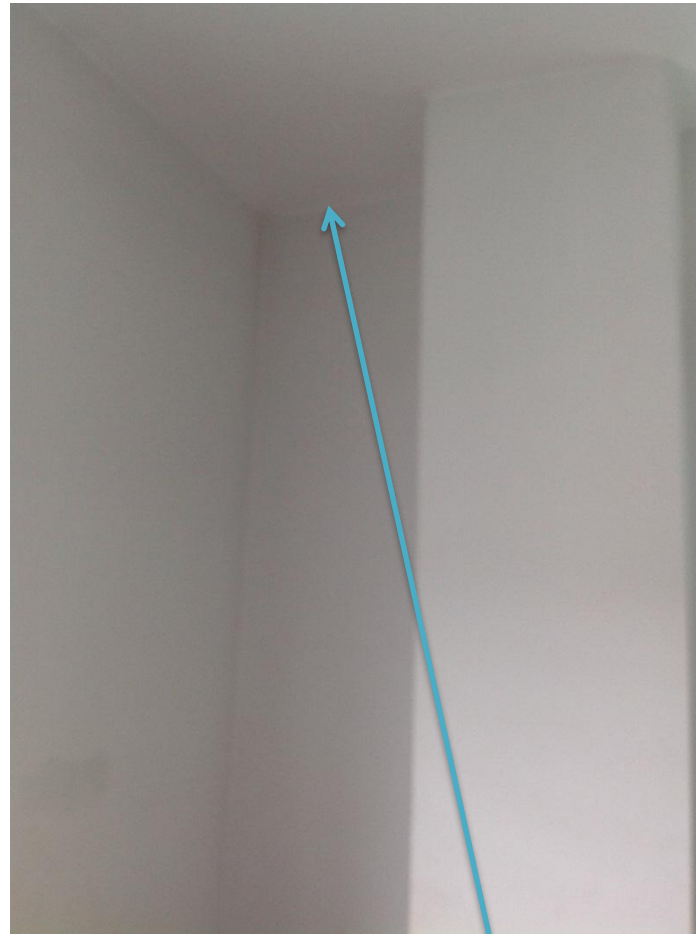
Cantilever beyond edge column

Cantilevers were present on site which were not shown on the permit or structural drawings

| Item No. | Observation | Recommended Action Plan | Recommended Timeline |
|---|---|---|---|
| 4 | Permit and structural drawings are not in line with the as-built condition | Building engineer to check, collect information and produce accurate and complete as-built documentation at the soonest opportunity. | 6-months |

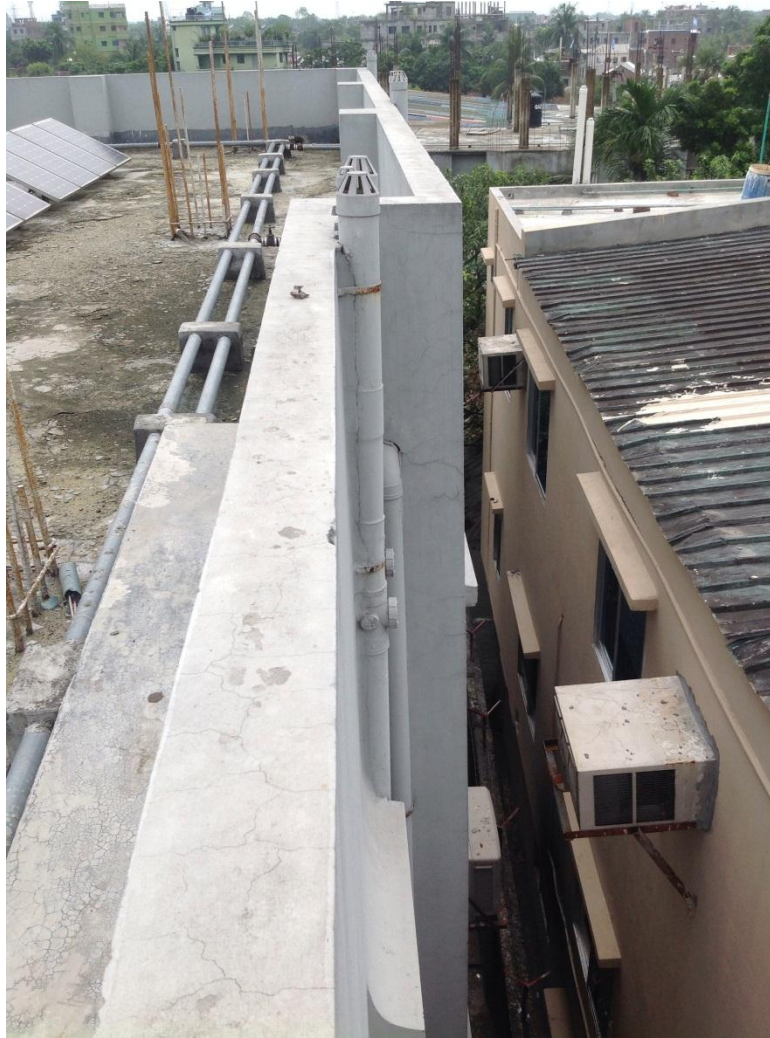
Masonry parapet is 1 brick thick and is insufficiently restrained by the structure

| Item No. | Observation | Recommended Action Plan | Recommended Timeline |
|---|---|---|---|
| 5 | Unrestrained masonry parapet to roof | Building engineer to check design of parapet under design loadings and install restraints, if necessary. | 6-months |

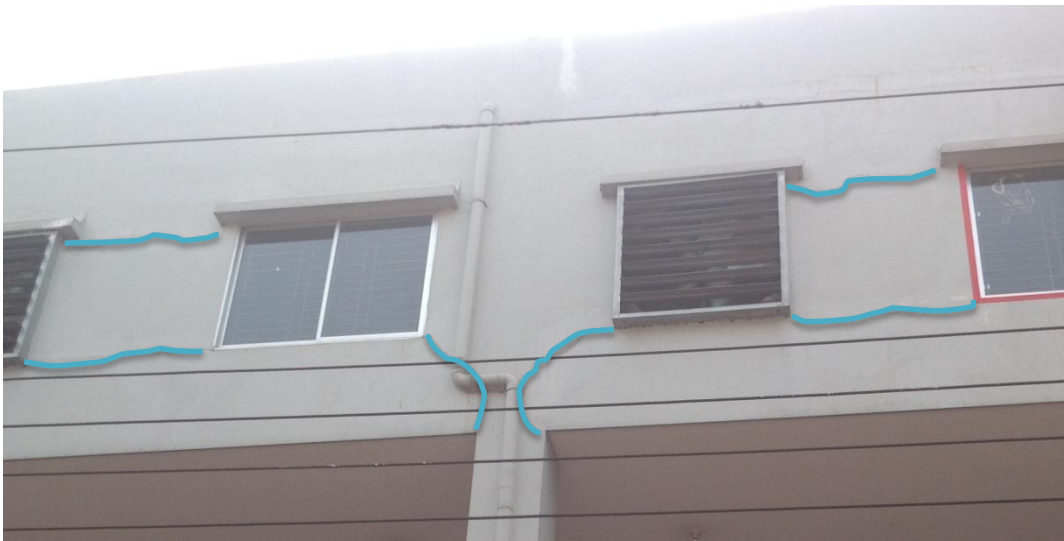
Masonry façade has multiple locations of cracking

| Item No. | Observation | Recommended Action Plan | Recommended Timeline |
|---|---|---|---|
| 6 | Cracks to masonry façade | Sections of plaster finish to be removed to investigate if cracks penetrate the masonry façade structure and to ensure masonry panels remain restrained to structure. | 6-weeks |
