# Target Fine-wear Industries Ltd. (9529)

Alauddin Chowdhury Tower, out para, Chandona Chowrasta, Joydebpur , Gazipur

11.MAY.2014

# Identified Priority 1 Concerns

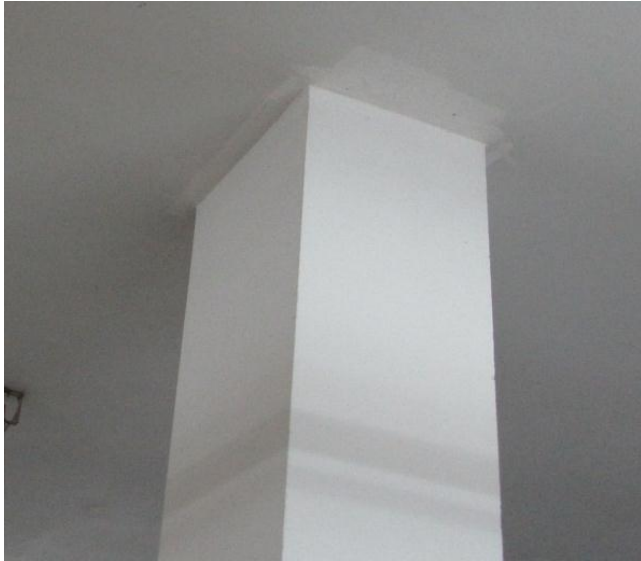
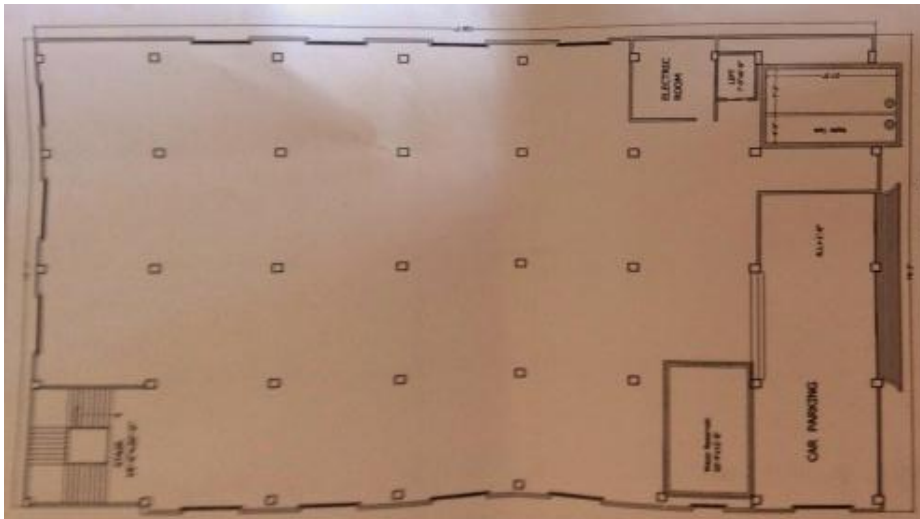
## 1<sup>st</sup> Priority 1 Concern

As per as-built drawing and the confirmed from design engineer, there are no shear links provided to resist the shear force at the column joint.

As per our calculation for punching shear at the typical column, the shear stress at the first perimeter is higher than the design concrete shear stress. Based on the code, this is not satisfied for the slab thinner than 200mm.

The span/depth ratio for flat slab which controls the limit of deflection for an RC element is defined apparently as  $L/30$ . The ratio for 6.09m span and 178mm thickness slab is 34 which was higher than ratio requirement. Thinner flat slab will lead to increase the deflection in short-term and long-term and reduce the punching shear resistance as well.

A flat slab system with insufficient punching shear will have the potential to fail without warning, which will cause the whole building to collapse.

The structural drawings also appear to represent incorrectly detailed flat slab rebar arrangement.

| Item No. | Observation | Recommended Action Plan | Recommended Timeline |
|---|---|---|---|
| 1 | The flat slab is not sufficient to resist the punching shear force. | Limit the average imposed load on the floor to a maximum of 1.5kPa (30 psf) | Immediate – Now |
| 2 | The flat slab is not sufficient to resist the punching shear force. | Carry out intrusive testing of the structure to determine the actual concrete strength, rebar strength and rebar layout | 6-weeks |
| 3 | The flat slab is not sufficient to resist the punching shear force. | Carry out the strengthening work to increase the punching shear capacity<br>Carry out the strengthening work to provide the lateral load resistance system | 6-months |

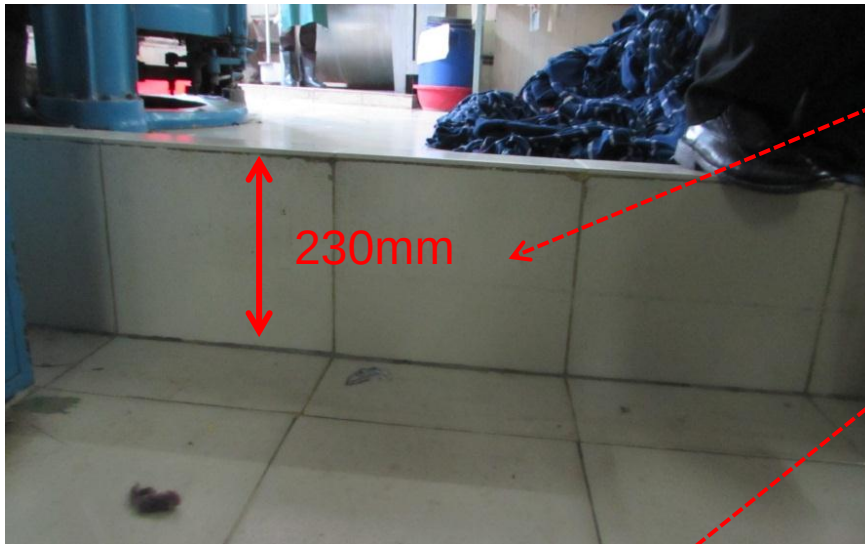
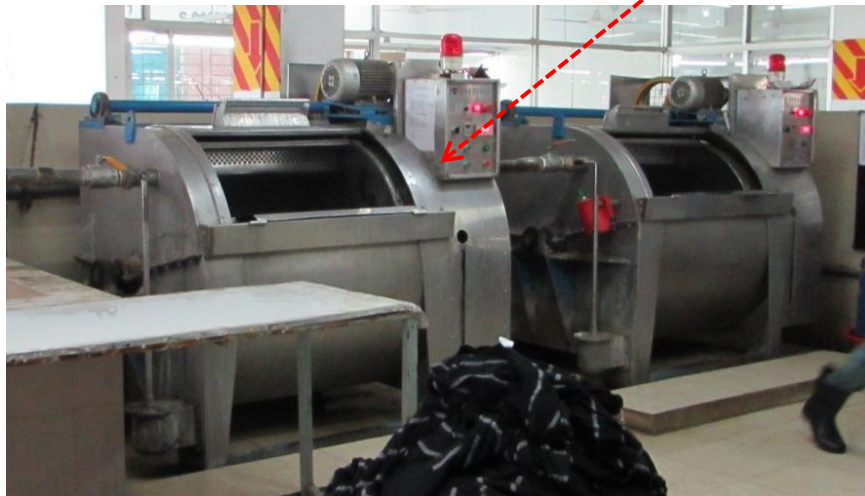
## 2<sup>nd</sup> Priority 1 Concern

Raised floor with 180mm sand filling and 50mm screed and tile

Industrial machine with a total operating weight exceeding 650kg

The raised floor has been built on level 4. However, the loading from the raised floor was not considered in the structural design. The design finish load was only assumed to be 1.2kPa, whilst the raised floor finishes has been assessed to be approximately 3.24kPa. In addition, the individual washing machine weight of 650kg with the dimension 1.75m x 1.35m, exerts a loading of more than 4kPa, which exceeds the design live load of 2.87kPa

| Item No. | Observation | Recommended Action Plan | Recommended Timeline |
|---|---|---|---|
| 4 | The raised floor at level 4 exceeds the design finish and live load | Limit all live load in this area to the absolute minimum.<br>Consider relocating some of the machines | Immediate – Now |
| 5 | The raised floor at level 4 exceeds the design finish and live load | Consider removing the raised floor, or constructing raised floor from lightweight fill, such as lightweight concrete or lightweight concrete block | 6-weeks |
| 6 | The raised floor at level 4 exceeds the design finish and live load | Introduce strengthening works under the slab (such as a steel beam support system) which can direct loads directly to the columns, and reduce loading burden to the slab. | 6-months |

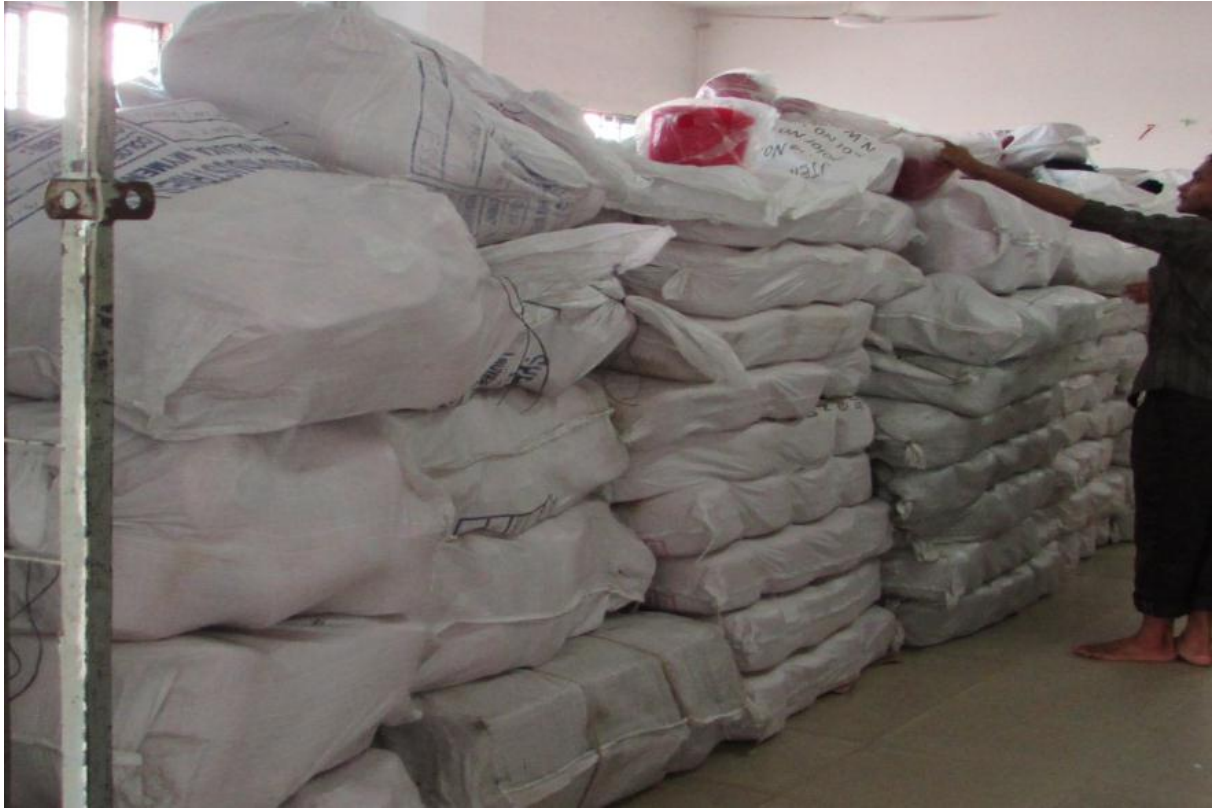
### 3<sup>rd</sup> Priority 1 Concern

Each bag of fabric is estimated to be approximately 35kg with the dimension 1.2x0.6m and 10 layers, so the live load for this area is 4.86 kPa which is higher than the design loading 3.0 kPa.

The maximum number of layers allowable should be reduced to a maximum of 6, and spread evenly around the storage area.

| Item No. | Observation | Recommended Action Plan | Recommended Timeline |
|---|---|---|---|
| 7 | Loading intensity appears to be greater than what was designed for in some locations. | Immediately reduce stacking height of fabric bag to ensure total load does not exceed 3.0kPa (~60 psf) | Immediate – Now |
| 8 | Loading intensity appears to be greater than what was designed for in some locations. | Mark the maximum allowable height of fabric stacking to ensure full compliance | 6-weeks |
| 9 | Loading intensity appears to be greater than what was designed for in some locations. | Ensure continued compliance to the loading intensity limitations on a long-term basis | 6-months |

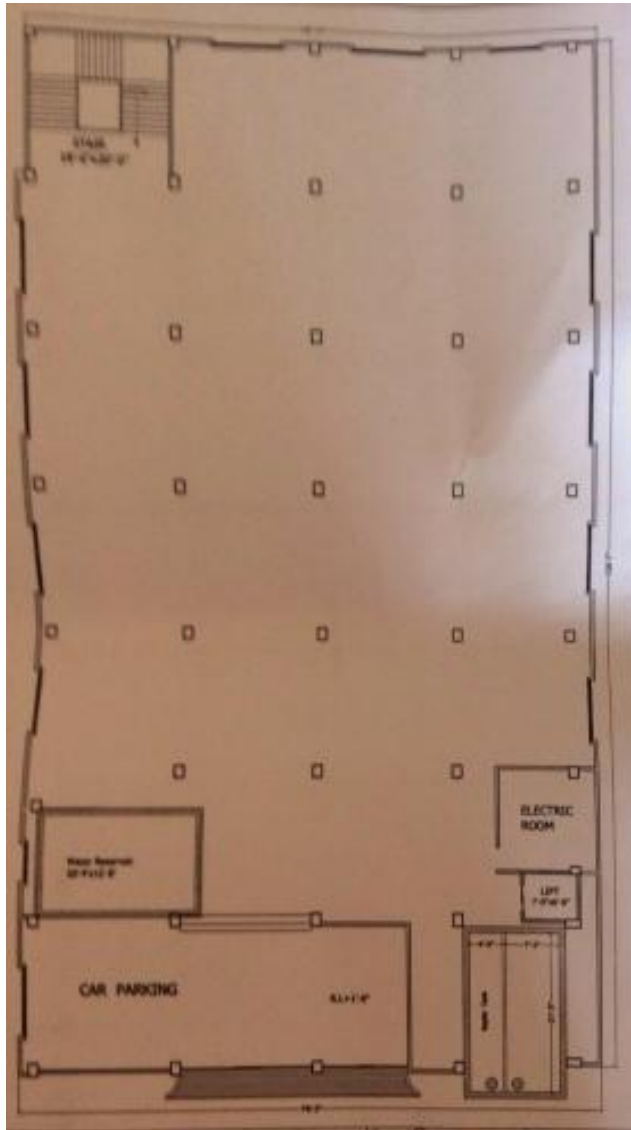
## 2<sup>nd</sup> Priority 3 Concern

The overall structural arrangement does not appear to have any rational form of lateral stability system to resist the wind or earthquake loads. A lateral load analysis is required to be carried out. Together with the very low factor of safety to resist punching shear, the building is at a very high risk of collapse if a significant event occurs.

The design engineer needs to check the deflection and storey drift under lateral wind and seismic load.

We require that these items be investigated in a Detail Engineering Assessment

| Item No. | Observation | Recommended Action Plan | Recommended Timeline |
|---|---|---|---|
| 12 | No lateral load resistance system considered in the structural design of the building | Building engineer to check and provide the solution for lateral resisting requirements of the structure. | 6-weeks |
| 13 | No lateral load resistance system considered in the structural design of the building | As per the results of structural analysis, the building needs to be revised to accord with BNBC building codes with regard to lateral stability. | 6-months |
