Designer Fashion Ltd.

Gohailbari, Shimulia, Savar, Dhaka-1345.
(23.980590, 90.224861)
29th March, 2017

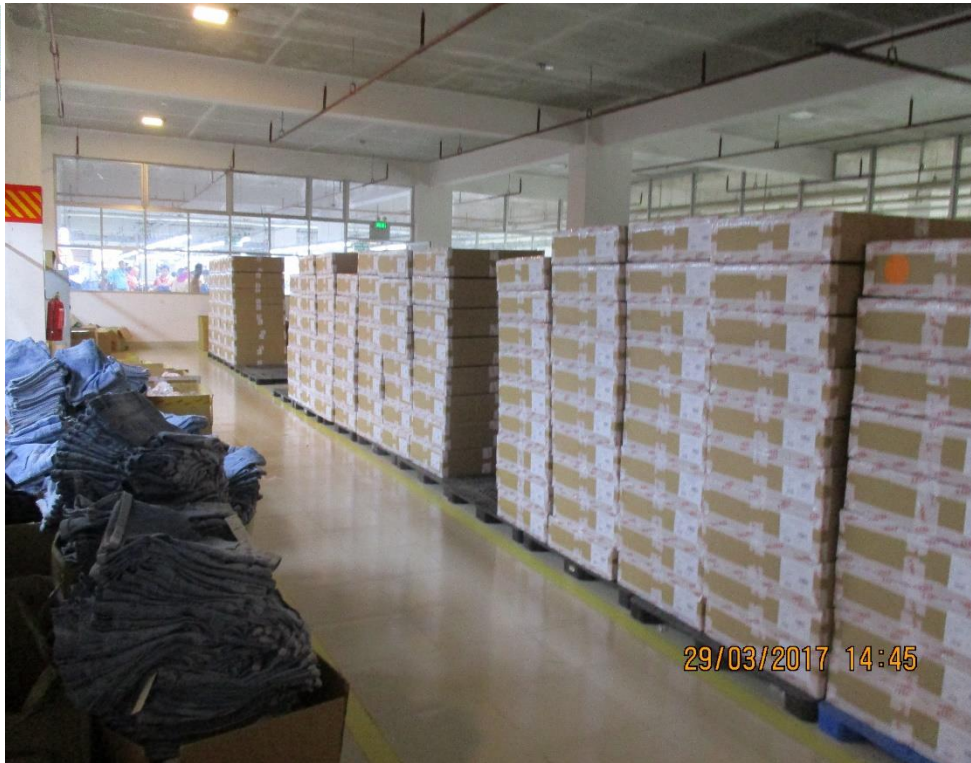
Implement floor loading management program

No load management programs were visible. Factory is required to implement load management program as per its floor loading capacity and Follow the load plans for all floors of the buildings and make sure that the workers understand the loading requirements.

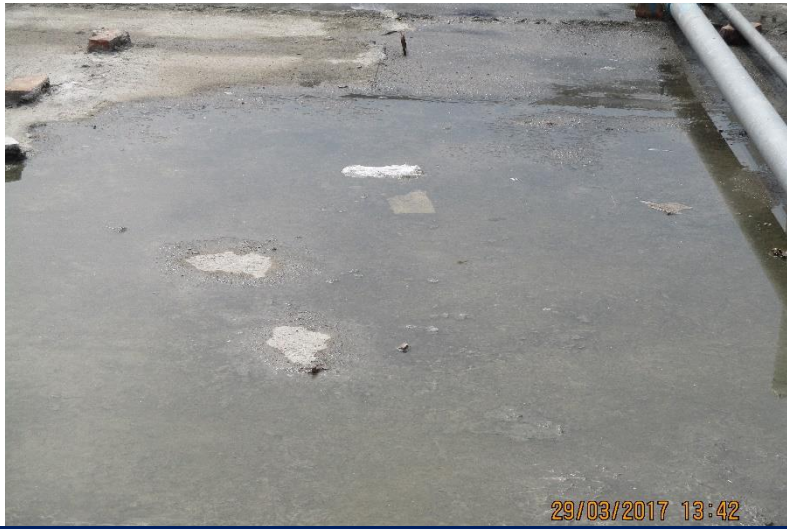
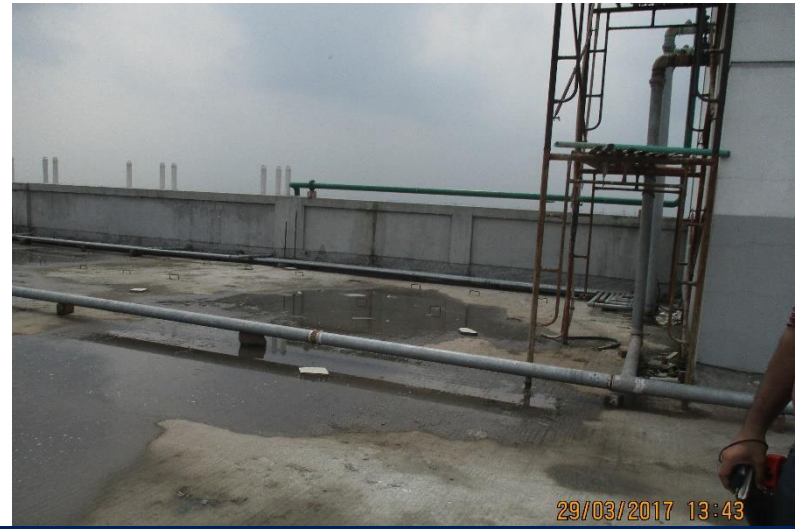
Water ponding on main factory building roof

Water ponding was observed at roof. No water proofing layer and proper drainage system was observed on roof of Building #1 & #2.

Item No.	Observation	Recommended Action Plan	Recommended Timeline
1	Implement floor loading management program	Factory is required to implement load management program as per its floor loading capacity.	6-weeks
2	Implement floor loading management program	Follow the load plans for all floors of the buildings and make sure that the workers understand the loading requirements.	6-months
3	Paucity in as built structural drawings	Update the structural drawings by confirming the actual depth of footing.	6-weeks
4	Paucity in as built structural drawings	Revise the footing adequacy check considering actual site condition.	6-weeks
5	Water ponding at roof	Waterproofing on the roof slab is to be applied. Moreover the roof slab drainage system should be investigated and improved.	6-months

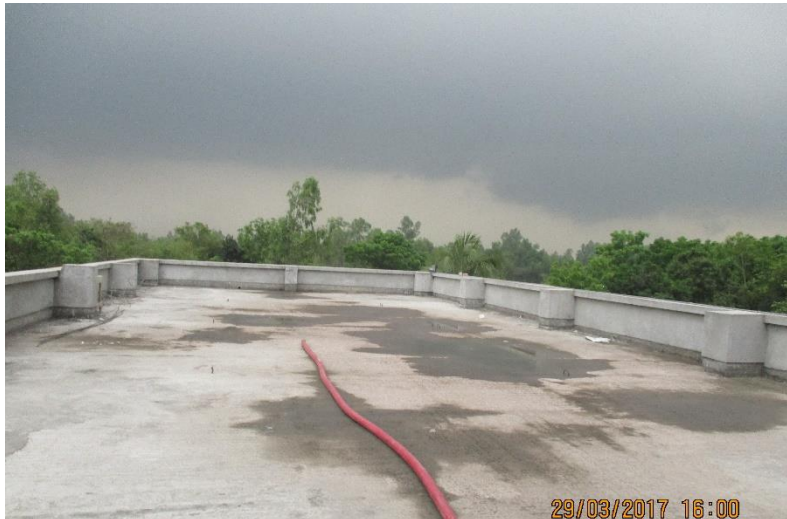
Utility building roof
