# Vision Composite Knit Ltd (10330)

## Vision Garments Ltd

26.May.2014

# Identified Priority 3 Concerns

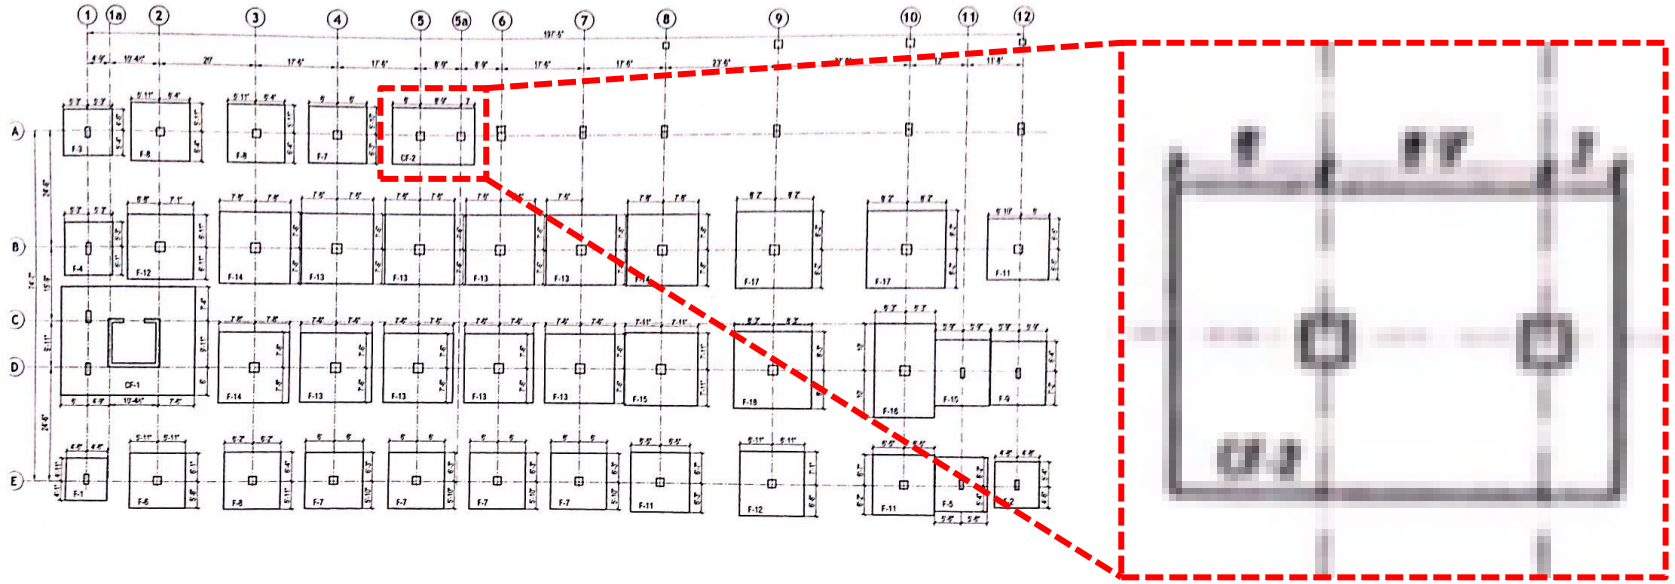
# 1st Priority 3 Concern

The foundation plans shows a combined footing for the columns at Grid A5 and Grid A5a. However, the detail is missing from the drawings.

**Lack of structural information with regard to the combined footing**

Item No.	Observation	Recommended Action Plan	Recommended Timeline
1	1st Priority 3 - Lack of information regarding the combined footing.	Building Engineer to advise as-built footing detail If necessary, carry out excavation to ascertain the actual layout of the footing.	6-months
