# Divine Fabrics Ltd. (11328)

Chandra, Kalia – Koir, Gazipur, Bangladesh

26.APRIL.2014

ACCBangladesh AccordRD  
on Fire and Building Safety in Bangladesh

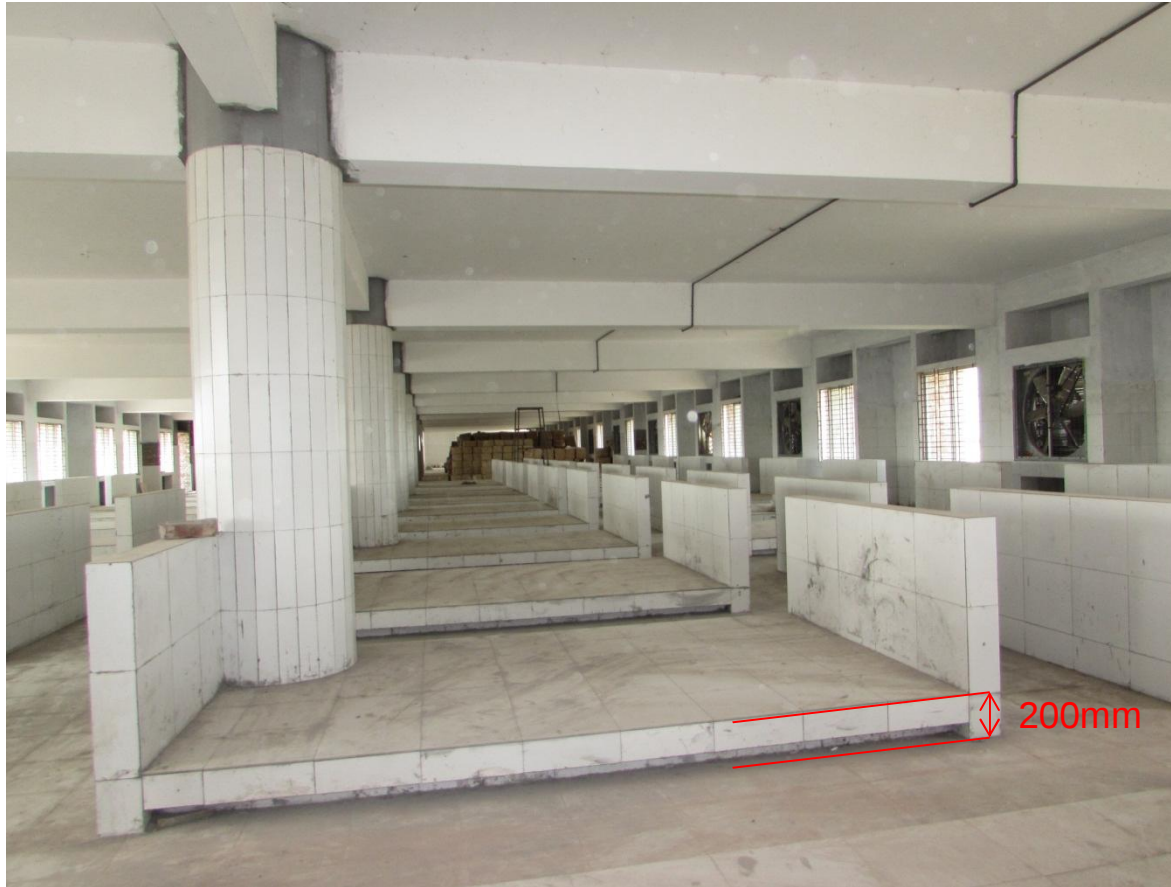
**Excessive load due to raised brick steps  
on 6<sup>th</sup> floor – in building 1**

On the 6<sup>th</sup> floor, these raised steps of 200 mm were prepared for cutting areas.

The weight of these step is  $0.2 \times 18 = 3.6$  kPa. It means that the floor is almost fully loaded and can not sustain any additional load from garment activities.

The allowable live load is 3kPa as per building code. Thus, it is required to demolish these steps due to the structural safety of the concrete floor.

**ITEM 1: (1<sup>st</sup> Priority 1) The raised brick step for cutting area impacts the excessive load on the 6<sup>th</sup> floor of building 1**

The raised brick steps for cutting area impact the excessive load on the 6th floor of building 1. Building is under construction, then it is easy to demolish these step to reduce the floor load.

- Demolish the brick steps on the 6<sup>th</sup> floor of building

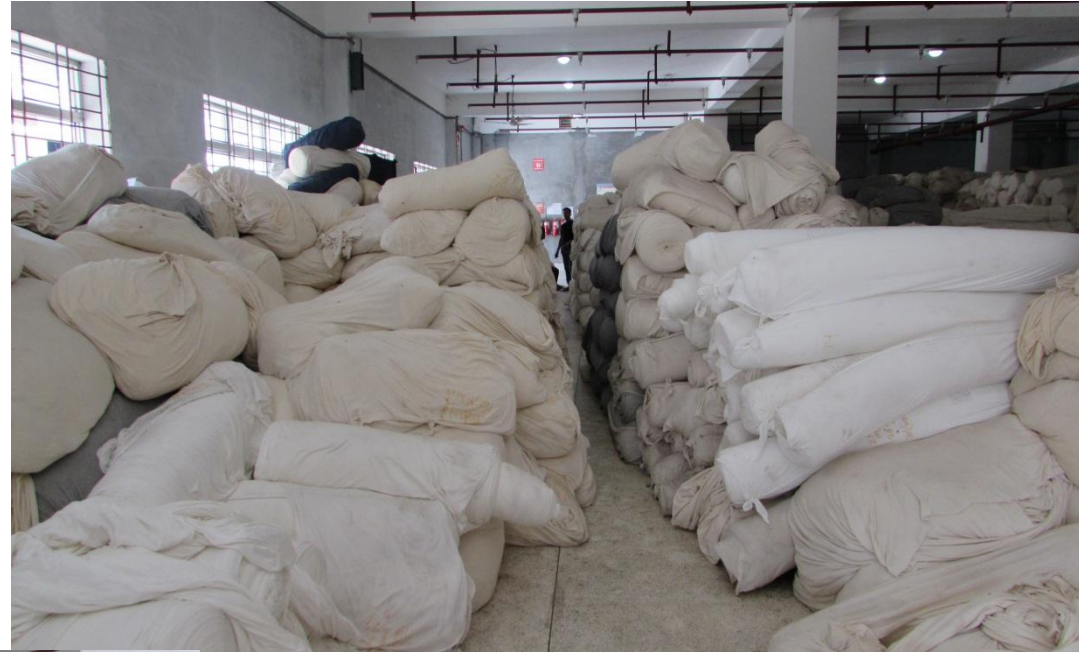
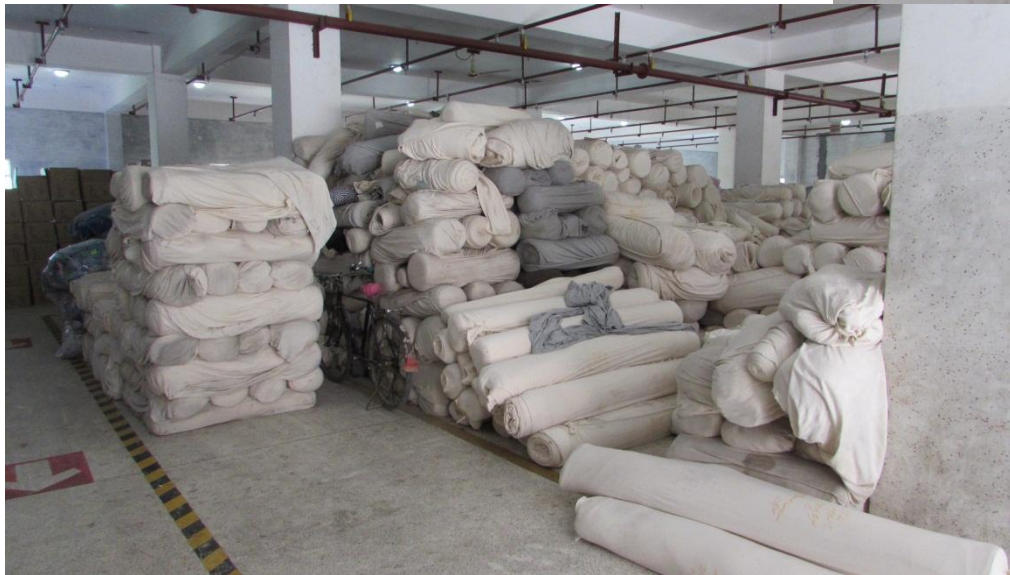
**Excessive Storage  
Height of Fabric**

Each roll of fabric is estimated to be approximately 25kg. As they are stacked 9 rolls high, and arranged 4 rolls per layer, the weight of each layer is around 100kg, resulting in a total weight of 900kg (8.8kN) per stack.

Based on a plan area of 1.2mx1.2m per stack, the equivalent live load per stack is estimated to be:

$$8.8\text{kN}/(1.2 \times 1.2)\text{m}^2 = 6.1\text{kPa}.$$

The allowable live load is max. 3.0kPa

**ITEM 2: (2<sup>nd</sup> Priority 1) Storage height of fabric in the 1<sup>st</sup> floor of building 4 exceeds allowable live load limit.**

Storage height of fabric in storage rooms on 1/F of building 4 appears to be excessive

- Immediately reduce stacking height of fabric rolls to ensure total load does not exceed 3.0kPa

- Mark the maximum allowable height of fabric stacking to ensure full compliance

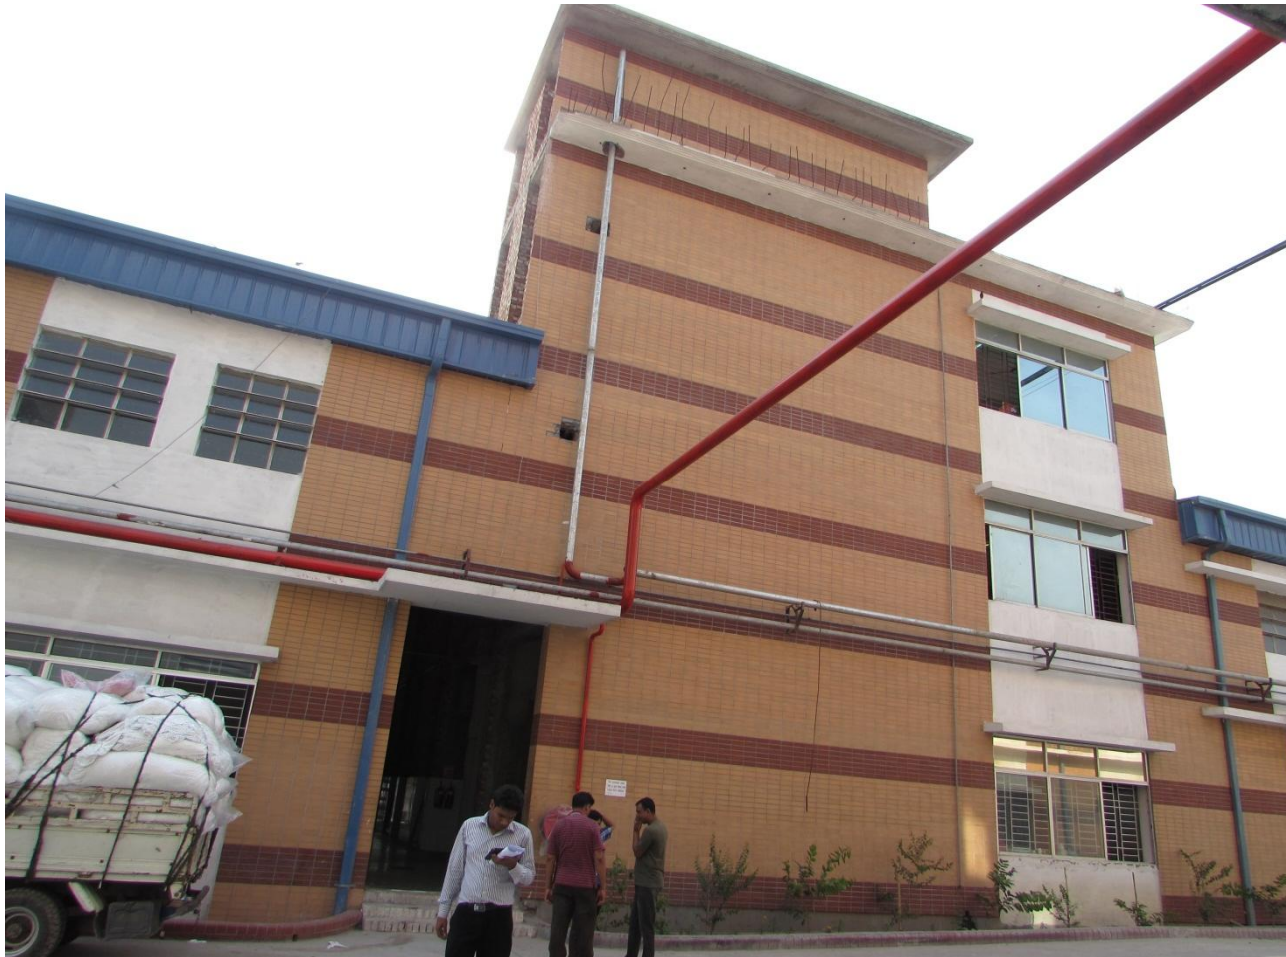
The fire water pipe across the road is not supported

**ITEM 3: (1<sup>st</sup> Priority 3) The fire water pipe system is not structurally supported in some locations**

The fire water pipe system is not structurally supported in some locations

- Provide the supporting system for fire water pipe system
