# Bovs Apparels Ltd. (11509)

Jamur Muchipara, Hemayetpur, Savar, Dhaka.

26.APRIL.2014

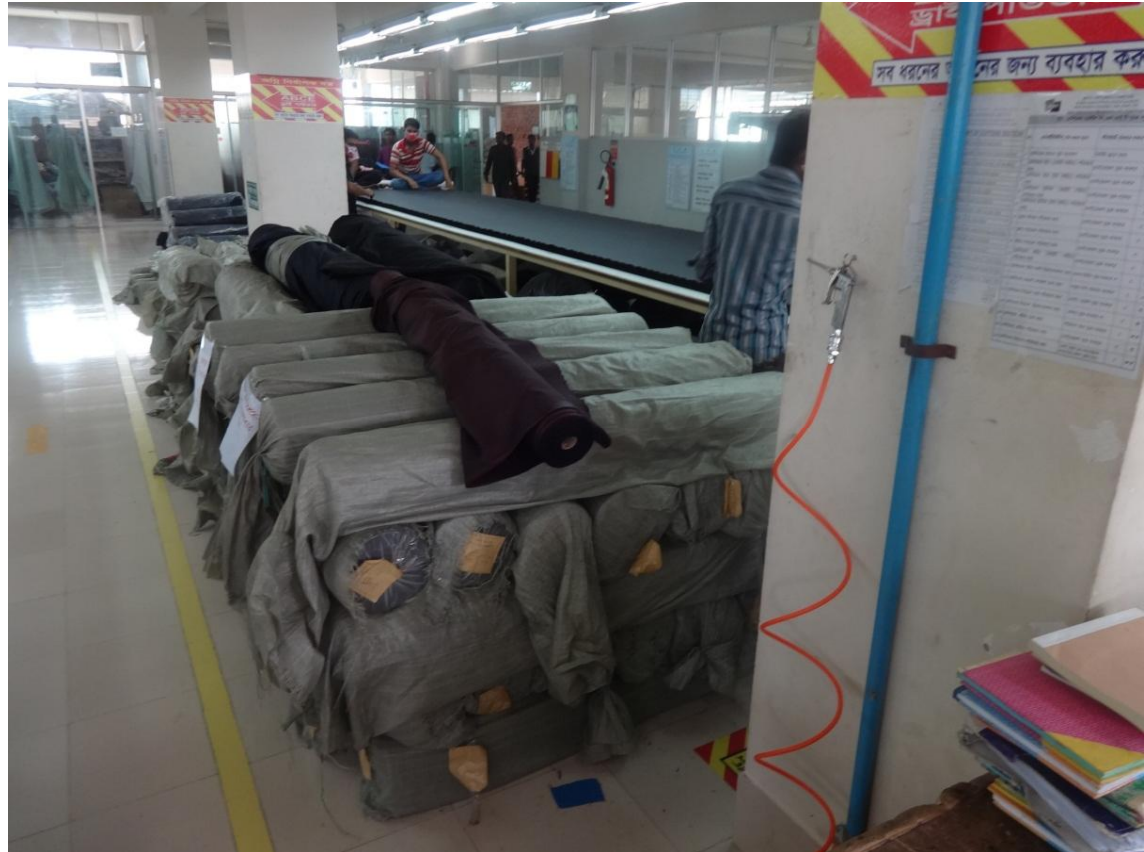
Priority 2 Concern

Loading plans were  
not made available

- Produce loading plans for all levels. Ensure these are displayed throughout the building and actively managed.

- Maintain and enforce the loading plans.

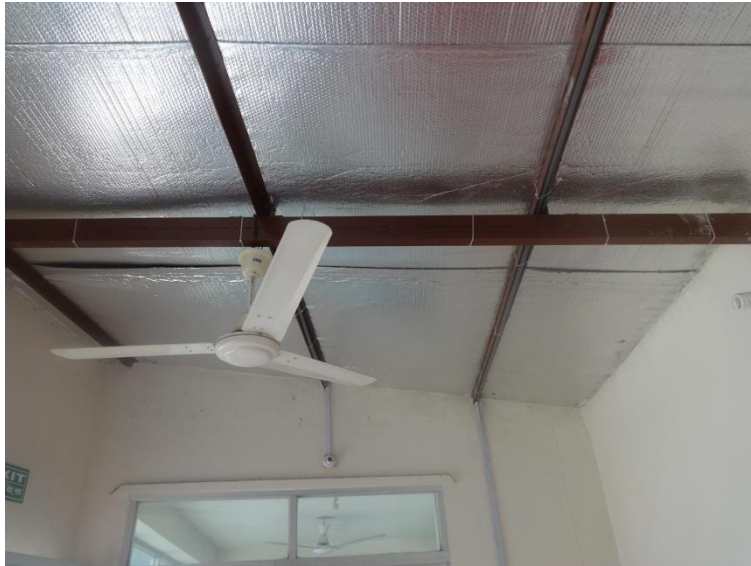
Priority 2 Concern

Poor detailing to roofs of  
secondary building

- Carry out an Engineering Assessment of the roofs of the ancillary buildings.

- Carry out any repairs highlighted in the Engineering Assessment.

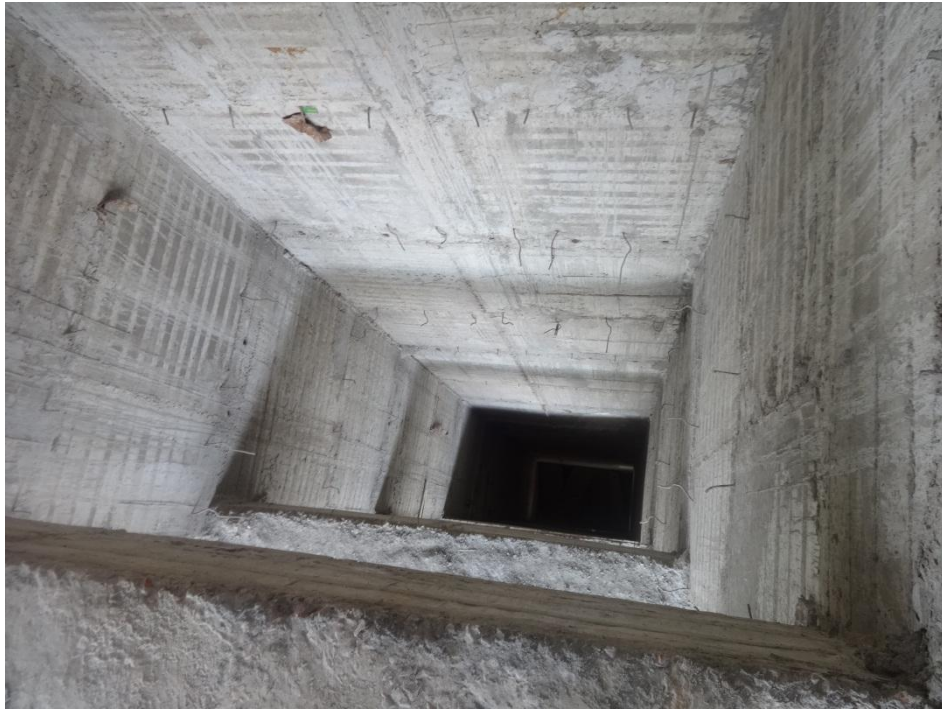
# Overall Stability System

The building has core walls.  
Stability was achieved through  
core shear walls.
