# ELECTRICAL SAFETY INSPECTION REPORT

## CONSUMER KNITEX LIMITED (UNIT 2)- NEW BUILDINGS

Bagan, Trishal, Mymensingh-2222

**Inspected on :** November 19, 2017

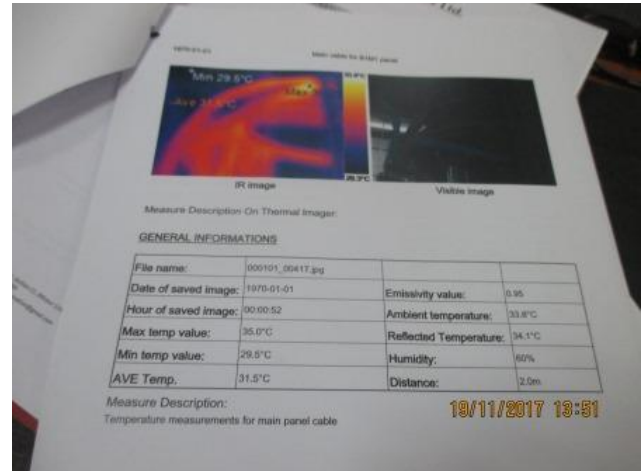
| <b>FINDING</b> | <b>E - 1</b> |

| <b>CATEGORY:</b> | <b>TESTING &amp; PERIODIC MAINTENANCE</b> |
| <b>FINDING:</b> | Prepared thermographic survey report on entire electrical system is incomplete |

| <b>RECOMMENDATION:</b> | A complete informative thermography survey report shall be prepared for entire electrical system at least twice in a year. |
| <b>PRIORITY:</b> | <b>P2</b> |
| <b>REMEDIATION TIME FRAME:</b> | <b>2 MONTHS</b> |
