# Bando Eco Apparels Ltd.

Plot # 188/2, Block- GA, Chanpur, Amin Bazar, Savar, Dhaka 1348, Bangladesh

21<sup>st</sup> November 2017

# Observations

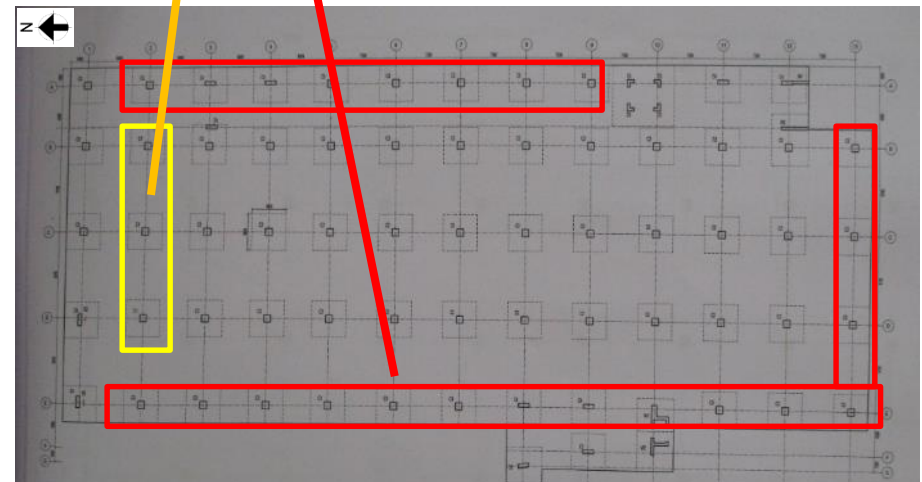
Column layout plan

Reinforcement detected by Ferro Scanning internal and external columns in Production Building (Building-1) appears to be different than shown in the structural drawings. Building engineer to verify number and diameter of rebars at least at two sides by removing plaster and concrete cover at typical columns before commencing future construction.

28 rebars  
(8 rebars on each face)

24 rebars  
(7 rebars on each face)

| Item No. | Observation | Recommended Action Plan | Recommended Timeline |
|---|---|---|---|
| 1 | (Production building)<br>Discrepancies between provided drawings and on site condition | Building engineer to verify number and diameter of rebar on at least two sides by removing plaster and concrete cover of columns. | 6-weeks |

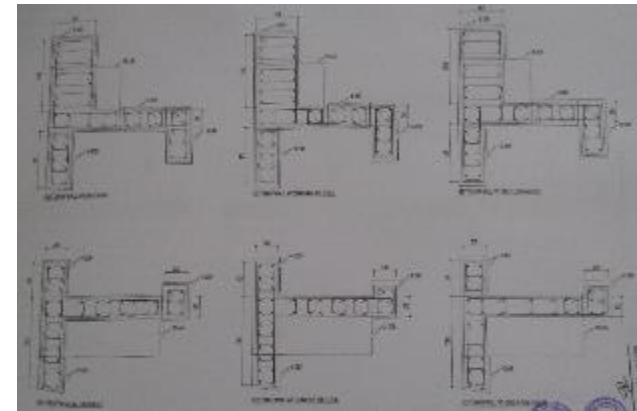
Details of shear wall

No details were found in column schedule for C6 & C7 type column. Size & number of rebar of shear wall didn't match with provided drawings. On grid-3 an extra column was found. No foundation system is shown on drawings for the additional column. So the load path and foundation system of the extra column is required to be investigated by the factory engineer.

| Item No. | Observation | Recommended Action Plan | Recommended Timeline |
|---|---|---|---|
| 2 | (Production building)<br>Discrepancies between provided drawings and on site condition | Building Engineer to survey as-built structure and prepare accurate as-built survey information for the building. | 6-weeks |

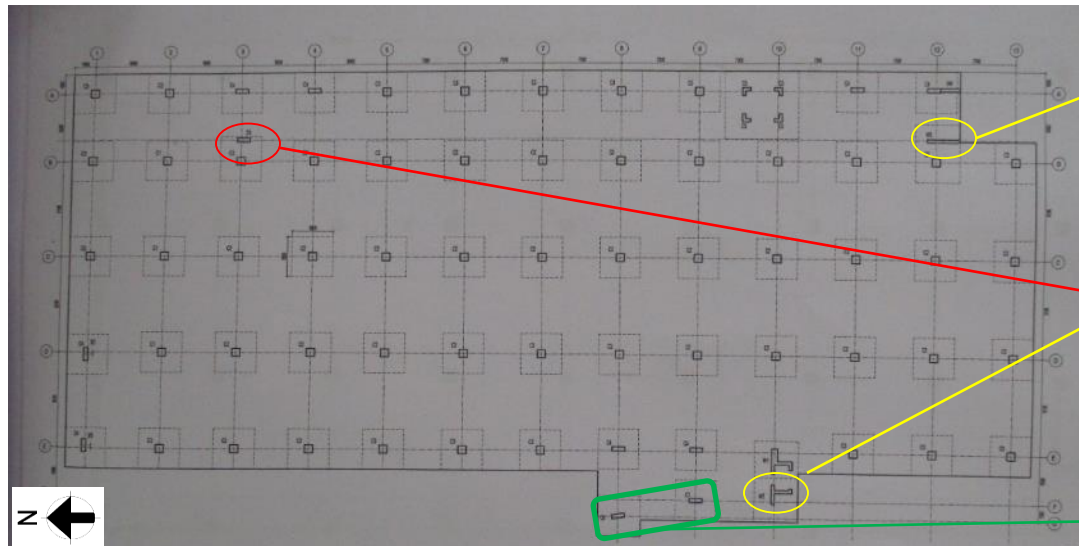
Column layout plan

Extra Column

| Item No. | Observation | Recommended Action Plan | Recommended Timeline |
|---|---|---|---|
| 3 | (Production building)<br>Discrepancies between provided drawings and on site condition | Building Engineer is required to investigate the foundation system of the additional columns. Also load path of the additional columns are required to verify. | 6-weeks |

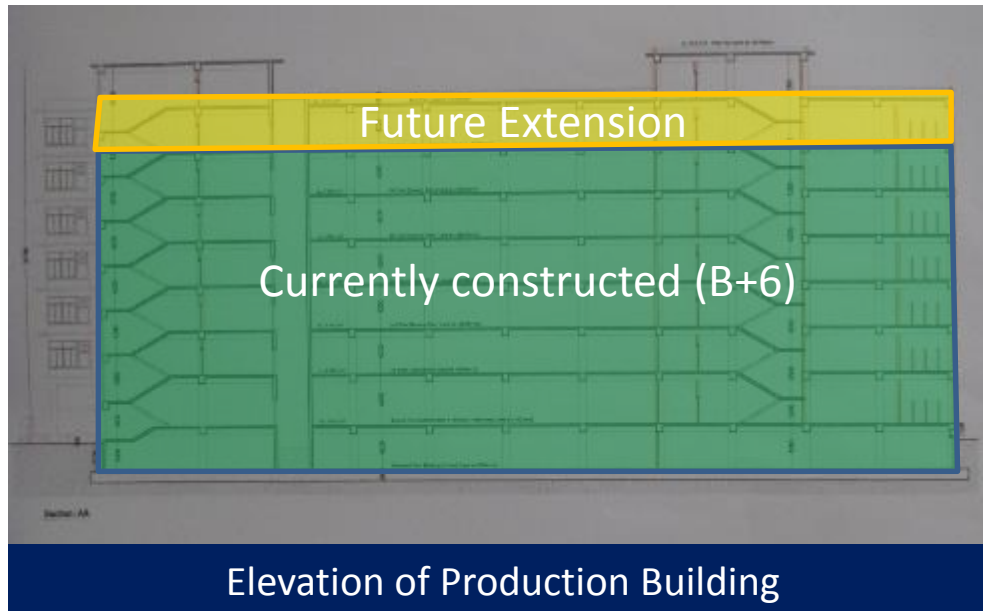
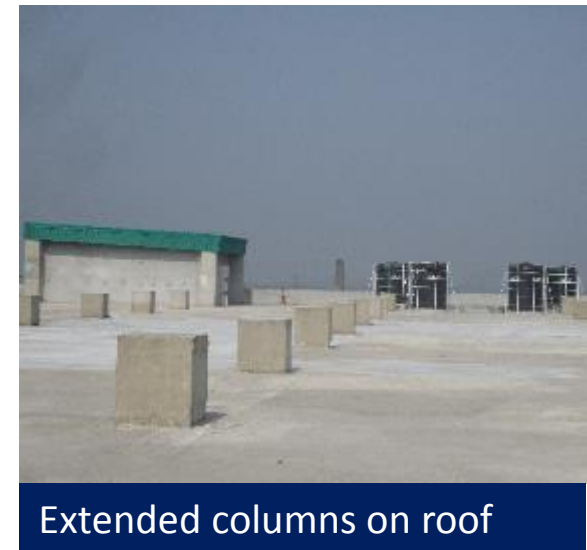
As building columns are extended on roof. There is a probability to extend the building vertically up to 8 storied (B+7) as per proposed drawings. Factory engineer is required to carry out a Detail Engineering Assessment considering BNBC provision prior to any extension work.

| Item No. | Observation | Recommended Action Plan | Recommended Timeline |
|---|---|---|---|
| 6 | (Production building)<br>Future extension to be carried out | In case of extension, factory engineer to be carried out further analysis and update design report following BNBC requirement. | 6-weeks |

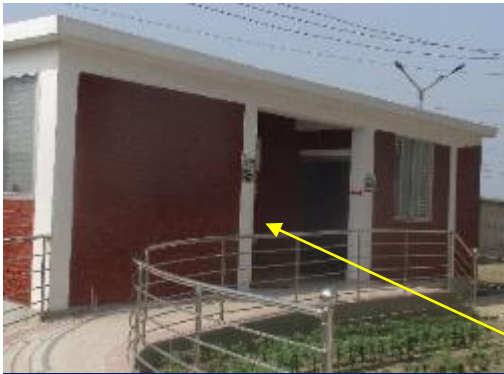
Tested column

Number of rebar at corner column didn't matched with as-built condition. 6 number of rebar were shown in column schedule whereas 4 rebar were found by ferro scanning.

| Item No. | Observation | Recommended Action Plan | Recommended Timeline |
|---|---|---|---|
| 7 | (Health & Child care)<br>Mismatch in drawings | Prepare update as-built documentation confirming rebar details for Health & Child care. | 6-weeks |
