Karooni Knit Composite Ltd.

Ratanpur, Shafipur, Kaliakoir, Gazipur
(+24.040104N, 90.277323E)

02 October 2013

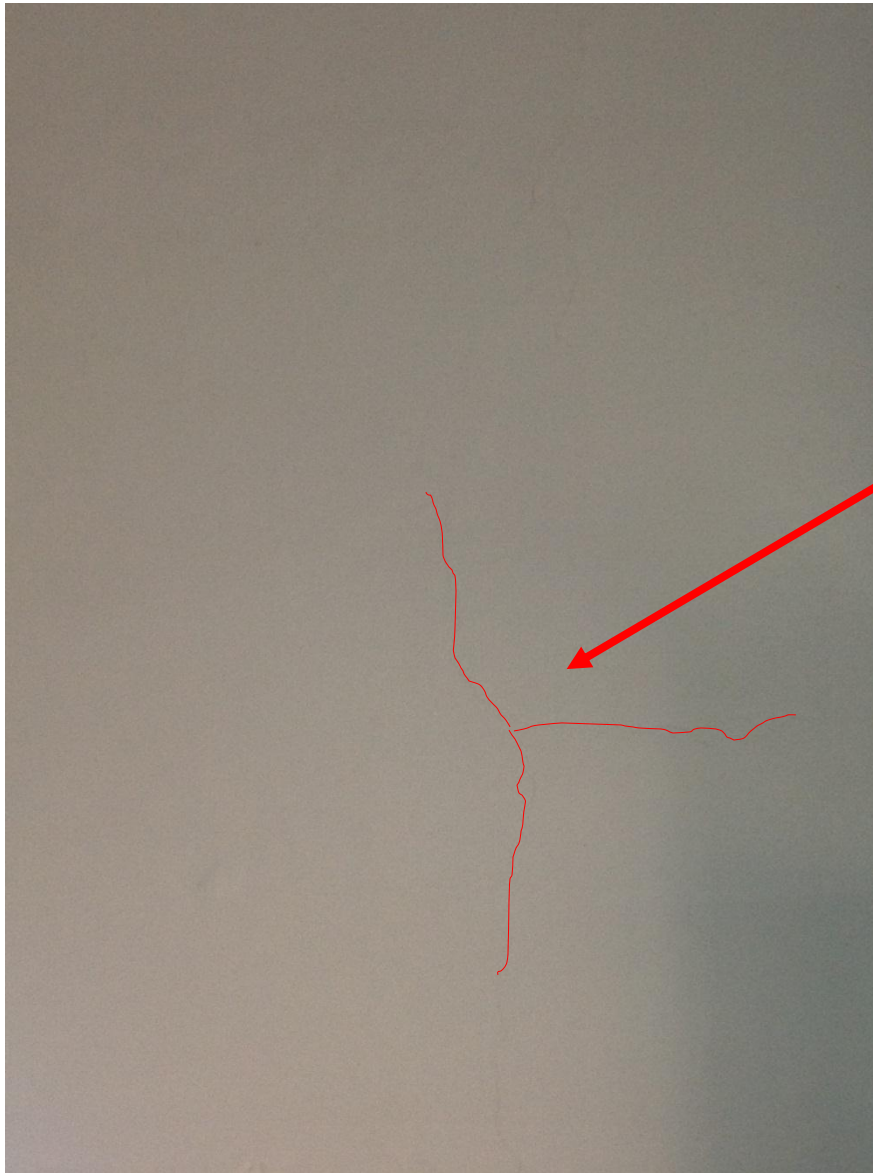
Flexural cracks (hairline) to slab

Flexural cracks to slab

Engineer to verify that slab has been designed to accommodate existing loading, and (if required) loading is to be reduced.

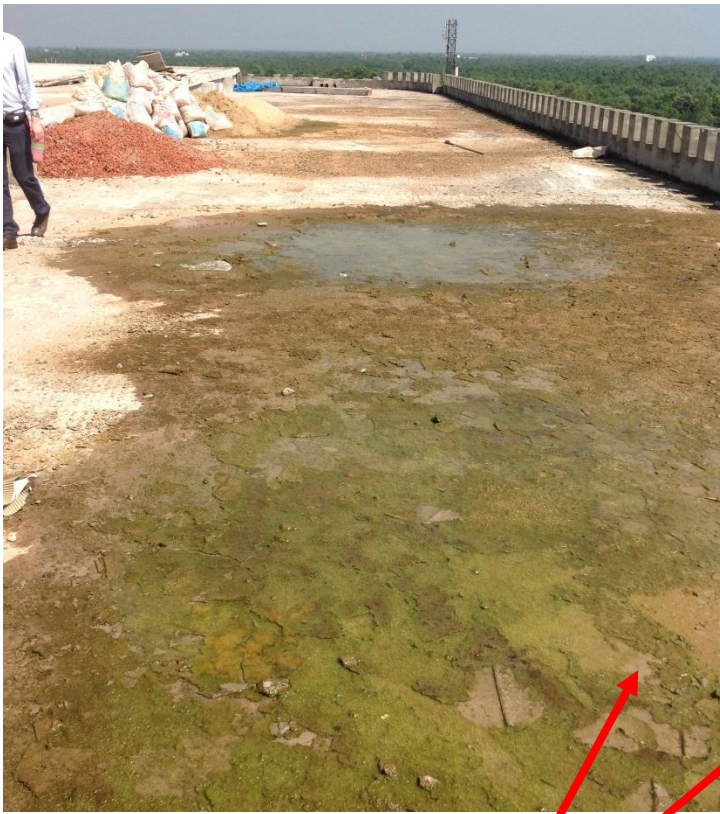
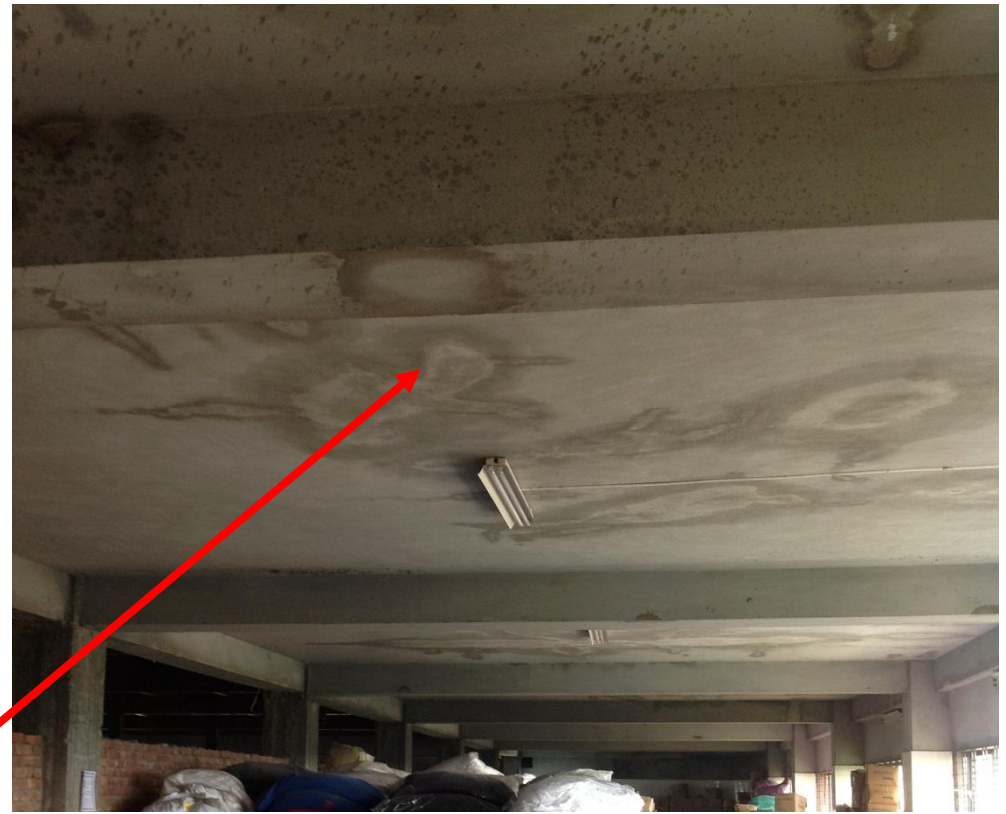
Water causing external and internal damage to slabs.

Water causing damage and corrosion to slabs

Repair internal and external water damage, upgrade roof drainage and install adequate water proofing system.

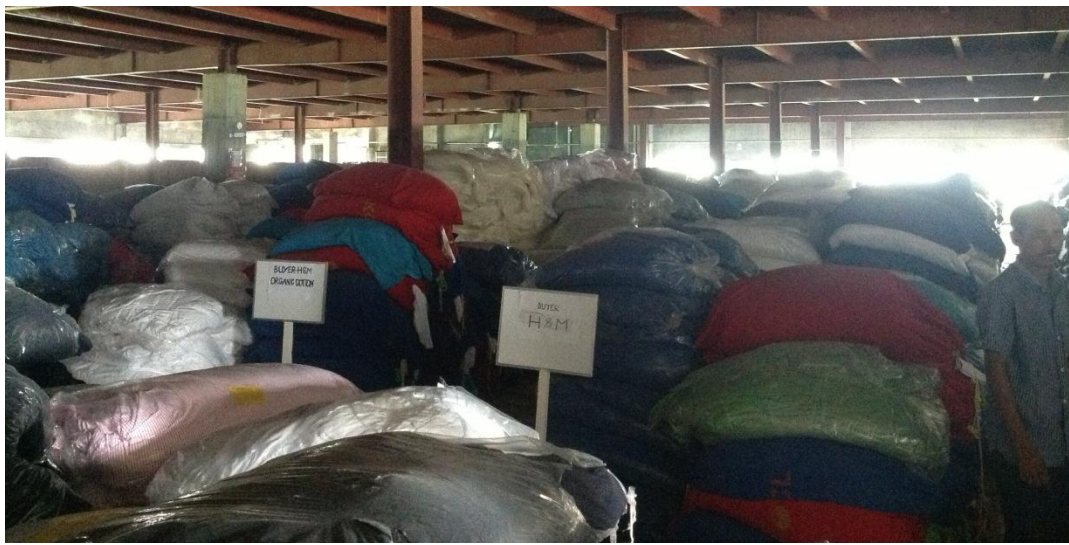
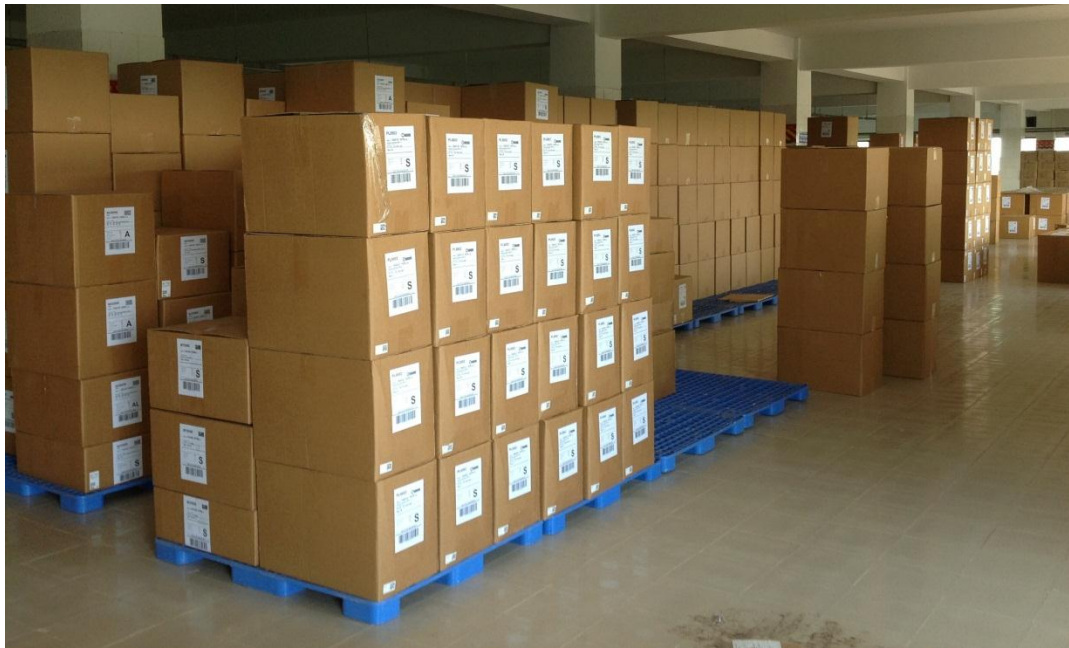
Load management

Load management: Plan and height restrictions to be introduced to prevent future overloading.

Restriction to be based on design floor loading.

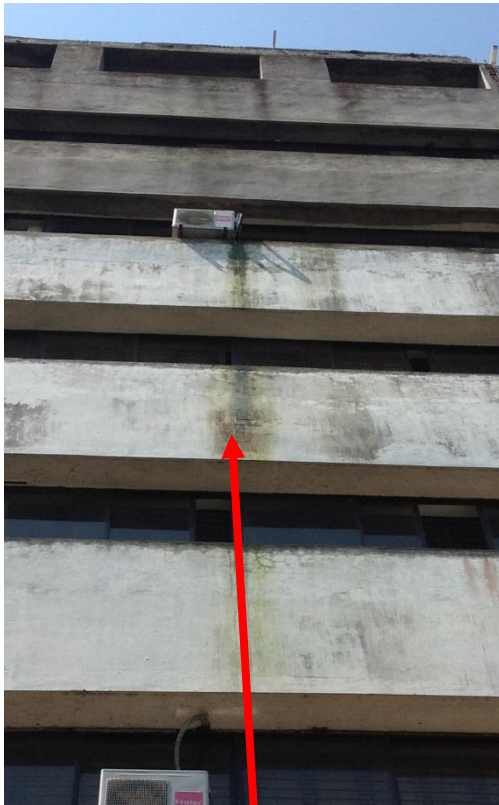
Water causing damage and corrosion to facades

Water damage

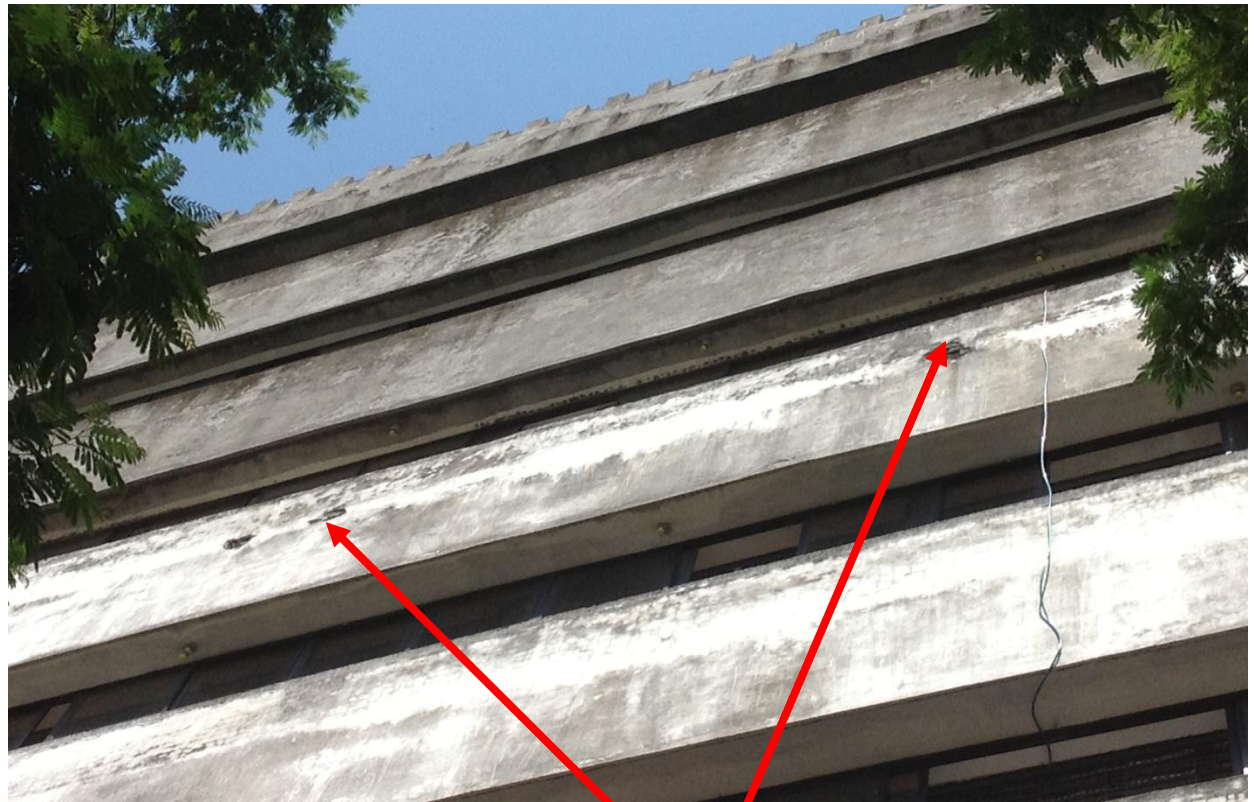
Plaster has fallen off

Water causing damage and corrosion to facades

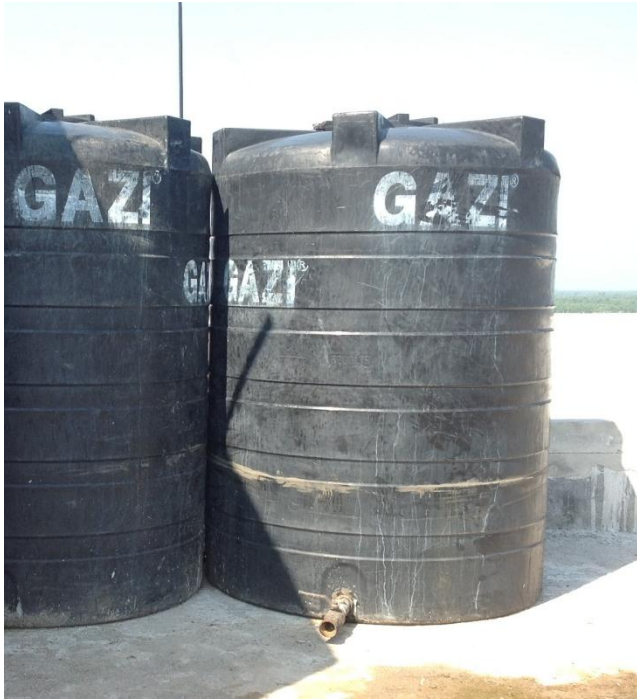
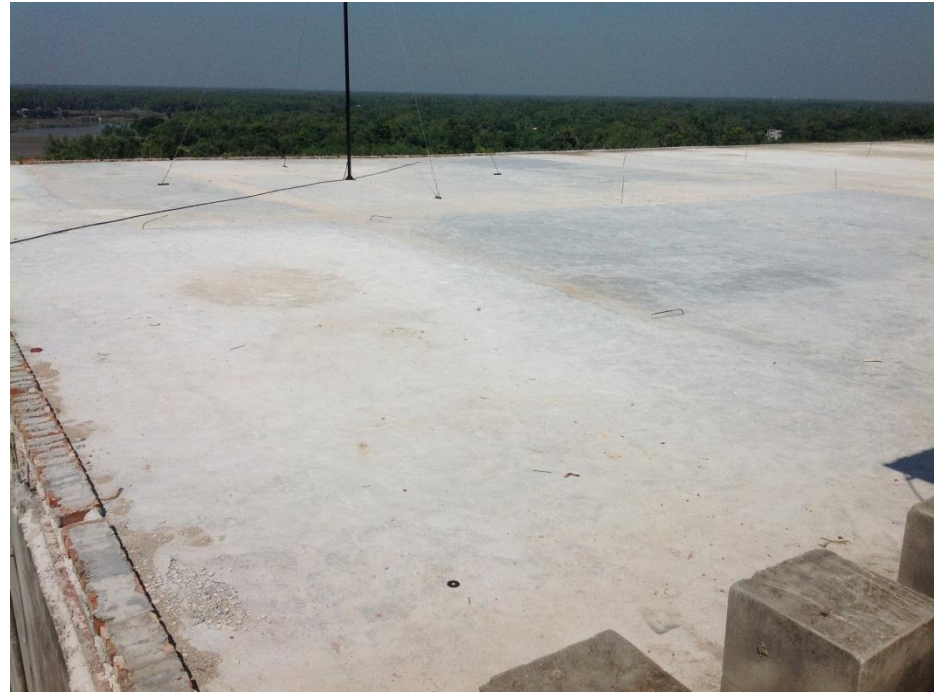
Roof maintenance

- Water tanks to be removed
- Construction debris to be removed
- Parapet to be installed
- Roof drainage and water proofing to be improved
