# FIRE SAFETY INSPECTION REPORT

**DRESSMEN FASHION WEAR LIMITED (New)**

**ACCORD ID: 22962**

**Date: 31 January, 2018**

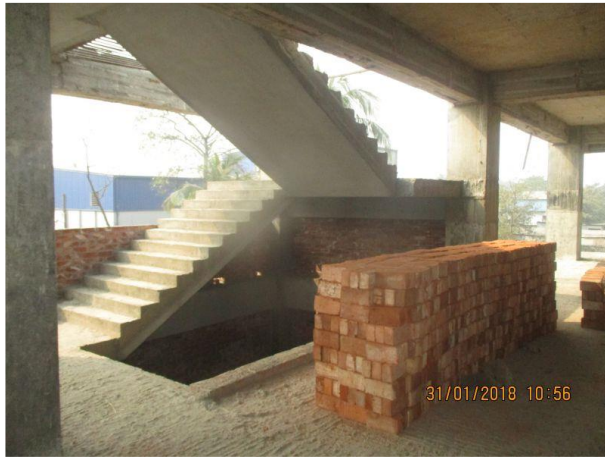
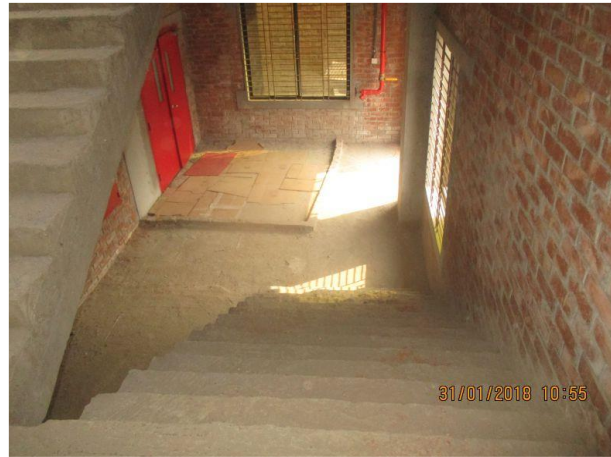
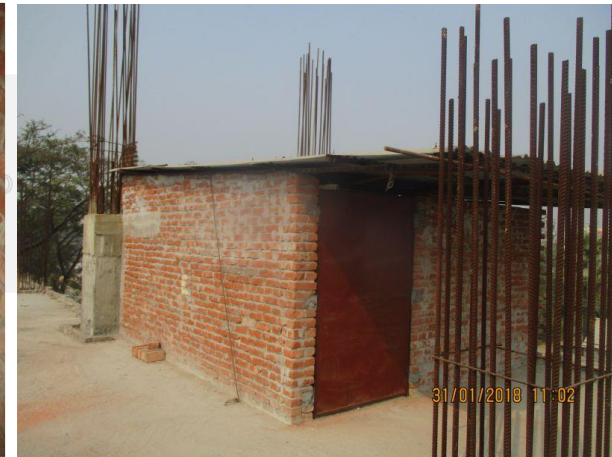
| Sl No. | Category | Findings | Required Action | Remediation Time Frame |
|---|---|---|---|---|
| 1 | Fire Rated Construction | The exit stairs are not separated from work areas and other spaces on each floor by fire-rated construction(Unsealed penetrations and openings, corrugated metal roof etc.). | Provide minimum 1-hr rated doors for buildings with 3 or fewer stories and 1.5-hr fire rated doors for buildings that are 4 or more stories. Seal all unprotected openings to separate the exit stairs from work areas and other building spaces on all floor levels. Ensure that the fire doors are self-closing and positive latching and that they are provided with fire exit (panic) hardware where serving production floors. If fire doors are required to be held open for functional reasons, provide automatic closing devices tied to the fire alarm system. Once fire doors are installed, every door in a stair enclosure serving more than 5 stories shall be provided with re-entry unless it meets. | Within 3 months |

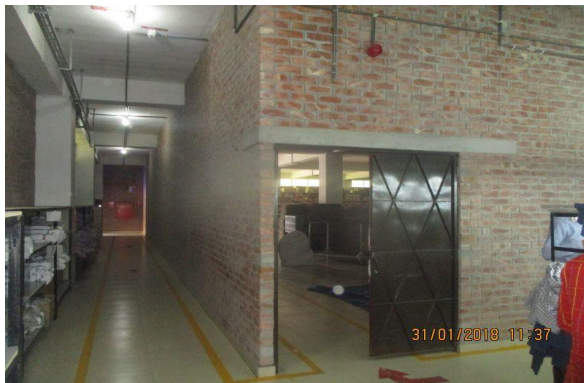
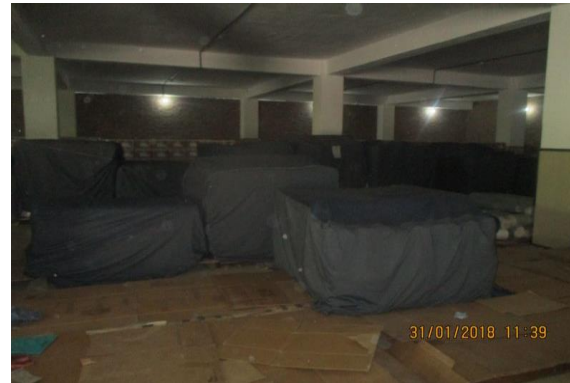
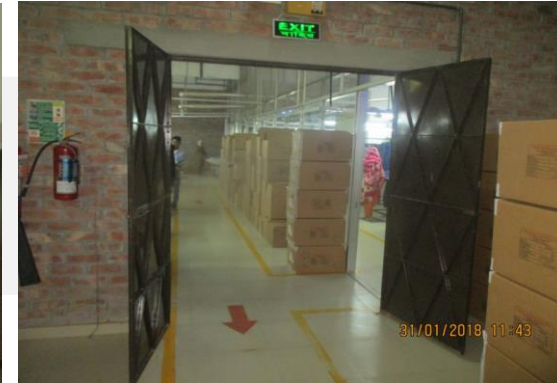
| 2 | Fire Rated Construction | Rooms used for combustible storage are not separated by fire rated construction properly.<br><b>Location: Bonded ware house on ground floor, north-east side of main production building</b> | Provide dedicated storage room separated by minimum 1-hr fire-rated construction. | Within 3 months |

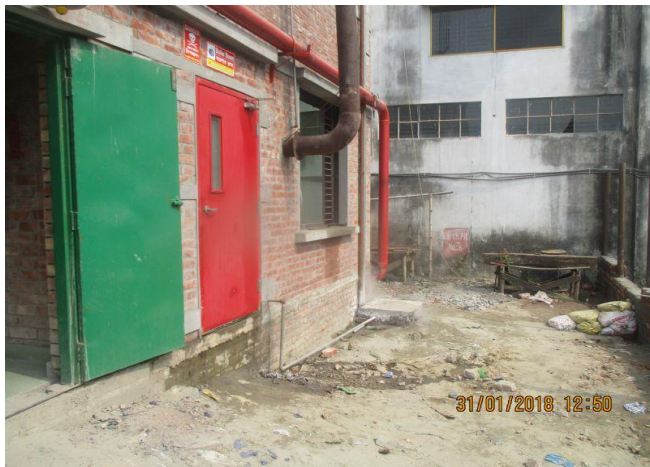
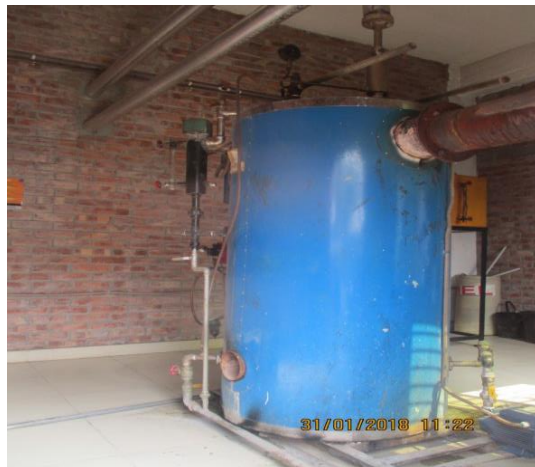
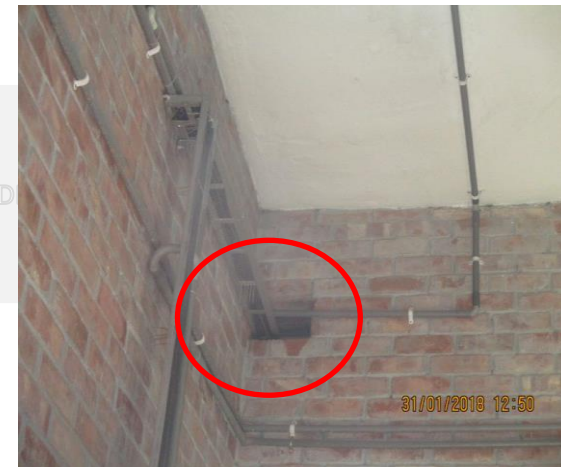
| 3 | Fire Rated Construction | The boiler room is not separated by fire rated construction (openings, non-rated doors, penetrations). <b>Location: Ground floor, south-east side of the main production building.</b> | Separate the generator, boiler and pump room by a minimum 2-hr fire rated construction. Seal and/or protected all openings to maintain fire separations. | Within 3 months |

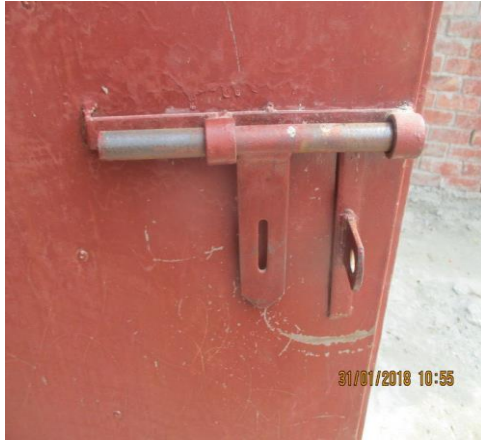
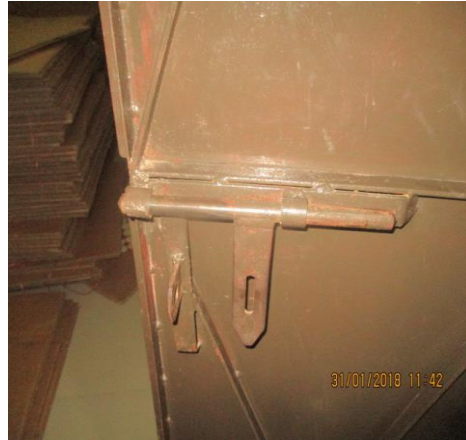
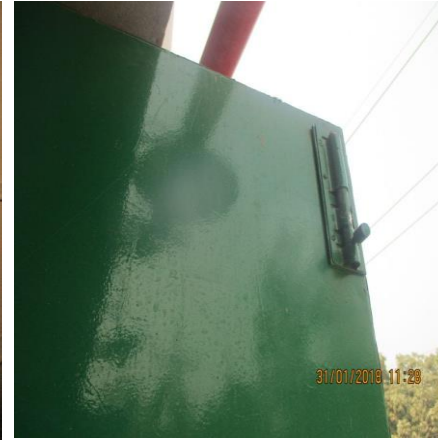
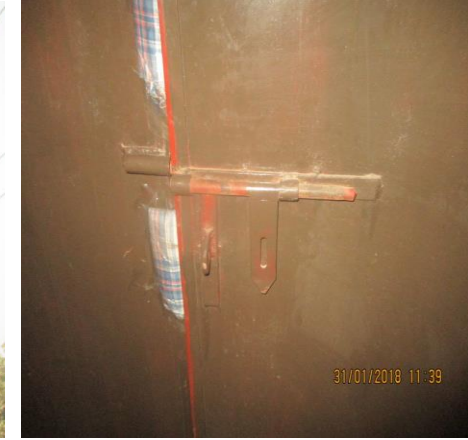
| 4 | Lockage Egress Doors | Egress doors/gates with locking features not complying with NFPA101 are provided at [ building exits, exit stairs, along egress routes, exit discharge] | Remove locking features from all egress doors/gates. If locks are required for security reasons, utilize specialized door locking features complying with NFPA101. | Immediate |

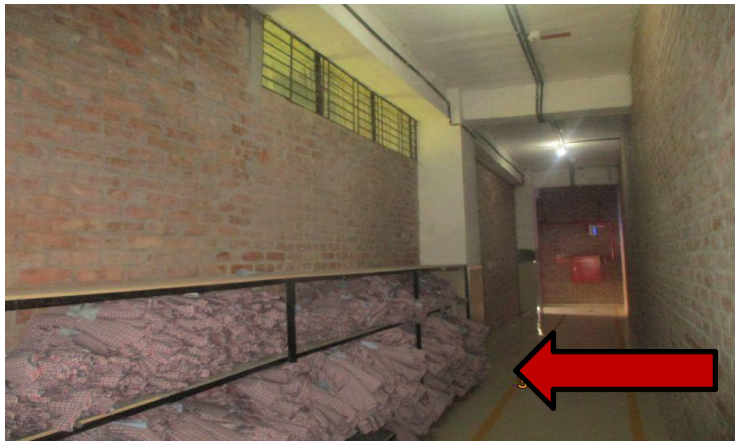
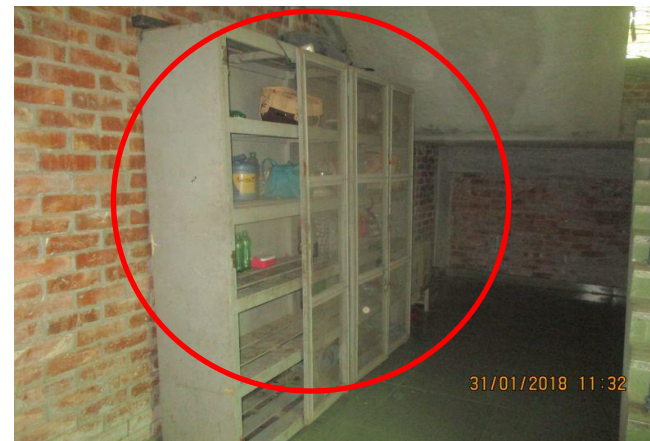
| 5 | Storage in Egress Path | Storage was located in the egress path and under exit stair. | Remove storage from the exit stairs and egress path | Immediate |

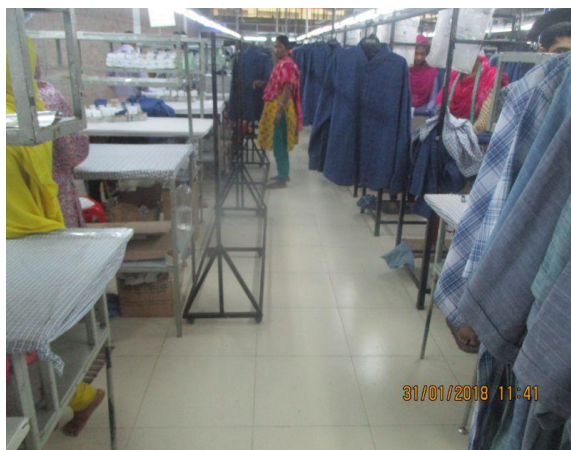
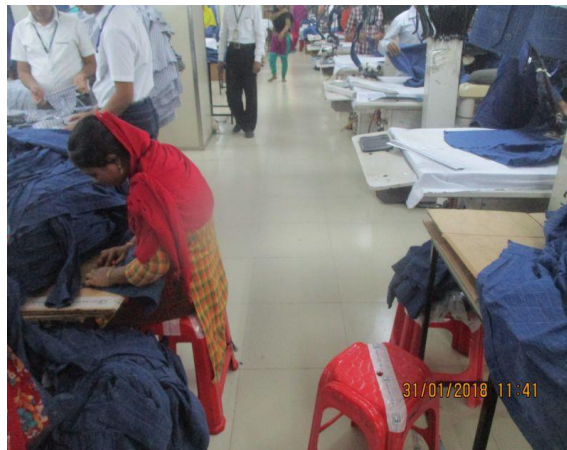
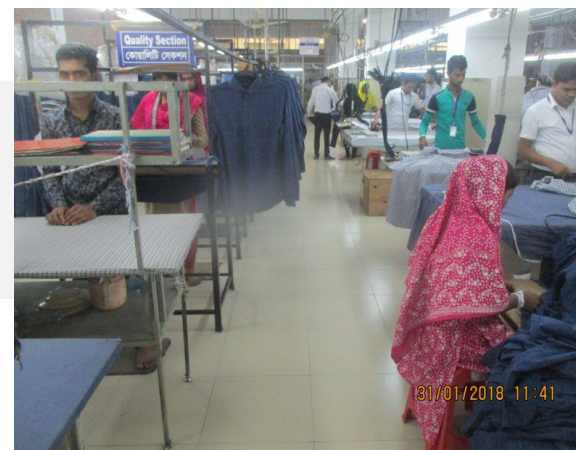
| 6 | Aisle Width | The width of egress aisles is less than 36-inch. | Provide minimum aisle widths of 36-inch. All the aisles shall be free from any kind of obstruction. | Within 3 months |

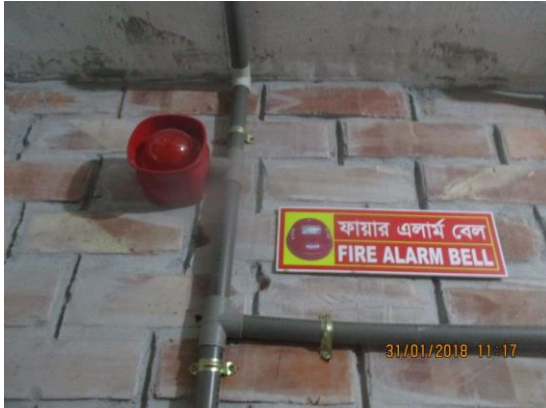
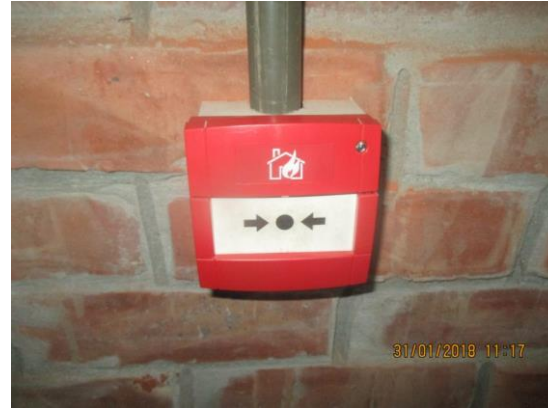
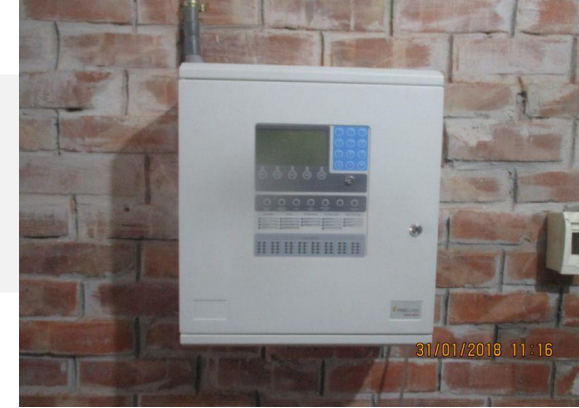
| 7 | Antiquated Fire Detection System | The fire detection system is antiquated, not a listed system, and does not provide alarm and notification features consistent with acceptable standards. | Replace the fire detection system with a new, listed addressable fire detection system in accordance with NFPA 72. | Design within 4 months, Install within 9 months |

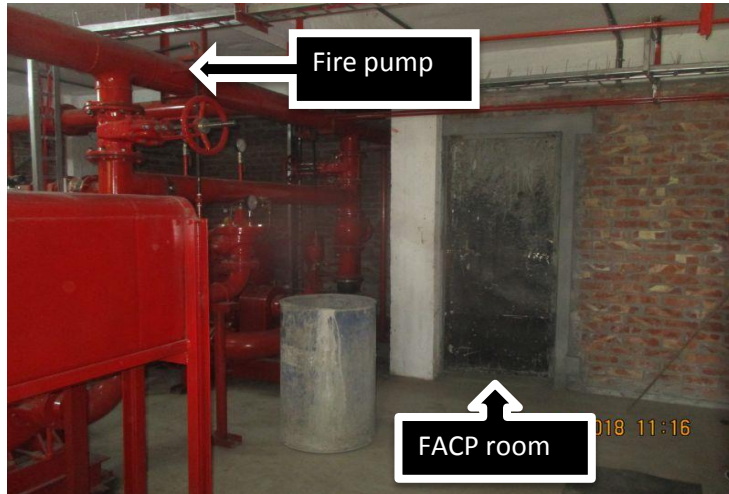
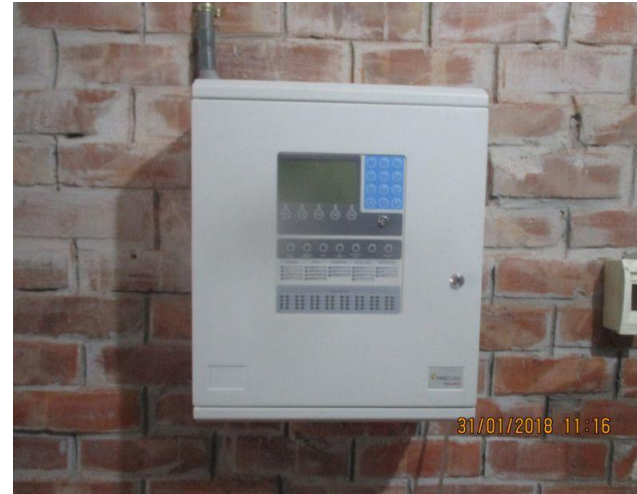
| 8 | Fire separation | FACP room is not properly separated from pump room. Unseal penetrations and openings were observed. Occupant had to discharge through pump room for evacuation. | Separate the FACP room by a minimum 2-hr fire rated construction and provide direct discharge. Seal and/or protected all openings to maintain fire separations. Or Provide 2 hr. fire rated passageway from FACP room to direct discharge for save evacuation. | Within 3 months |

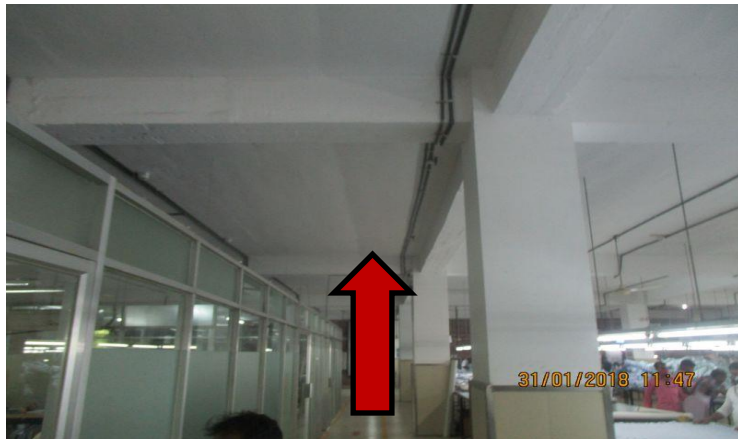
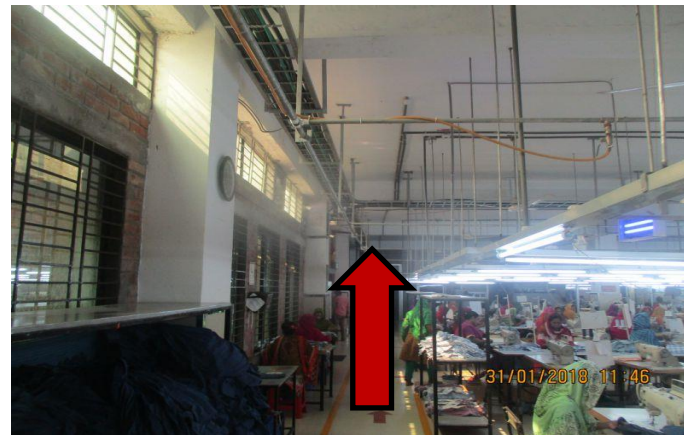
| 12 | Inadequate Lighting | Based on the number and location of emergency lights observed, adequate illumination levels are not anticipated along egress routes. | Test the emergency lighting system on each floor and provide additional emergency fixtures to provide adequate illumination along the means of egress. Provide a minimum illumination of 10 lux at the floor level within exit stairs and exit discharge paths and minimum 2.5 lux along exit access aisles. | Within 3 months |

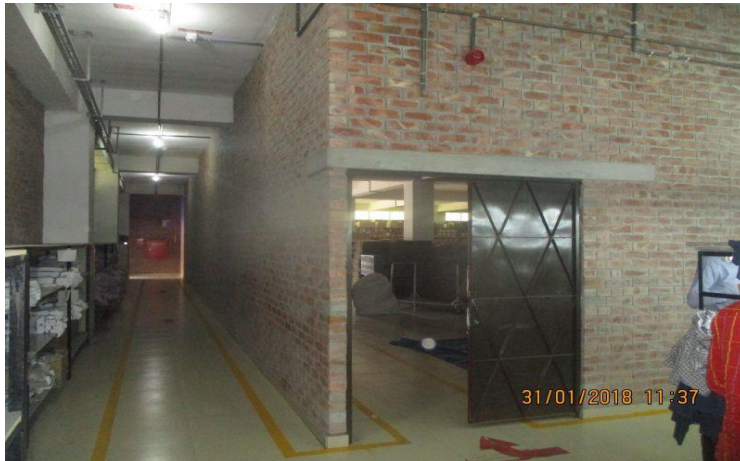
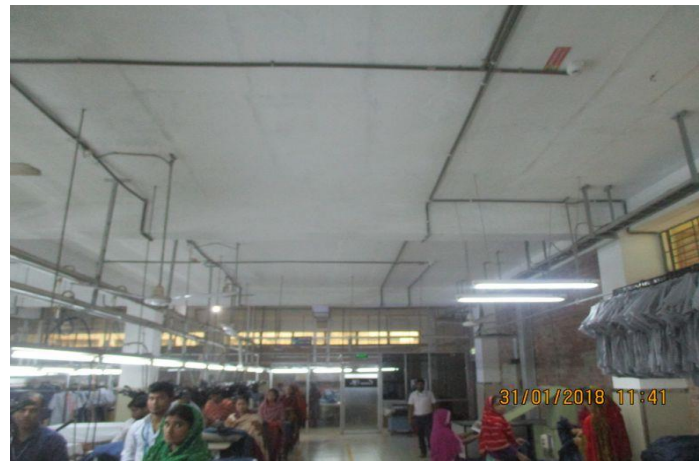
| 14 | Directional Sign | Directional signs are not provided where direction of the path of travel to an exit has changed. | Illuminated directional signs shall be provided where there is a change in the direction for the path of travel and the direction to an exit is not obvious. | 03 Month |
