FIRE SAFETY INSPECTION REPORT

Factory Name: Rezaul Apparels (Pvt) Ltd

Date: 19 December, 2017.

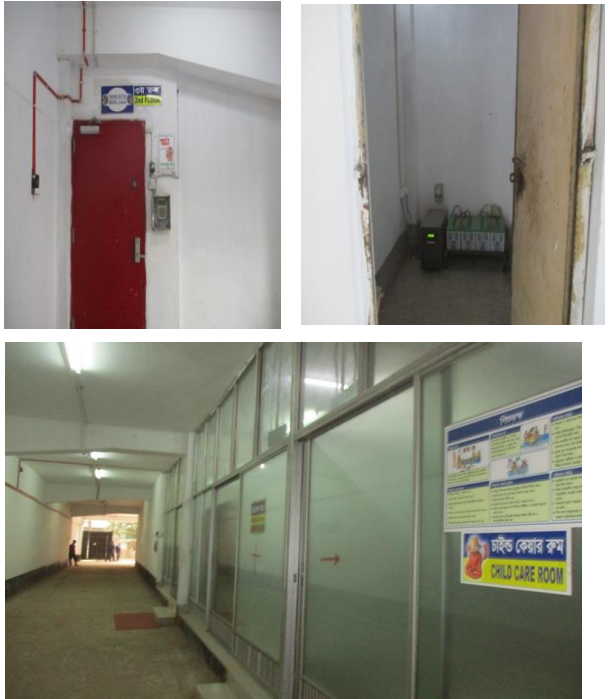
SI No.	Category	Findings	Required Action	Remediation Time Frame	Pictorial Evidence
1	Fire Rated Construction	The exterior exit stair is not separated from the building. Non rated wall & unprotected openings to external exit stairs have been observed.	<p>Exterior exit stairs shall be separated by minimum 1-hr fire-rated construction and The rating of the exterior wall shall extend 3.05 m (10 ft.) beyond the ends of the stair structure. Provide minimum 1-hr fire rated doors (if required) to separate the exit stairs from work areas and other building spaces on all floor levels. Ensure that the fire doors are self-closing, positive latching and that they are provided with fire exit (panic) hardware where serving production floors.</p> <p>If fire doors are required to be held open for functional reasons, provide automatic-closing devices tied to the fire alarm system.</p>	Within 3 Months

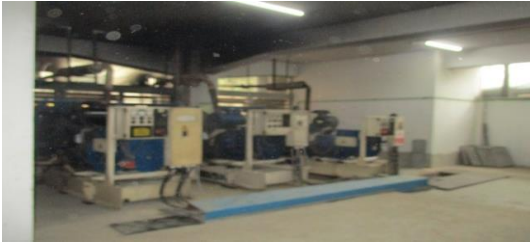
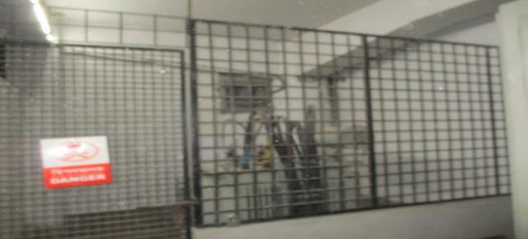
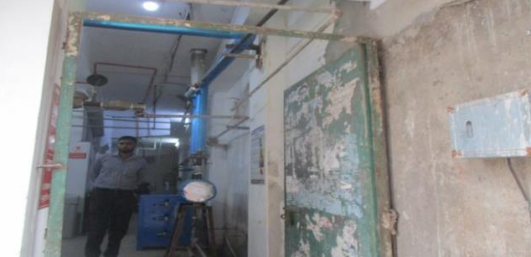
SI No.	Category	Findings	Required Action	Remediation Time Frame	Pictorial Evidence
2	Fire Rated Construction	Generator, Transformer, Boiler and Compressor room are not properly separated by fire rated construction with other Occupancies	<p>1. Service rooms shall be separated from other occupancies by a minimum 2-hr fire rated construction (wall, floor, slab etc.). Seal all penetrations and openings (door, window etc.) should be protected by 1.5-hr fire rated materials to maintain the fire separation if required. All exhaust systems shall discharge to the exterior of the building in a safe location.</p> <p>Or</p> <p>Relocate it to exterior of the building and maintain a minimum 3m (10 ft.) spatial separation distance from the building.</p>	Within 03 Months

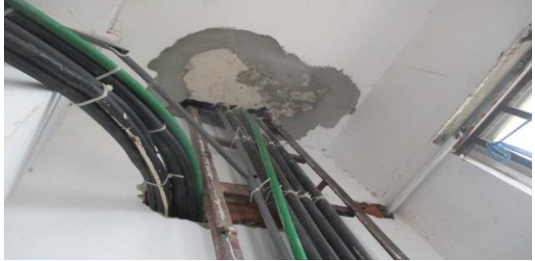
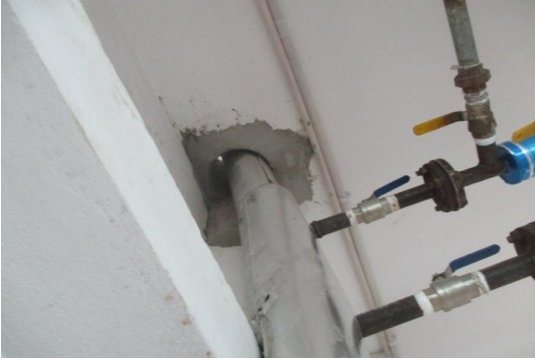
SI No.	Category	Findings	Required Action	Remediation Time Frame	Pictorial Evidence
3	Fire Rated Construction	Penetrations through floor/ceiling assemblies are found unsealed.	Seal all penetrations and openings in floor/ceiling (full thickness of the floor/ceiling) assemblies by fire rated materials to maintain the fire resistance rating. Provide a minimum 2-hr fire rated shaft to separate the utility risers from each floor if required.	With in 3 months

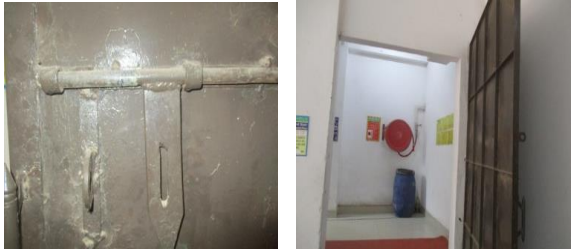
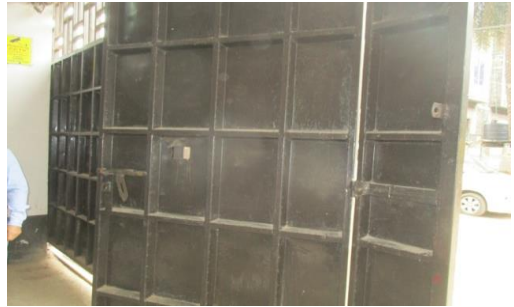
SI No.	Category	Findings	Required Action	Remediation Time Frame	Pictorial Evidence
4	Egress	Doors along means of egress are provided with non compliant locking system.	<ol style="list-style-type: none"> 1. Remove all non compliant locking features from egress doors. 2. If locks are required for security reasons, utilize special door locking features complying with NFPA 101. 3. Doors may be locked where the latch and lock are disengaged with one motion where the occupant load does not exceed 49 persons. 4. Doors may be provided with locking hardware from the ingress side provided that a panic bar is installed on any door with an occupant load exceeding 49 persons. 	Immediate

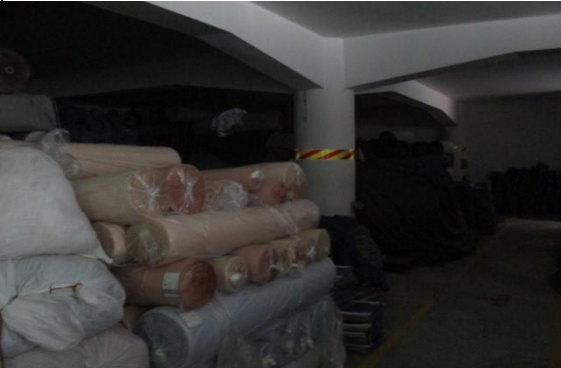
5	Storage Areas	Rooms used for combustible storage on the ground floor are not separated by fire-rated construction. Location: Office building.	Provide dedicated storage rooms separated by minimum 1-hr fire-rated construction.	Within 3 Months

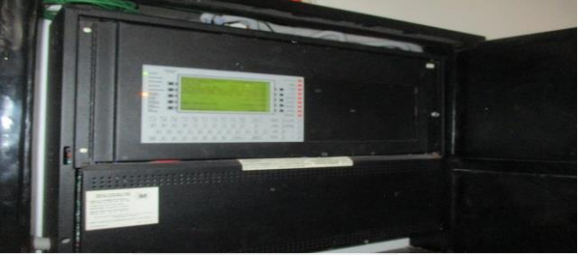
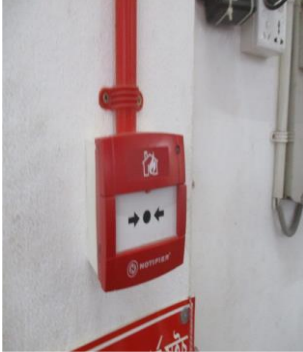
SI No.	Category	Findings	Required Action	Remediation Time Frame	Pictorial Evidence
6	Fire Alarm & Detection System	The factory has been designed & installed the addressable fire alarm system without having approval from AHJ (Authorities Having Jurisdiction). Note: They have submitted the as-built design/drawing of fire alarm system to Accord.	Existing addressable fire alarm & detection system shall be designed & installed as per NFPA 72. Modify the system (if required) after getting approval from AHJ.	Within 06 Months
