# Fakhruddin Textile Mills Ltd. (9290)

Ghargharia, Master Bari, Kewa, Sreepur, Gazipur, Dhaka.

23.AUGUST.2014

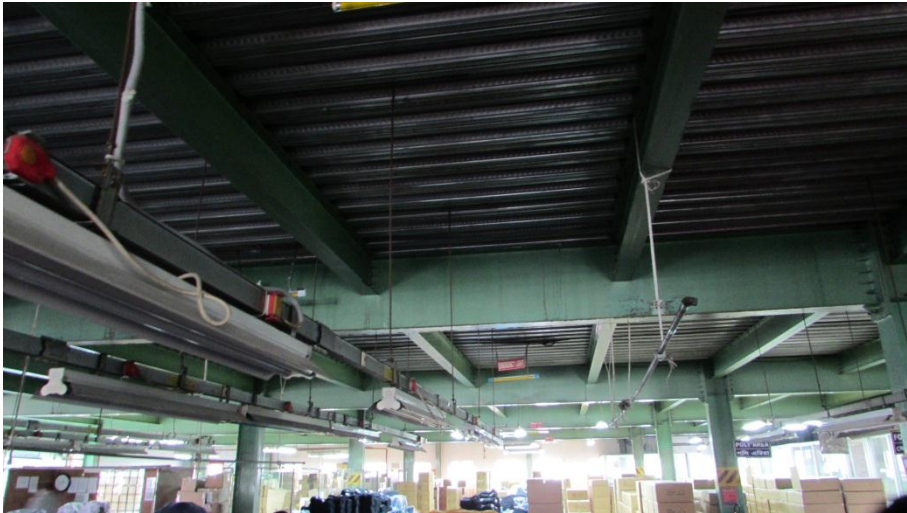
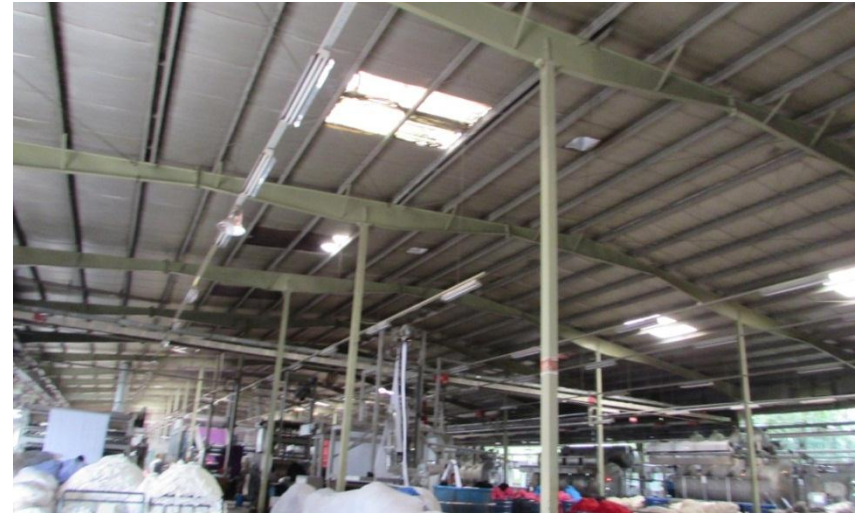
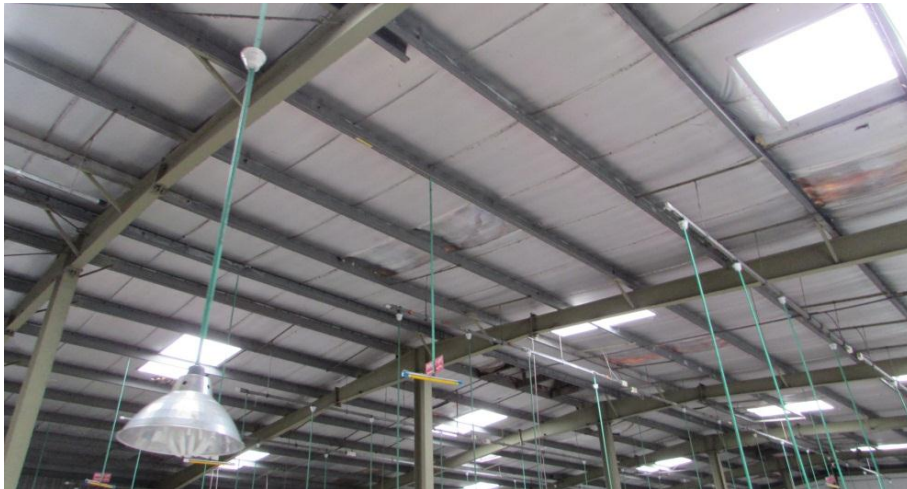
The As-built drawings for the steel buildings need to be produced.

| Item No. | Observation | Recommended Action Plan | Recommended Timeline |
|---|---|---|---|
| 5 | 1st Priority 3 - The As-built drawings of the steel buildings 2, 3, 4 & 8 need to be produced. | An Engineer should survey the actual conditions and produce the drawings as early as possible. | 6-months |

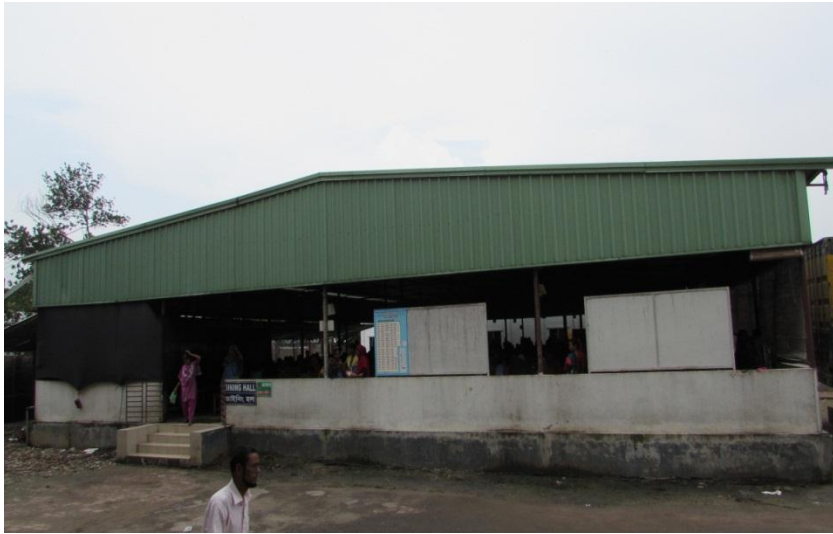
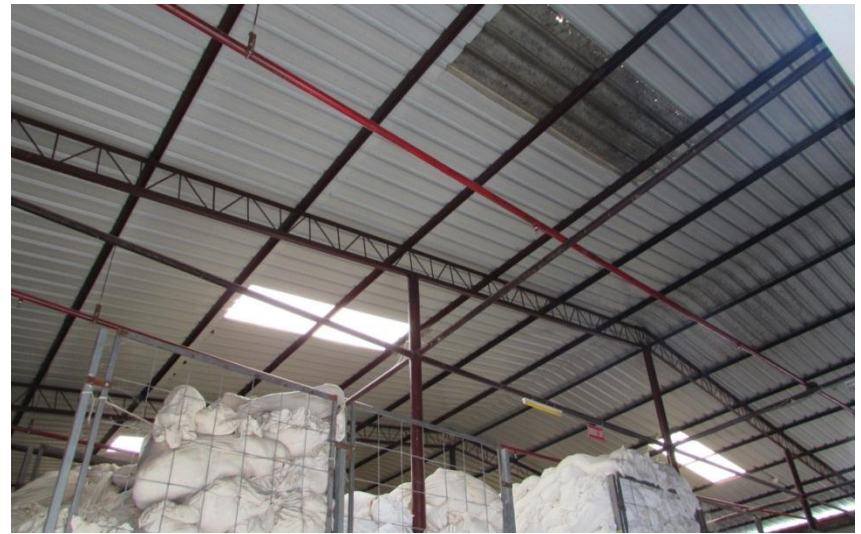
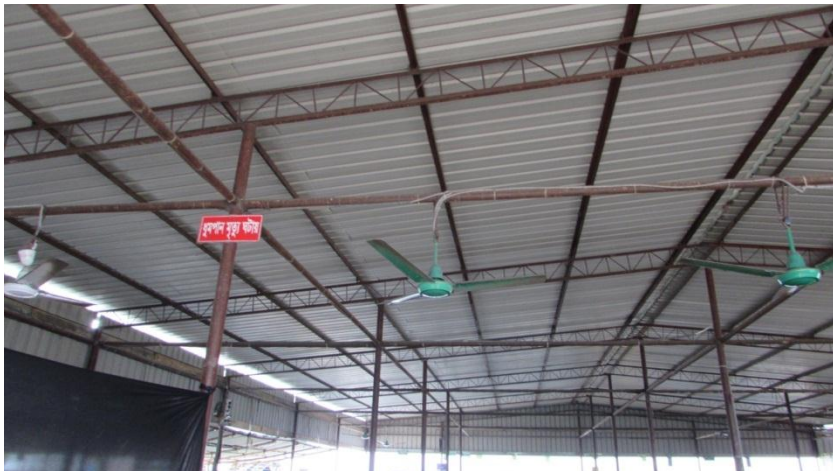
The As-built drawings for the steel buildings need to be produced.

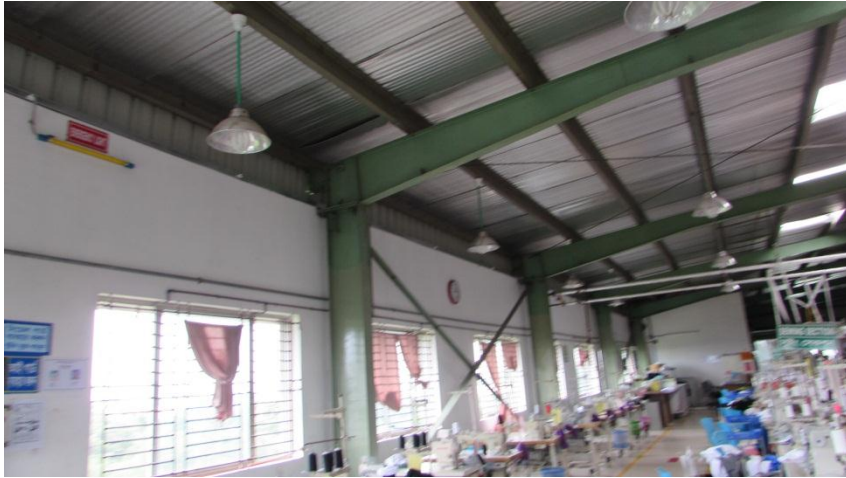
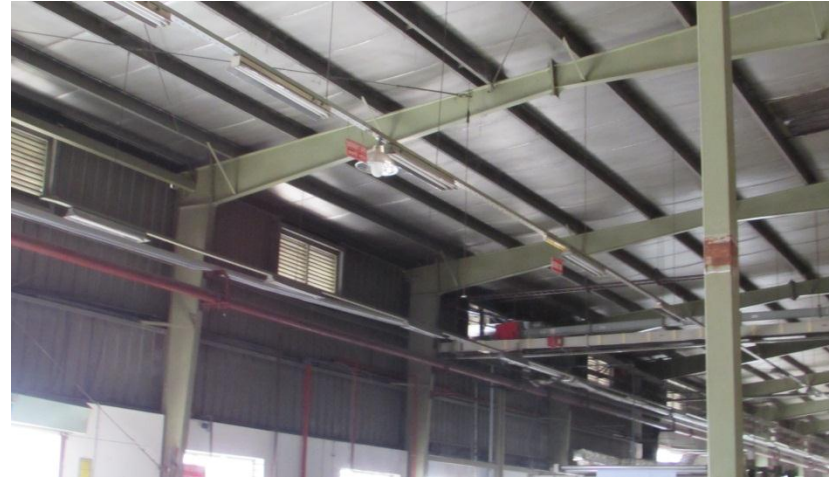
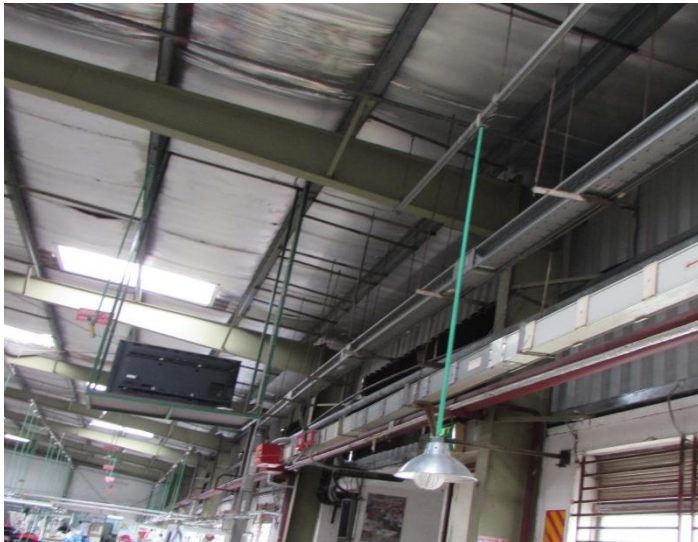
The steel columns of all shed buildings need to be provided with eaves tie beams in the longitudinal direction to unify the structural system stability under wind loads.

| Item No. | Observation | Recommended Action Plan | Recommended Timeline |
|---|---|---|---|
| 6 | 2nd Priority 3 - The steel columns of all shed buildings need to be provided with eaves tie beams in the longitudinal direction to unify the structural system stability under wind loads. | Insert eaves tie beams at all column-beam joints. | 6-months |

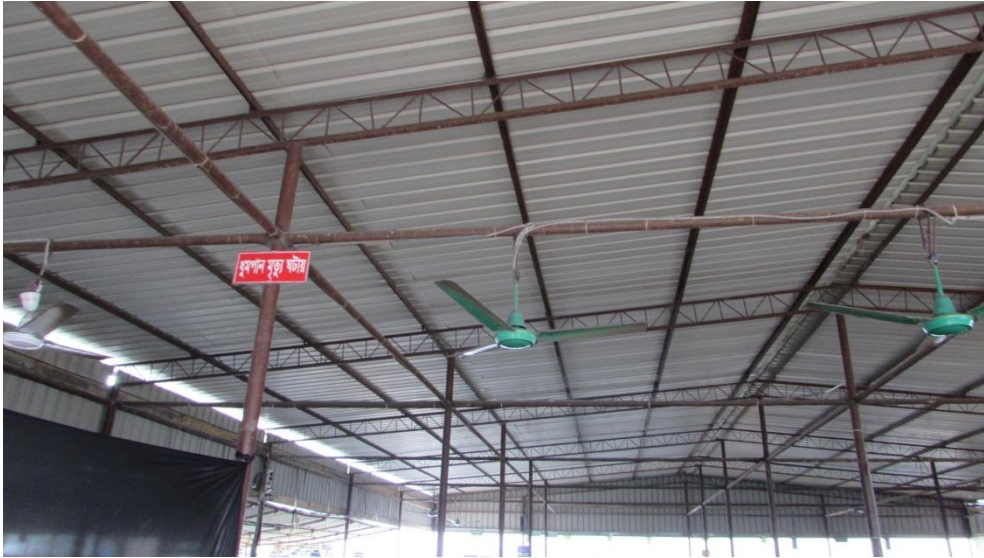
The steel trusses need to be longitudinally braced to combine these trusses together to help resist wind loads.

| Item No. | Observation | Recommended Action Plan | Recommended Timeline |
|---|---|---|---|
| 7 | 3rd Priority 3 - The steel trusses need to be longitudinally braced to combine the these trusses together to help resist wind loads. | The detailed design of building 8 needs be reviewed to verify the structural stability under wind loads. Bracing will need to be provided in the longitudinal direction. | 6-months |

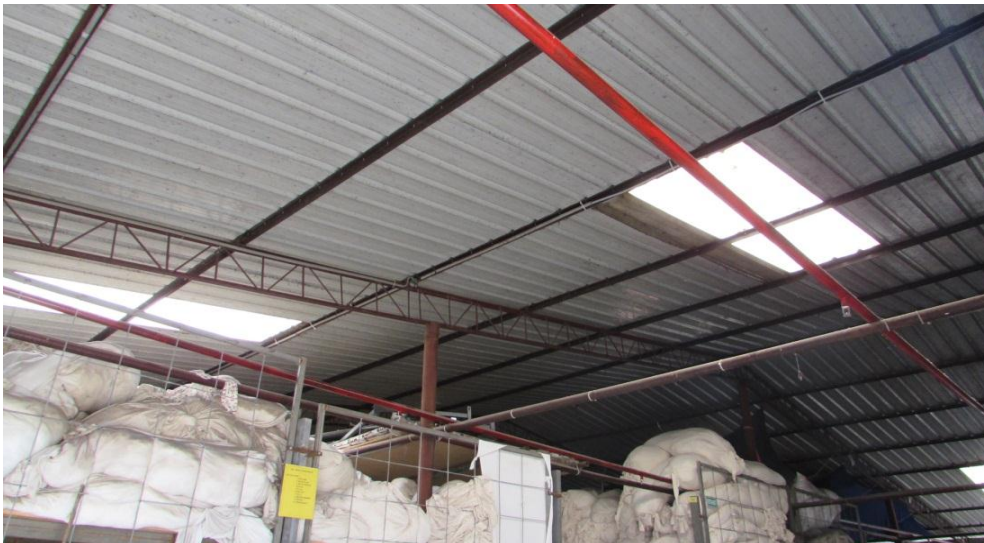
The Structural Engineer needs to review the design of the roofs to check the stability of the trusses under lateral wind loads and uplift loads.

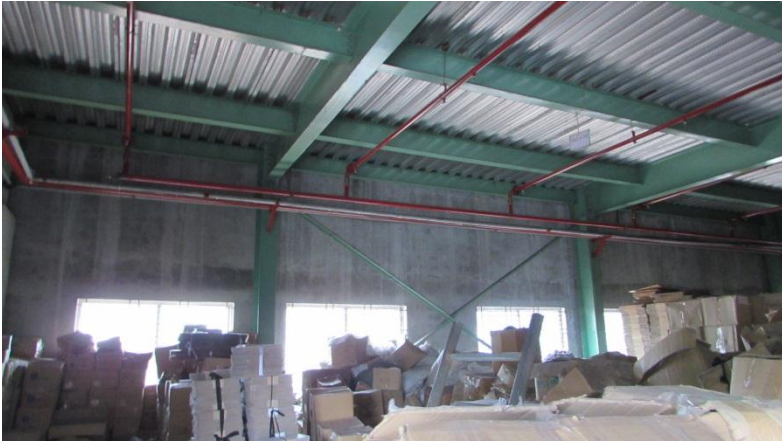
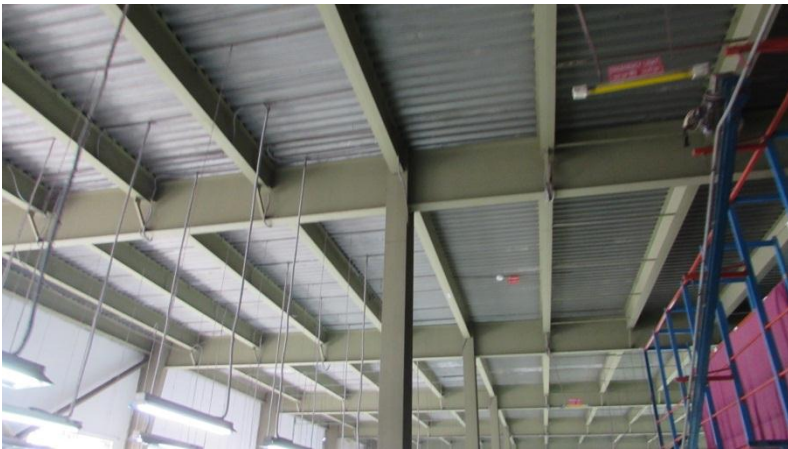
The steel structures have not been protected with fire proofing.

Fire proofing needs to be applied with a minimum 1-2 hours of resistance as per BNBC code requirements.

| Item No. | Observation | Recommended Action Plan | Recommended Timeline |
|---|---|---|---|
| 8 | 4th Priority 3 - The steel structures have not been protected with fire proofing. Buildings 2 & 3. | Fire proofing needs to be applied with a minimum of 1-2 hours of resistance, as per the BNBC code requirements. | 6-months |

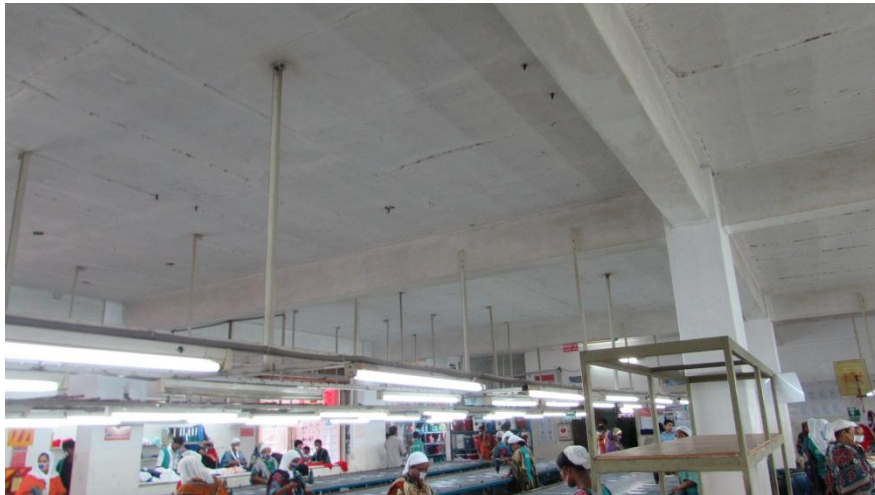
## Building 01

R.C Beam and column frame with a 2-way solid slab  
Stability provided by moment frame action.

Slab Thickness 152.4mm  
Column Size 381x762mm (typ.)  
Beam Size 254x609mm (typ.)

Grid 7.04m x 8.31m.

This type of structural framing is appropriate for buildings lower than 10 storeys high and with large plan areas.

We require that these items be investigated by a Structural Engineer.

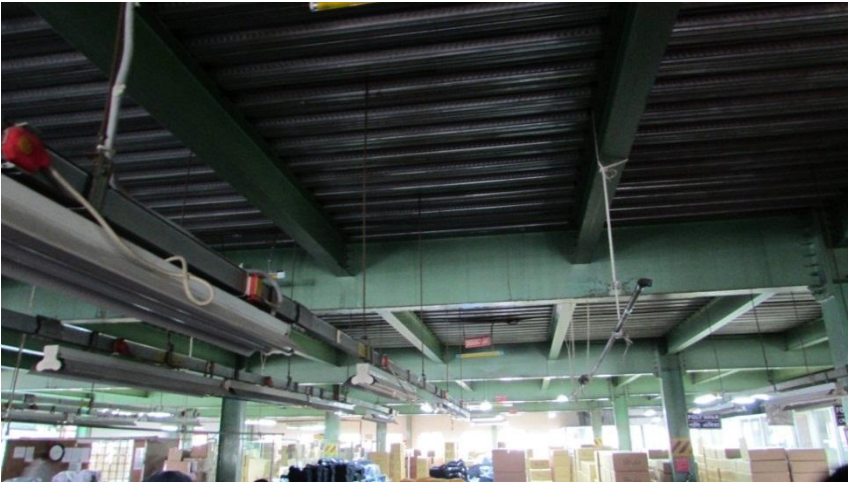
## Building 02

The structure of the 1<sup>st</sup>, 2<sup>nd</sup> and 3<sup>rd</sup> floor levels consist of steel beams and a 1-way composite slab.

The main beam are 620x200x6x8. The secondary beams are 350x150x5x6. The slab thickness is 85mm (average).

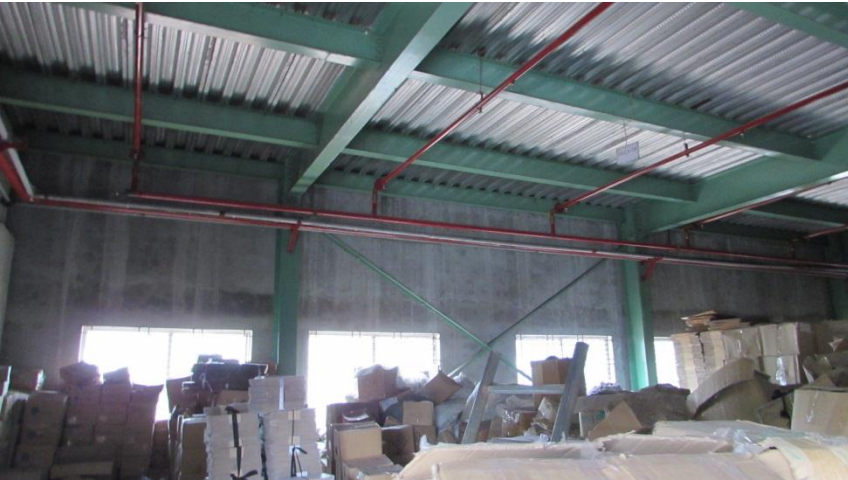
Moment frames in the transverse direction provide stability. A cross bracing system in longitudinal direction.

We require a Structural Engineer to review and check the lateral deflection and storey drift under wind and seismic loading.

We require that these items be investigated.
