# **FIRE SAFETY INSPECTION REPORT**

**Factory Name: Base Fashions Ltd. (New Unit)**

**ACCORD ID: 22923**

**93, Sataish Road, Tongi, Gazipur  
23.920764, 90.390770**

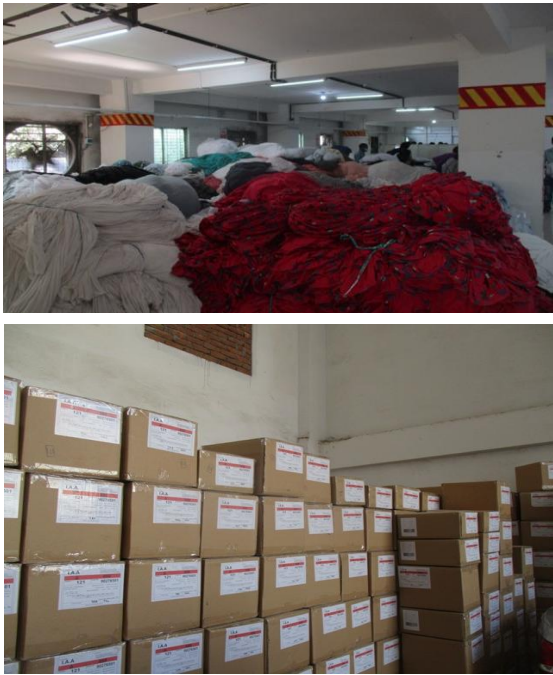
| SI No. | Category | Findings | Required Action | Remediation Time Frame | Pictorial Evidence |
|---|---|---|---|---|---|
| 1 | Fire Rated Construction | <p>Areas used for in-process storage of combustible materials are open to the surrounding occupancy which are not defined or separated.</p> <p>Location: Under Cutting Table, Several floors, Building- 1</p> | <p>Provide defined storage areas and limit the storage arrangement as follows:-</p> <ol style="list-style-type: none"> <li>1. General Condition: Maximum height of 2.4m and maximum area of 23m<sup>2</sup>. Separate areas of unenclosed combustible storage by a minimum clear distance of 3m.</li> <li>2. If sprinkler protected: maximum height of 3.66m and maximum area of 93m<sup>2</sup>. Separate areas of unenclosed combustible storage by a minimum clear distance of 3m. or</li> <li>3. Enclose the storage area from the surrounding occupancy with a minimum 1 hour construction.</li> </ol> | Within 3 Months | |

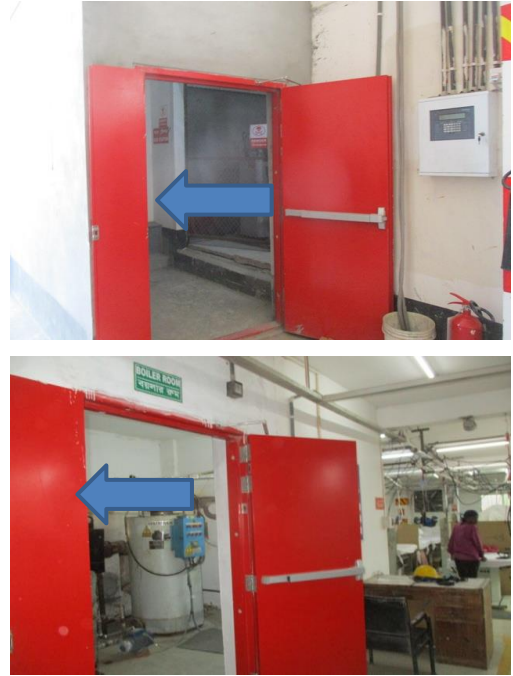
| SI No. | Category | Findings | Required Action | Remediation Time Frame | Pictorial Evidence |
|---|---|---|---|---|---|
| 2 | Fire Rated Construction | Generator, Transformer and Boiler rooms have fire door installed but the passive door during the inspection were found open those have no option to be interfaced with Fire Alarm system neither has the ability to get automatically closed. | Provide appropriate fire door for the required occupancy with all the options available as per NFPA 80 & 258 and interface with Fire Alarm System. | Within 3 Months | |

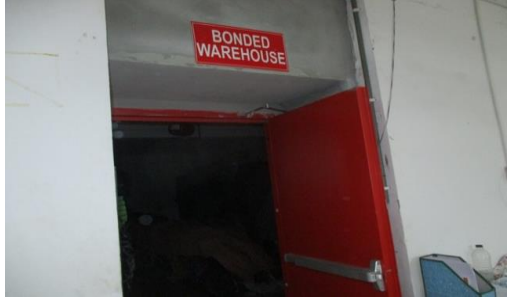
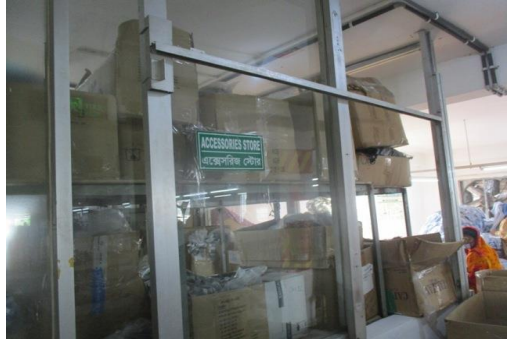
| SI No. | Category | Findings | Required Action | Remediation Time Frame | Pictorial Evidence |
|---|---|---|---|---|---|
| 3 | Fire Rated Construction | Bonded Warehouse and Accessories stores have passive door kept open with the help of external sources that are not interfaced with Fire Alarm System | Provide 2-hr Fireseparation at all dedicated storage. Fire doors shall be interfaced with Fire Alarm System. | Within 03 Months | |

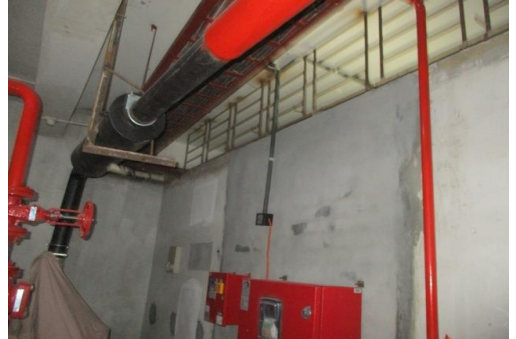
| SI No. | Category | Findings | Required Action | Remediation Time Frame | Pictorial Evidence |
|---|---|---|---|---|---|
| 4 | Fire Rated Construction | Fire Pump room is not separated from Transformer room and other occupancies | Provide minimum 2-Hr Fire Separation to Fire Pump Room | Within 3 months | |

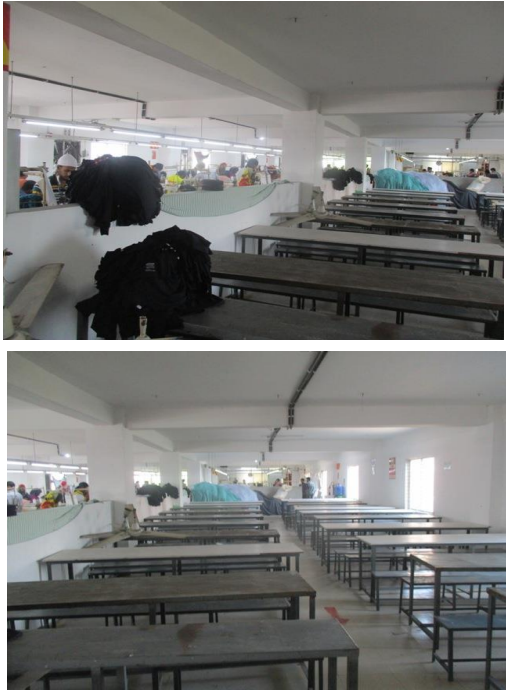
| SI No. | Category | Findings | Required Action | Remediation Time Frame | Pictorial Evidence |
|---|---|---|---|---|---|
| 5 | Fire Rated Construction | Dinning Area is not separated from production floor | Provide minimum 2-hr of Fire Separation at Dinning Area with other occupancies. | Within 3 months | |

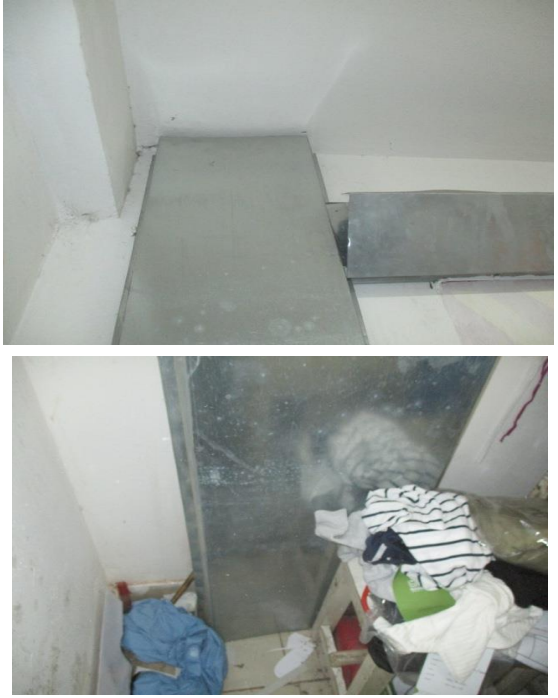
| SI No. | Category | Findings | Required Action | Remediation Time Frame | Pictorial Evidence |
|---|---|---|---|---|---|
| 6 | Fire Rated Construction | <p>Penetrations through floor/ceiling assemblies/Electrical Shaft are found unsealed.</p> <p>Location(s): All floor near stair 1.</p> | <p>Seal all penetrations and openings in floor/ceiling (full thickness of the floor/ceiling) assemblies by fire rated materials to maintain the fire resistance rating.</p> <p>Provide a minimum 2-hr fire rated shaft to separate the utility risers from each floor if required.</p> | Within 2 months | |

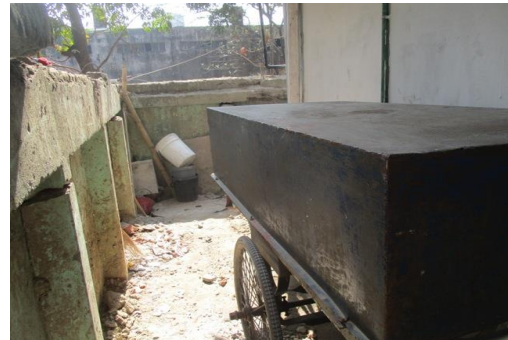
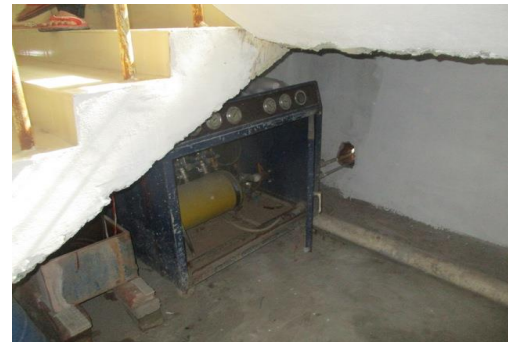
| SI No. | Category | Findings | Required Action | Remediation Time Frame | Pictorial Evidence |
|---|---|---|---|---|---|
| 7 | Fire Rated Construction | Liquefied or compressed gas cylinders were located within the factory under the east exit stair. | The storage or use of liquefied or compressed flammable gas cylinders shall be prohibited within the factory building. | Within 3 Months | |

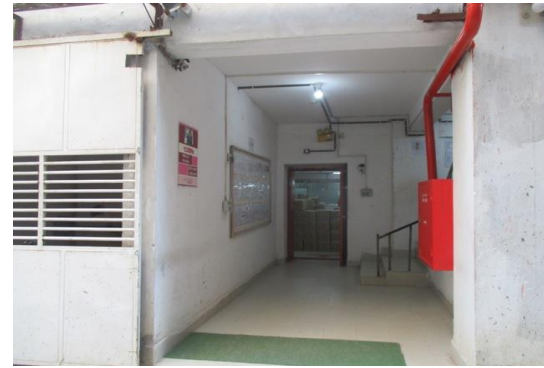
| SI No. | Category | Findings | Required Action | Remediation Time Frame | Pictorial Evidence |
|---|---|---|---|---|---|
| 8 | Fire Rated Construction | Gas Meter room is directly open to the exit discharge | Provide minimum 2-hr of Fire Separation at Gas meter room with other occupancies. | Within in 3 months | |

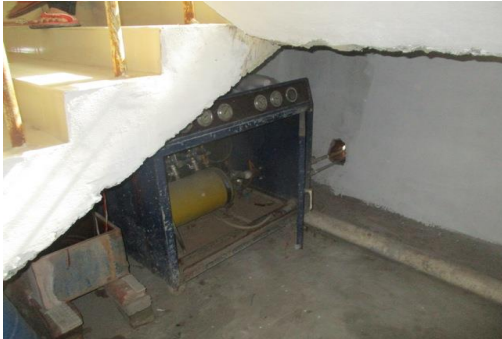
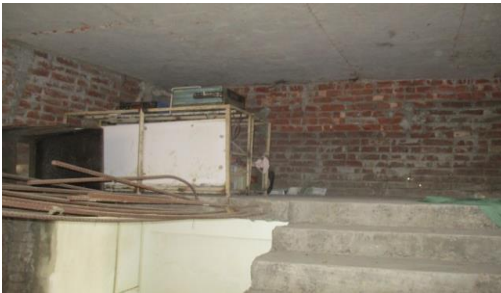
| SI No. | Category | Findings | Required Action | Remediation Time Frame | Pictorial Evidence |
|---|---|---|---|---|---|
| 9 | Egress | Storage were located at both exit stairs at ground floor at roof floor. | Remove all the storage from stairs | Immediate | |

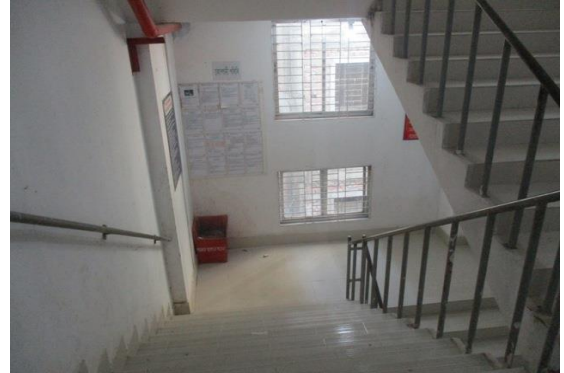
| SI No. | Category | Findings | Required Action | Remediation Time Frame | Pictorial Evidence |
|---|---|---|---|---|---|
| 10 | Egress | Landing of 4th Floor of Stair 1 is less than 48 inches. | Provide adequate landing space as per NFPA 101 | Within 1 month | |

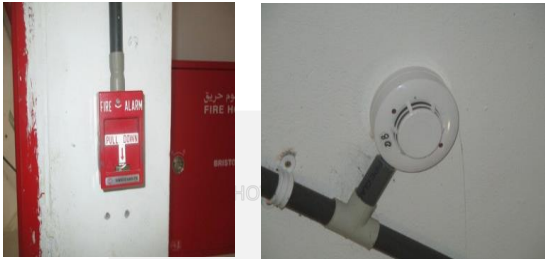
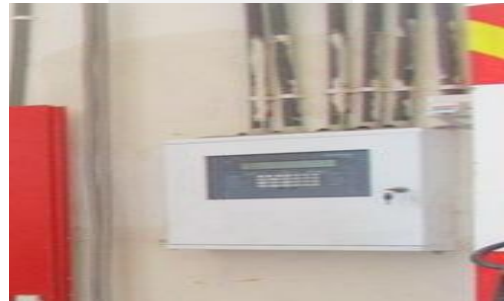
| SI No. | Category | Findings | Required Action | Remediation Time Frame | Pictorial Evidence |
|---|---|---|---|---|---|
| 11 | Fire Alarm & Detection System | The factory has been designed & installed the addressable fire alarm system without having approval from AHJ | Existing addressable fire alarm & detection system shall be designed & installed as per NFPA 72. Modify the system (if required) after getting approval from AHJ. | Within 06 Months | |

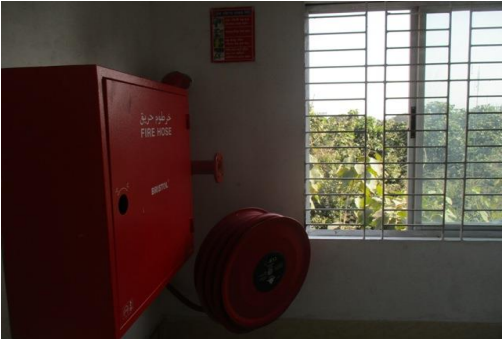
| SI No. | Category | Findings | Required Action | Remediation Time Frame | Pictorial Evidence |
|---|---|---|---|---|---|
| 13 | Fire Protection System | The factory has designed & is installing the Standpipe system without having approval from AHJ (Authorities Having Jurisdiction). | Existing Standpipe system shall be designed & installed as per NFPA 72. Modify the system (if required) after getting approval from AHJ. | Design in 3 months<br>installation in 6 months | |
