Tanaz Fashions Ltd. & Zayantex Ltd. L Usine Fashion Ltd (Unit 1)

216 , Sataish Road, Gazipura, Tongi, Gazipur, Bangladesh
(23.921458N,90.386581E)

22 September 2013

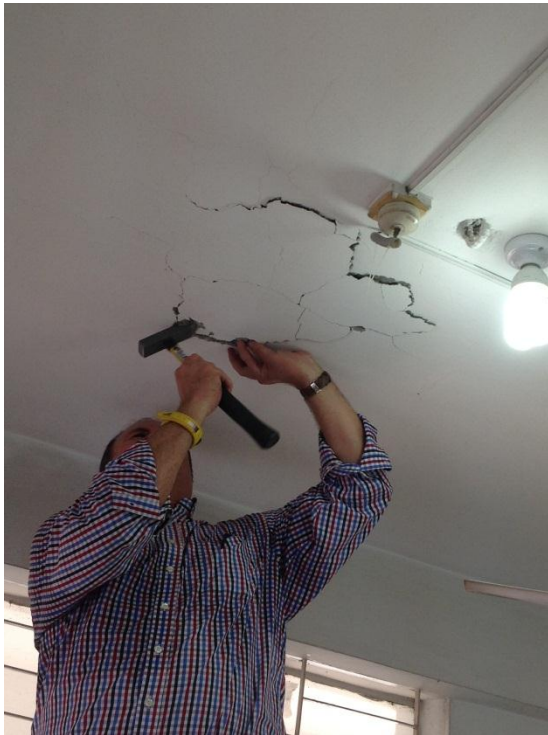
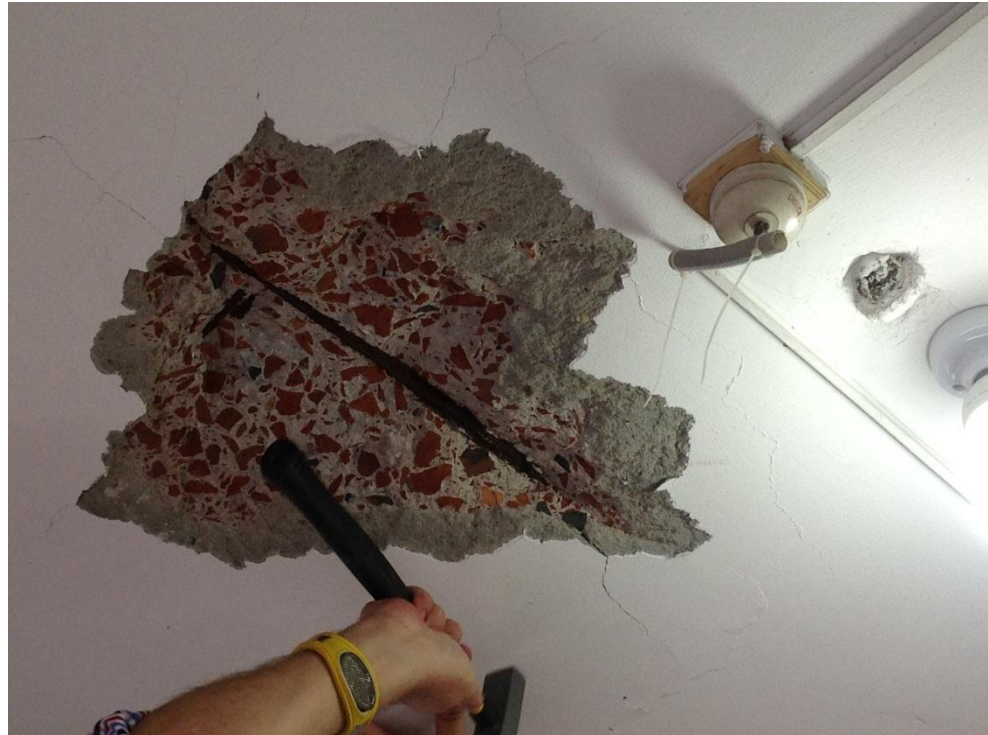
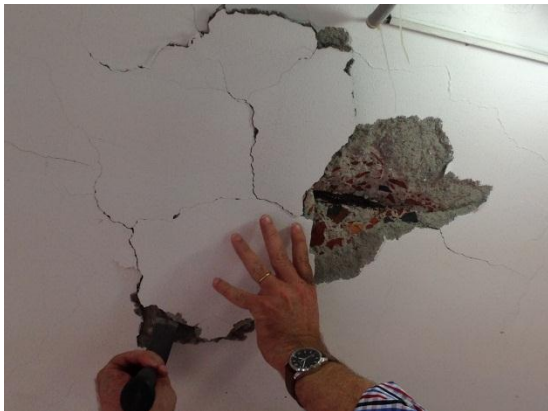
Local concrete spalling caused by corrosion of lower reinforcement bars.

Condensation and leaking from above boiler room causes constant wetting and heating of concrete slab. Heat and wetting causing corrosion and spalling

Item No.	Observation	Recommended Action Plan	Recommended Timeline
7	Concrete strength in columns	Continue to implement load plan.	6-months
8	Local concrete spalling caused by corrosion	Building engineer to inspect slab under boiler room for corrosion damage and spalling risk.	6-weeks
9	Local concrete spalling caused by corrosion	Mitigate water source from boiler room above. Manage drainage, waterproof system and isolating layer.	6-months
10	Local concrete spalling caused by corrosion	If required, specify a treatment system for corrosion and concrete repair	6-months
11	Water causing damage and corrosion	Manage drainage from roof level and downpipes to avoid structural corrosion due to continuous moisture	6-months
12	High density of loading in bonded/storage areas	Building Engineer to create controlled loading plans for all floors designating where storage can be placed and can not be placed.	6-months

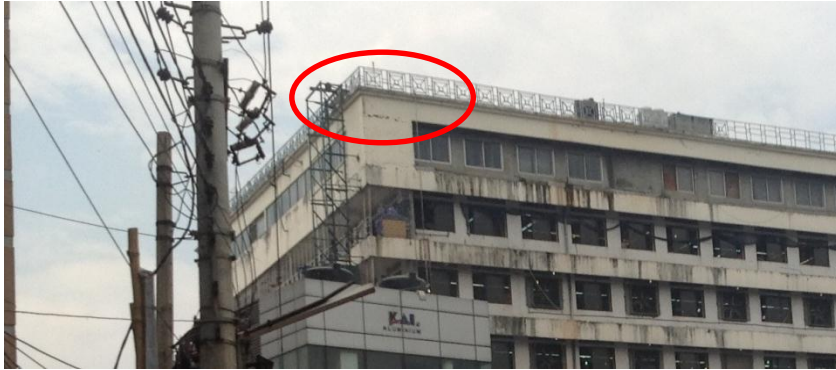
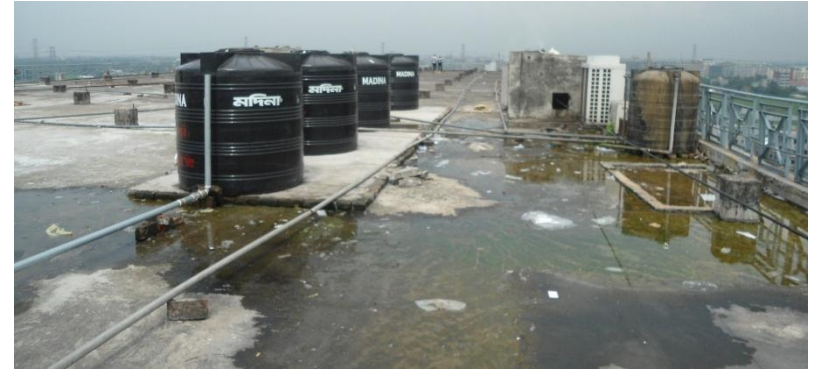
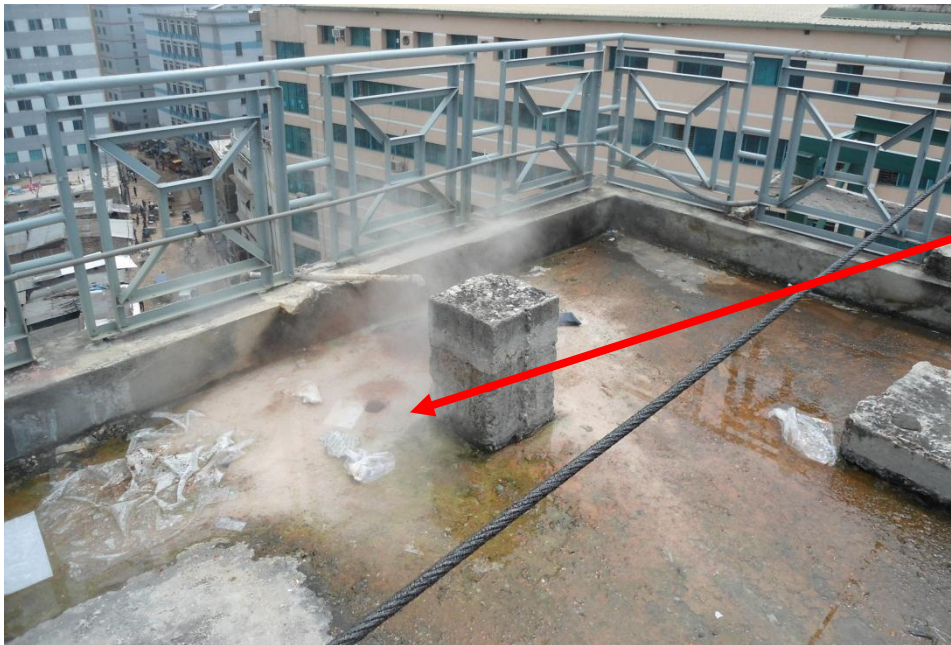
Water causing damage and corrosion

Steam rejection causing constant wetting

Unmanaged roof drainage causing corrosion to façade and structure

Water causing local damage

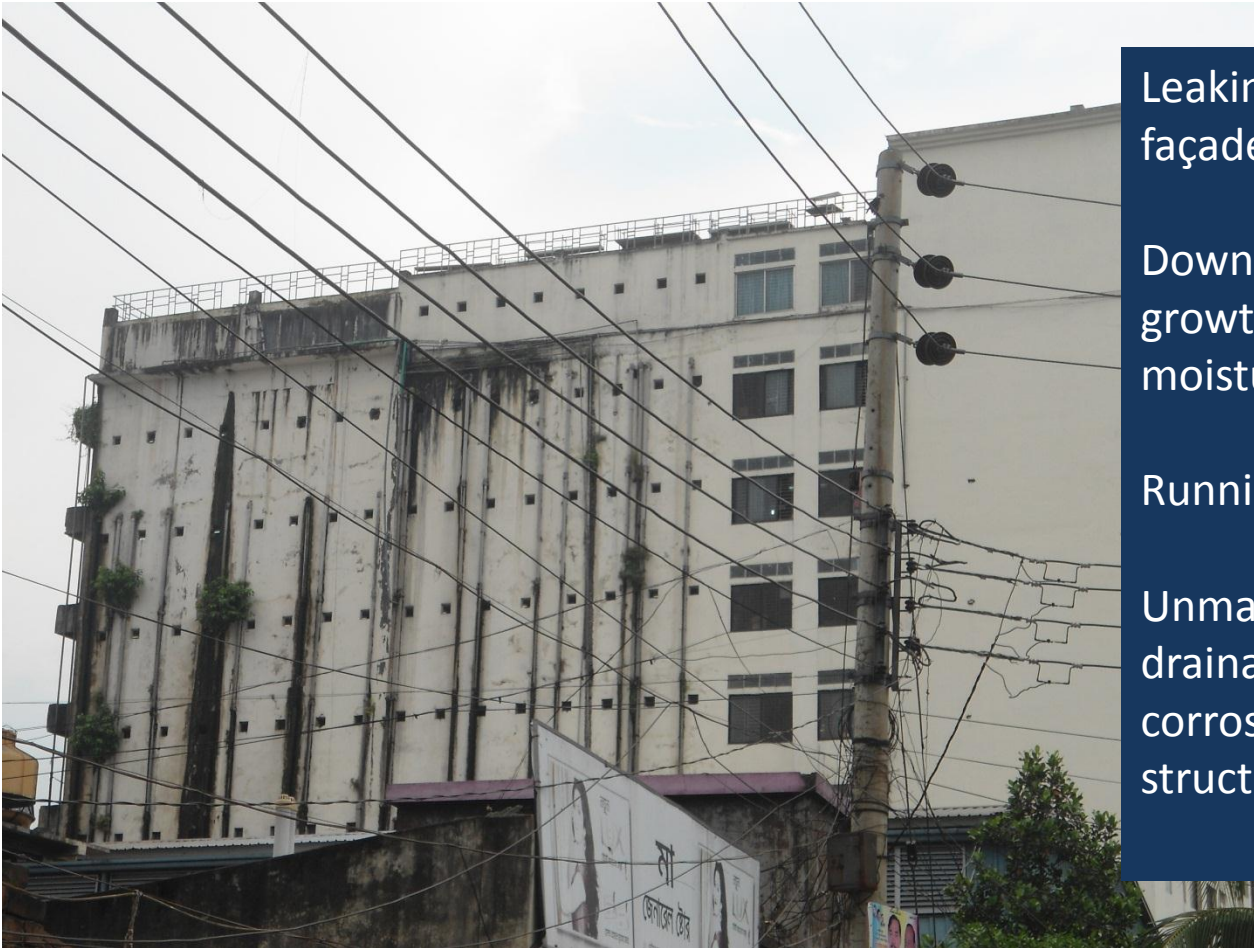
Leaking drainage pipes on façade.

Downpipes vegetation growth indicates moisture.

Running water visible

Unmanaged leaking drainage causing corrosion to façade and structure

Water causing local damage

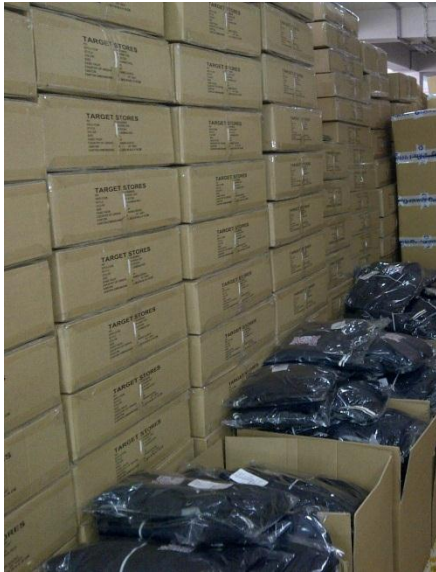
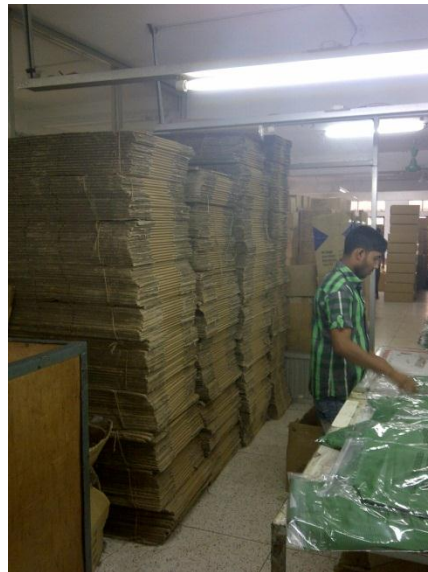
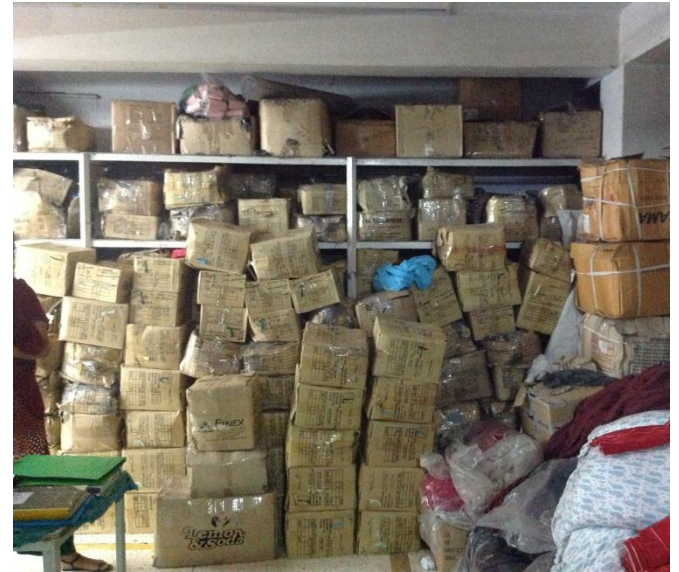
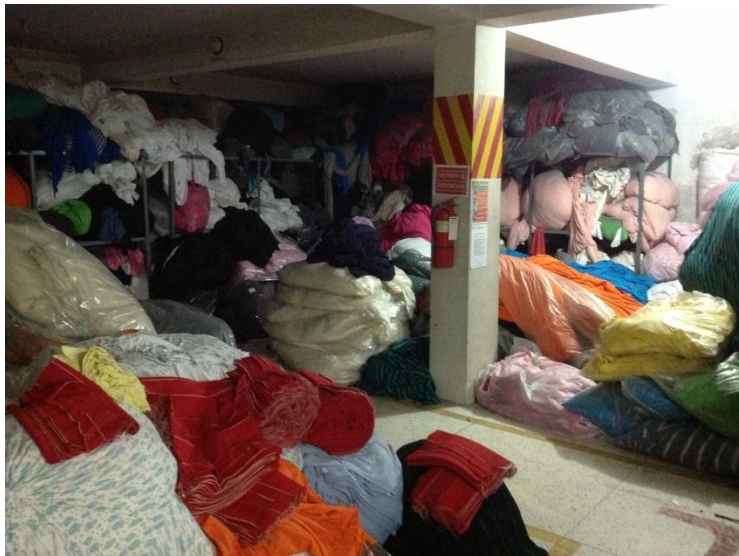
High loads on bonded/storage areas

Material stacked to ceiling within storage areas.

Floor loading

Plan and height restrictions to be introduced to prevent future overloading.

Limit height to 1.80 (1.50x1.50 area) and keep 0.50-0.75 m cleared strip around.

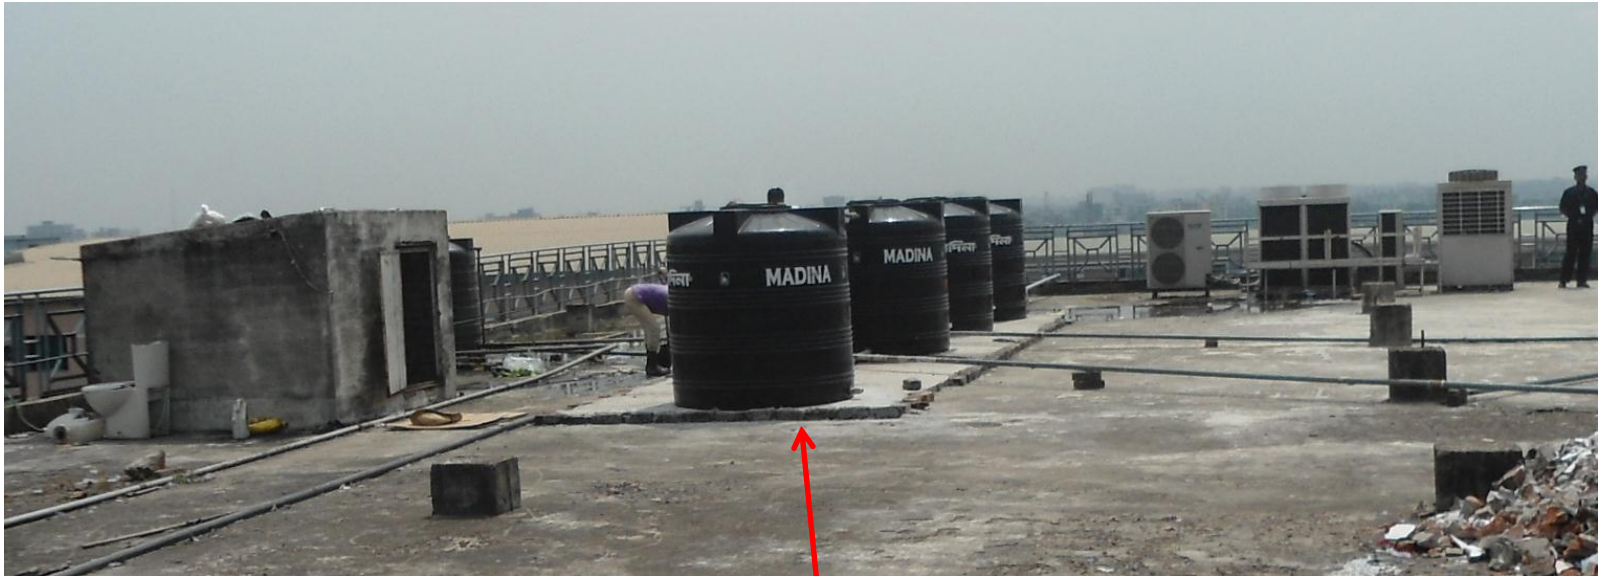
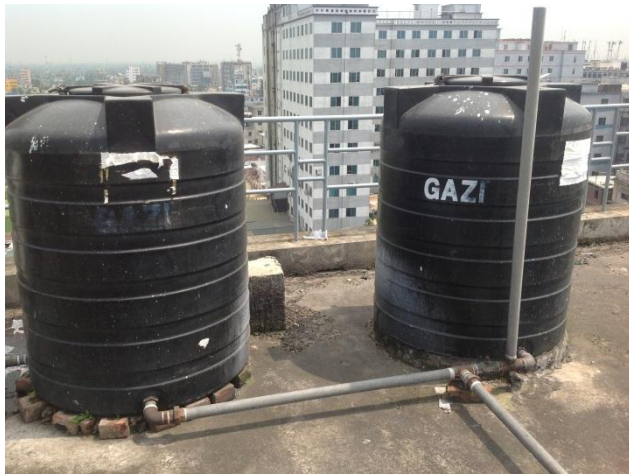
Check on roof structure from localised high loading from water tanks required

Water tanks mounted on small concrete plinths

Water tanks loading

Building Engineer to check that beam and slab have been designed to accommodate loads.

Item No.	Observation	Recommended Action Plan	Recommended Timeline
13	Check on roof structure from localized high loading from water tanks required	Building Engineer to check that beam/slab has sufficient capacity to support fully filled water tanks plus concrete plinth	6-months
14	Check on roof additions required	Addition structures should be Designed and upgraded to support code vertical and wind loads by the building Engineer, or they should be vacated and removed.	6-months

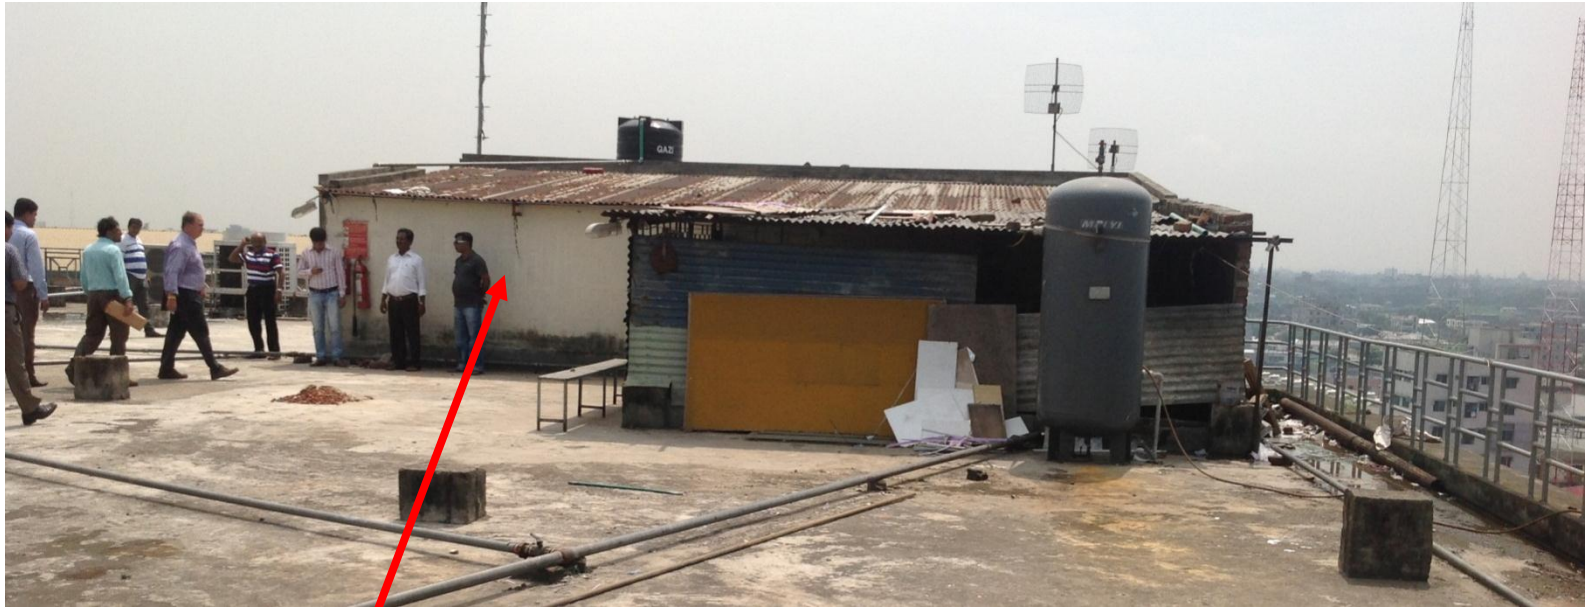
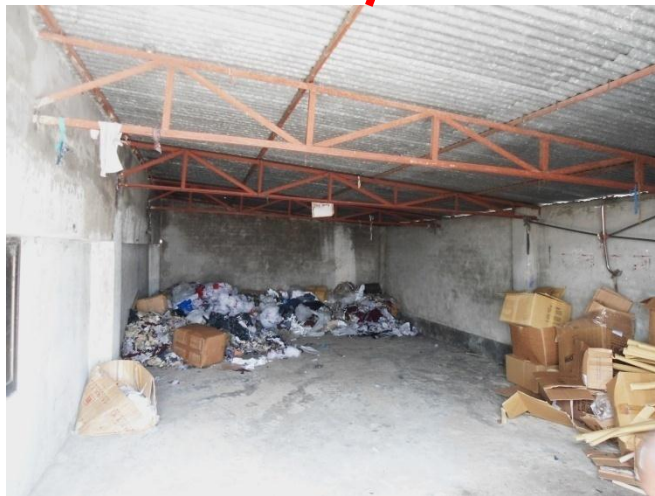
Check on roof additions required

Addition roof structures not shown in the structural design drawings.

Built with unreinforced masonry walls and a lightweight steel roof open to wind uplift.

Inadequate tie-down details
