FIRE SAFETY INSPECTION REPORT

Southeast Sweaters Ltd. NEW

ACCORD ID: 23154

Fire Safety Inspection Report

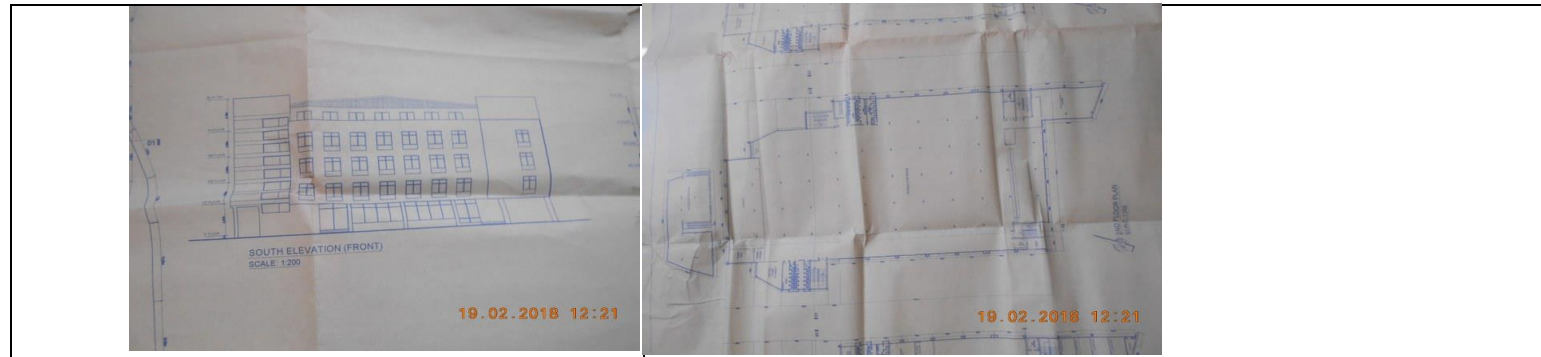
Elevation View

Typical Floor Plan

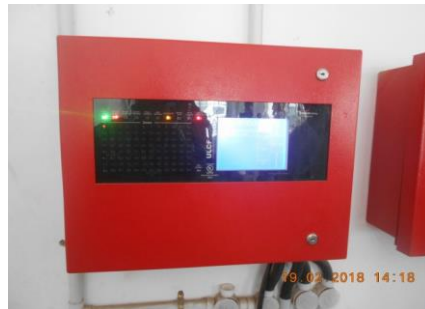
Current System Overview: An addressable fire alarm & detection system is built around 2 inter-connected control panels for all structures. The panels were located inside the fire control room near the main gate. No functional test has been conducted. System commissioning verification has also not been done.

Fire Alarm Control Panel

F-3	Fire Detection & Alarm System	Fire detection & alarm system installation requires detailed review to confirm compliance with NFPA 72 and ACCORD standards	<p>Submit as-built drawings, testing records, listing information and other relevant documentation to the ACCORD for review and approval, modification shall have to be done as per the reviewed design (if required)</p> <p>Upon approval & installation/modification the owner shall contact the Accord prior to conducting the final acceptance testing of the fire detection & alarm system installation.</p> <p>Also inspect, test and maintain the fire detection & alarm system and keep written records on-site, in accordance with NFPA 72 and ACCORD standards.</p>	Design submission within 2 months; Installation/modification within 4 months
-----	-------------------------------	---	---	---

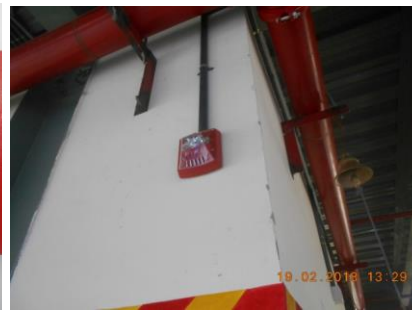
Visual Alarm Unit

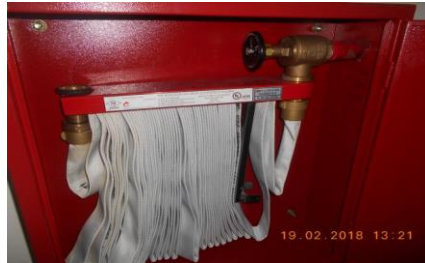
Current System Overview: A class-III wet type standpipe system is installed currently. 65 mm hose connections were provided inside the staircase. 40 mm hose rack assembly is provided inside the floors and staircases. The system was reported to be connected to fire pumps. Fire pumps have been selected and installed based on hydraulic design and furnished design without any approval from AHJ.

Class II Hose Rack Assembly

F-4	Fire Protection System	Fire pump, water supply & standpipe system installation requires detailed review to confirm compliance with NFPA 14, 20, 22, 25 and ACCORD standards	<p>Submit as built drawings, testing records, listing information and other relevant documentation to the ACCORD for review and approval, modification shall have to done as per the reviewed design (if required)</p> <p>Upon approval & installation/modification the owner shall contact the Accord prior to conducting the final acceptance testing of the sprinkler system installation.</p> <p>Also inspect, test and maintain the standpipe system & fire pumps, and keep written records on-site, in accordance with NFPA 14, 20, 25 and ACCORD standards.</p>	Design submission 2 months; Modification/installation within 6 months.
F-5	Fire Protection System	Sprinkler system installation requires detailed review to confirm compliance with NFPA 13 and ACCORD standards	<p>Submit as built drawings, testing records, listing information and other relevant documentation to the ACCORD for review and approval, modification shall have to done as per the reviewed design (if required)</p> <p>Upon approval & installation/modification the owner shall contact the Accord prior to conducting the final acceptance testing of the sprinkler system installation.</p> <p>Also inspect, test and maintain the standpipe system & fire pumps, and keep written records on-site, in accordance with NFPA 25 and ACCORD standards.</p>	Design submission 2 months; Modification/installation within 6 months.

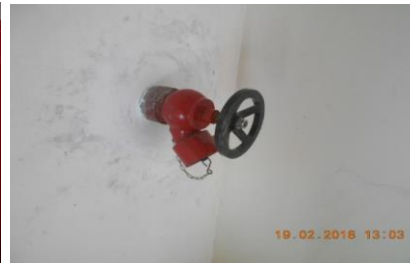
65 mm Landing Valve

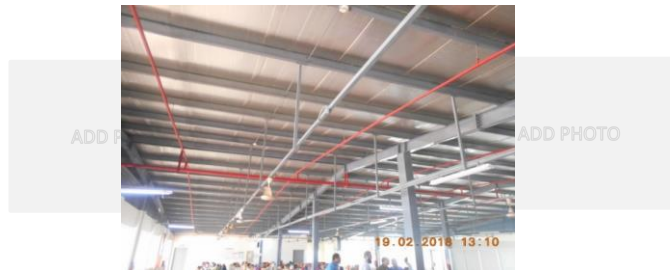
Sprinkler Protection Required	Yes	
Type of System Installed	Wet Type	
Location/Coverage	Full	
Inspection, Testing & Maintenance as per NFPA25	Yes	
Comments

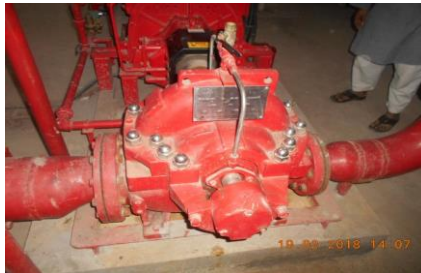
Current System Overview: A dedicated underground reservoir is provided for fire fighting purpose. There are total 3 fire pumps provided to pump water from the underground reservoir. One electrical motor driven pump connected as main duty pump, one diesel engine driven pump as standby one and a pressure booster pump to maintain the system pressure. All pumps appear to be UL listed based on visual inspection. Separate listed controllers have been provided for each pump.

Fire Pump

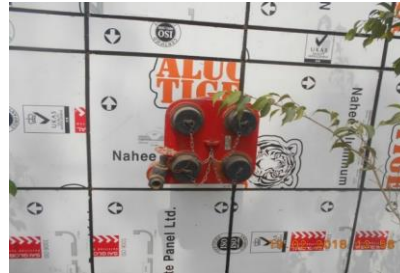
Fire Department Connection

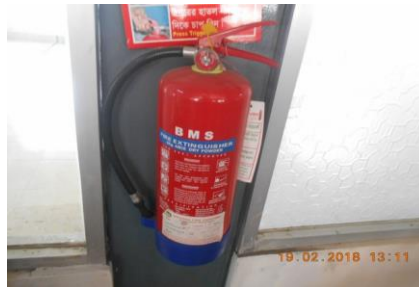
Current System Overview: Portable fire extinguishers, consisting of a mixture of CO2 and dry chemical extinguishers were provided throughout the building. There were foam extinguisher located in the utility room. Inspection tags show recent and up-to-date inspections.

ABC Dry Powder

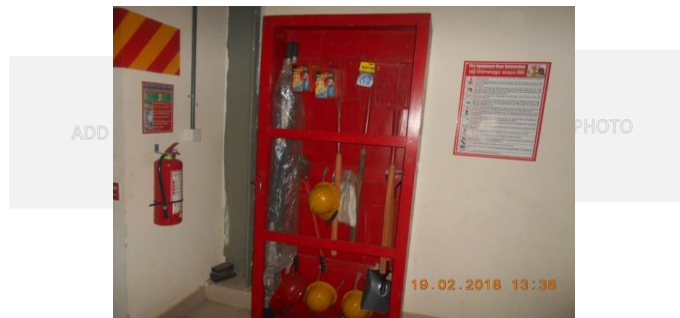
Current System Overview: Each floor had firefighting equipment staged inside staircases. Types of manual firefighting equipment provided included: buckets, escape hoods, bolt/lock cutters, shovels, stretchers and personal protection equipment.

Type of Equipment Provided	Buckets, escape hoods, bolt/lock cutters, shovels, stretchers and personal protection equipment	
Location of Equipment	Inside the staircase

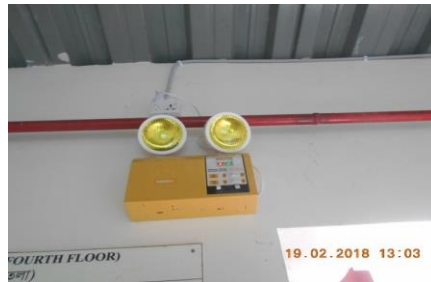
Overview: There were multiple industrial lamps provided over the aisles & exit access doors at each floor with self battery back up. Each floor had a number of illuminated exit signs located at exits. Directional exit signs were provided in adequate number & properly located. The factory management reported that these are all serviced by normal electricity as well as by "Instant Power Supply" (IPS) units. Records of regular testing or maintenance of the emergency lighting system were provided and they were in accordance with The ACCORD Standard

Fog Light (Self Battery)

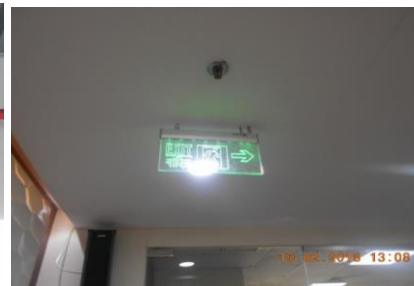
Directional Sign (IPS Connected)

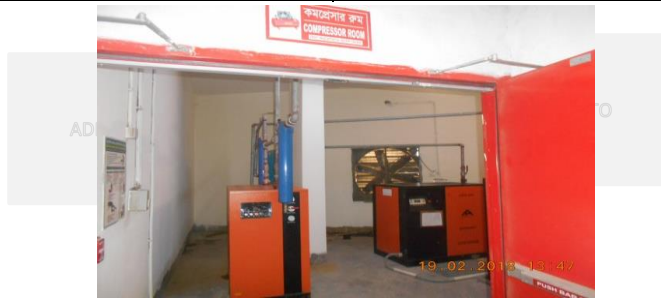
Overview: There were 3 compressor units installed at the ground floor of utility building. Proper fire separation was provided for compressor room.

Compressor Equipment

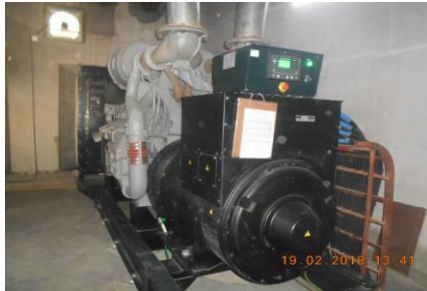
Overview: There were two boilers & two generators installed at the ground floor of utility building. Proper fire separation was provided for the boiler & generator room.

Generator

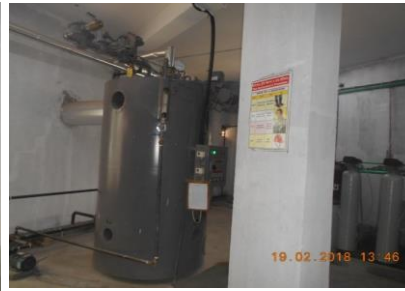
Boiler

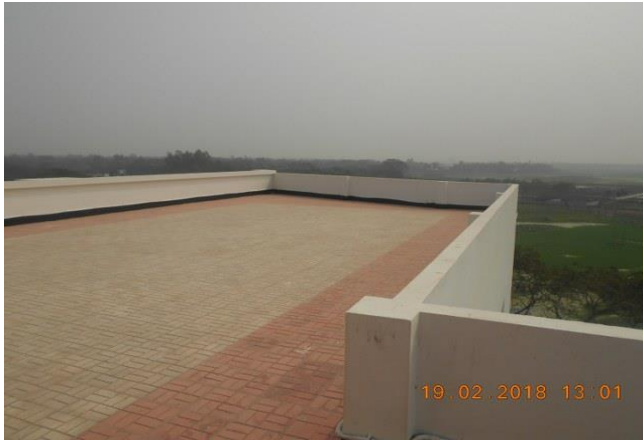
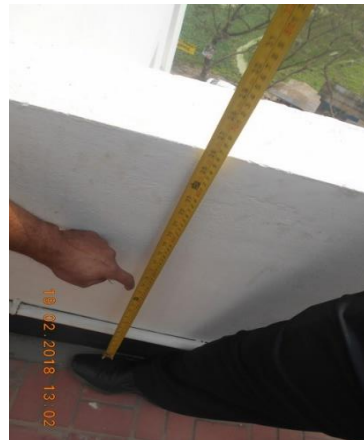
SI No.	Category	Findings	Required Action	Remediation Time Frame
F-1	Structural Fire Protection	The new building construction is prefabricated steel type which is non rated and all the RCC deck slabs are resting on the steel columns and beams/girders. Hence the structural members of each floor require insulation by fire resistive rated construction materials to separate the floors from each other.	Provide fire-resistive rated insulation of the structural members of each floor following Section 4.4 and Table 4.4.1 of the Accord Standard or Table 3.3.1 (Part 3, BNBC 2006) and Table 4.1.1 from BNBC Part 4. Consult a qualified fire protection engineer to design the rated insulation.	Within 6 months
F-2	Egress	Parapets or guards are provided at occupied roof which is less than 1067mm (42 inch.).	Provide parapets or guards with a minimum height of 1067mm (42 inch).	Within 3 months

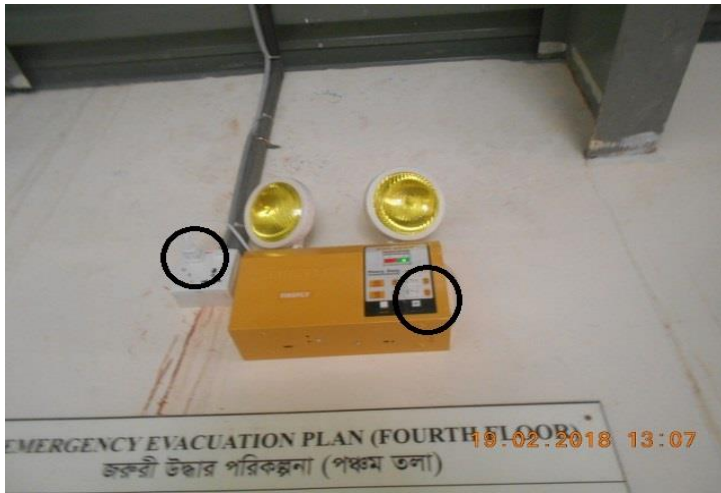
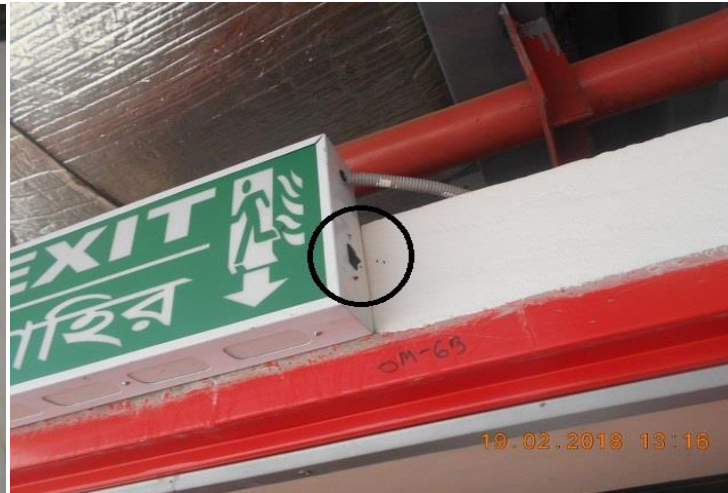
F-6	Egress Lightng	Manual on-off switch is provided for emergency lighting & exit signage units.	Remove manual on/off switches from emergency lighting & exit signage units to prevent them from being switched off	Within 1 month
-----	----------------	---	--	----------------
