FIRE SAFETY INSPECTION REPORT

GLOBAL OUTWEAR LTD.

PLOT # M/1, ROAD # 7, SECTION # 7, MIRPUR, DHAKA

March 3, 2014

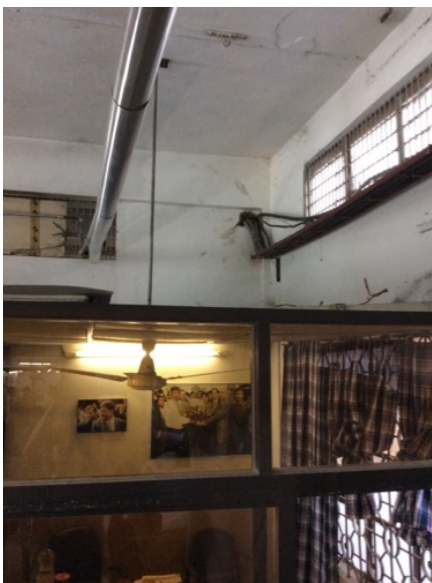
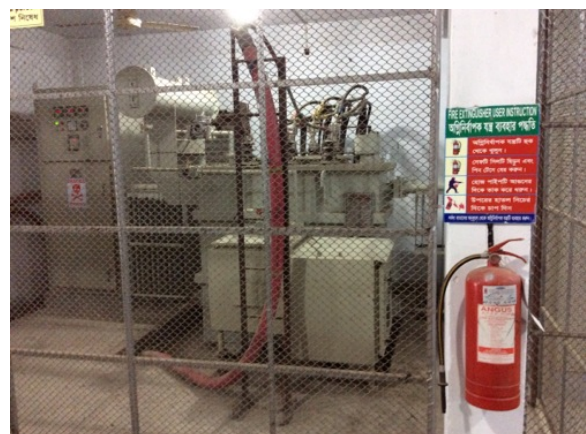
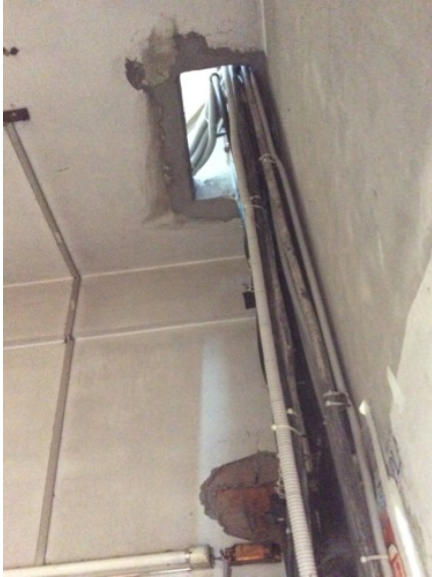
| No. | Category | Finding | Recommendation | Remediation Timeframe |
|---|---|---|---|---|
| F-1 | Fire Rated Construction | <p>The boiler / generator and transformer room is not separated by fire-rated construction and is open to each other in the one service room openings, non-rated doors and penetrations all present located on the ground floor.</p> <p>The services room is open to the factory floor due to no adequate fire rated construction i.e. penetrations and door openings.</p> | <p>Separate the boiler / generator and transformer room by a minimum 2-hr fire-rated construction. Seal and/or protected all openings to maintain the required fire separations</p> | <p>Within 3 months</p> |

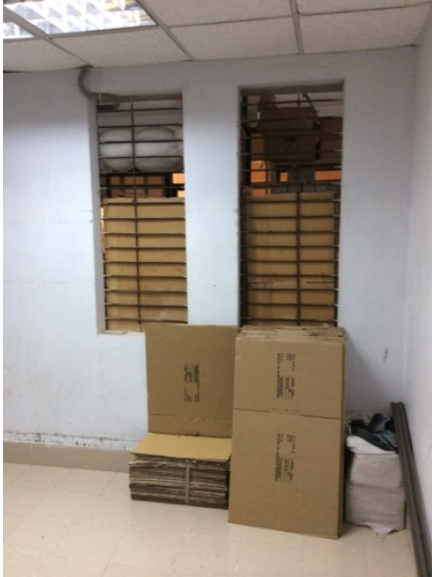
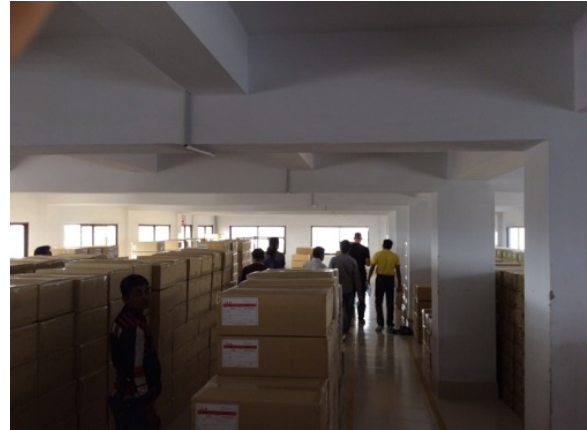
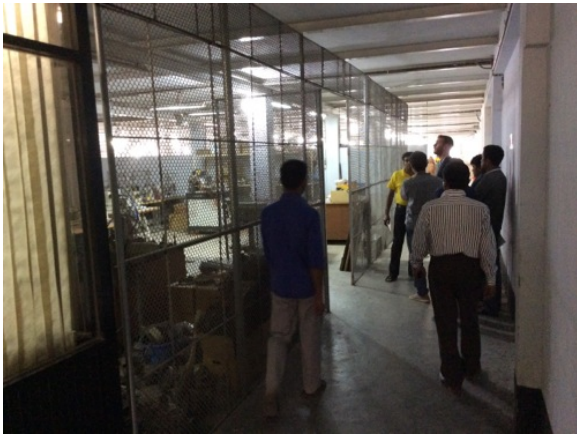
| F-2 | Fire Rated Construction | <p>Areas used for combustible storage are not separated by fire-rated construction on the main store located on the ground floor and minor storage spaces throughout the factory. No adequate fire rated doors and penetrations present.</p> | <p>Provide dedicated storage rooms separated by minimum 1-hr fire-rated construction.</p> <p>Where separate storage rooms are not feasible, provide defined storage areas and limit the storage arrangement as follows:</p> <ul style="list-style-type: none"> - Maximum height of 2.4m and maximum area of 23m² - If sprinkler protected: maximum height of 3.66m and maximum area of 93m² <p>Separate areas of unenclosed combustible storage by a minimum clear distance of 3m.</p> | Within 3 months |

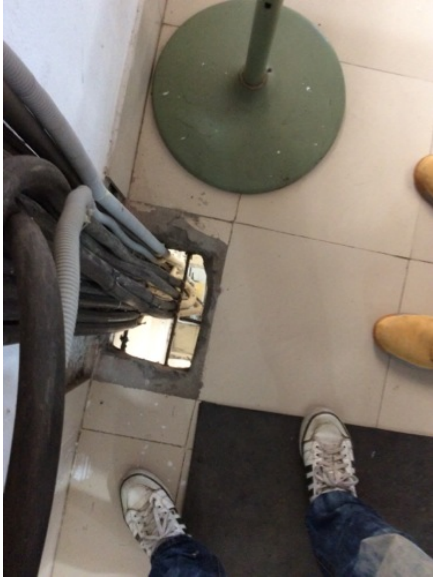
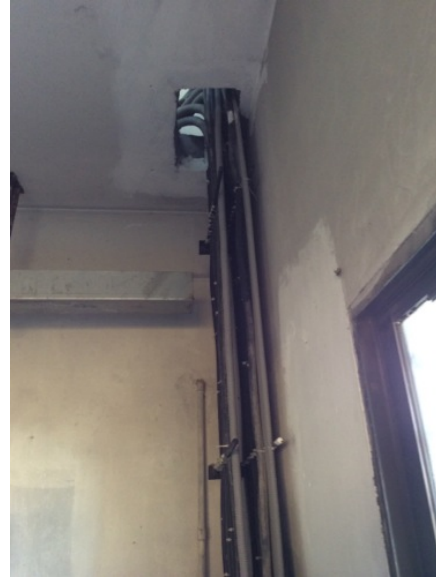
| F-3 | Fire Rated Construction | Unsealed penetrations and openings are located in the fire-rated floor/ceiling assemblies to each floor located at all service shaft zones, daylight can be seen through each level allowing smoke to rise up each floor in the event of a fire. | Provide a minimum 2-hr fire-rated shaft to separate the utility risers from each floor level. Seal all penetrations and openings in floor/ceiling assemblies to maintain the fire separation. | Within 3 months |

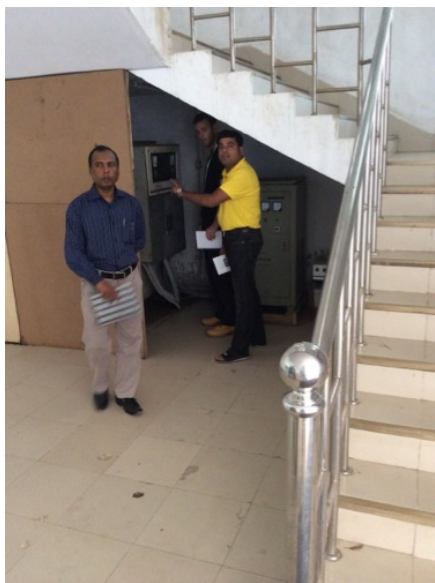
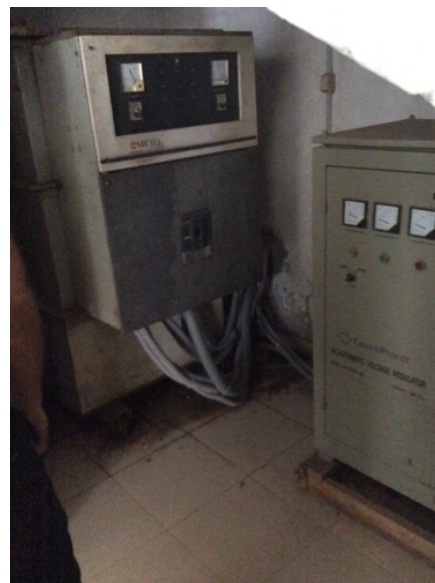
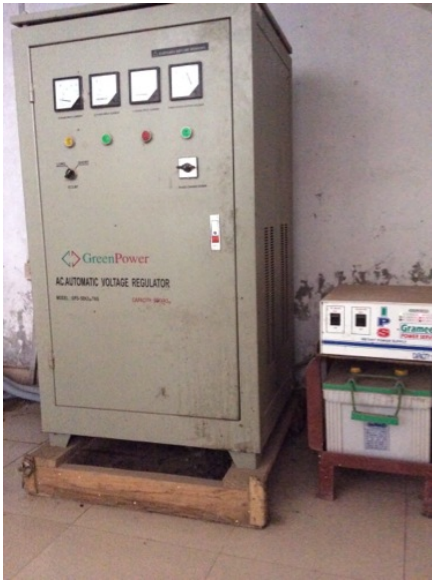
| F-5 | Fire Rated Construction | Voltage stabilizer and IPS system located beneath stairwells, area is not separated by fire-rated construction (openings, non-rated doors, penetrations). | Separate the electrical supply area by a minimum 2-hr fire-rated construction. Seal and/or protected all openings to maintain the required fire separations. | Within 3 months |

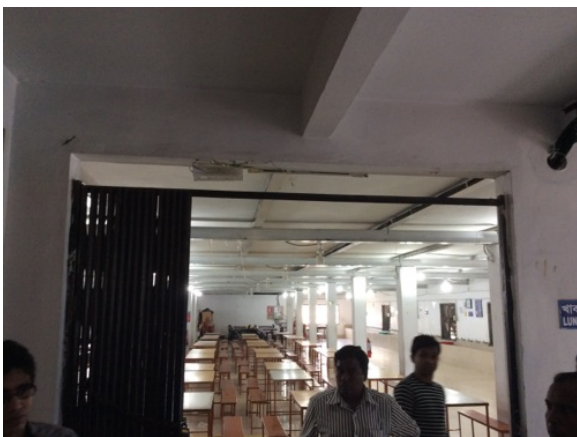
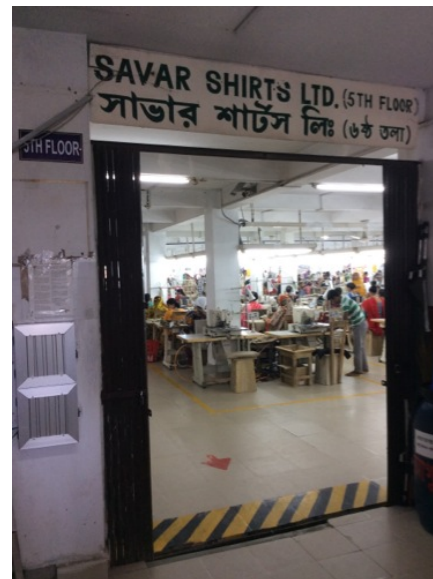
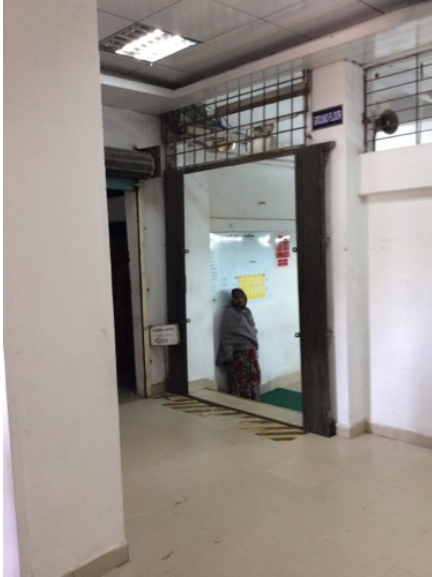
| F-6 | Egress | <p>All egress steel sliding gates have locking features located at all exits on floor plates, storage areas and main egress routes to assembly points. All doors were open and unlocked during the inspection.</p> | <p>Remove locking features from all egress doors / gates.</p> <p>If locks are required for security reasons, utilize special door locking features complying with NFPA 101.</p> | Immediate |

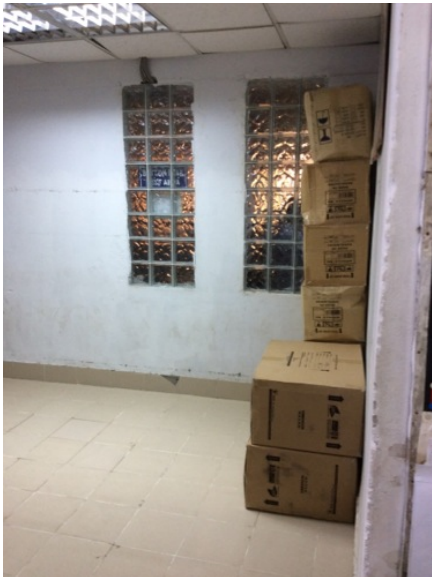
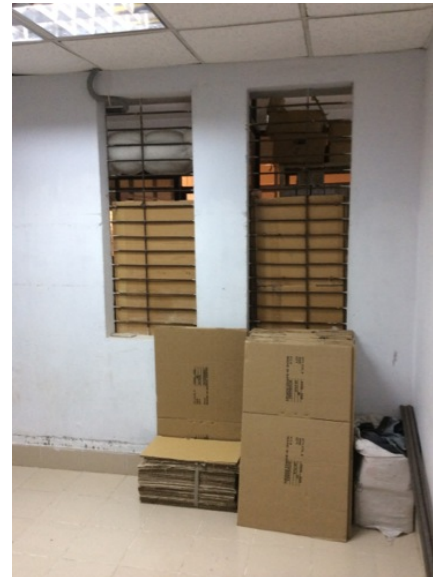
| F-7 | Egress | Combustable storage was located in the East most facing exit stair. | Remove all storage from exit stairs and egress paths. | Immediate |

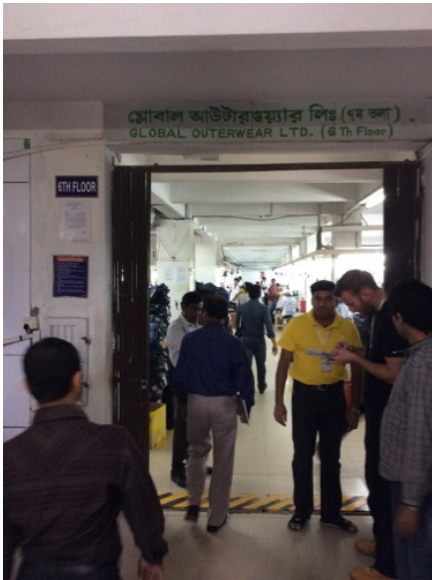
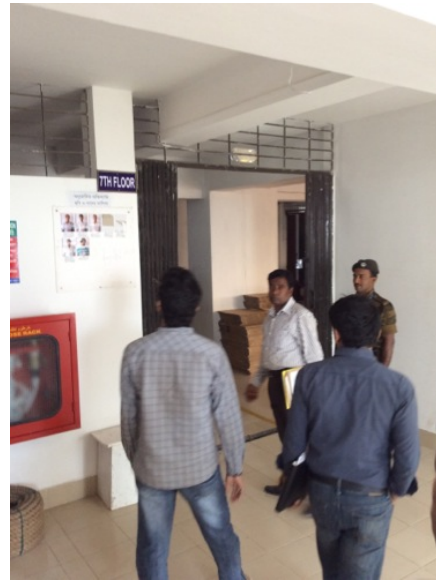
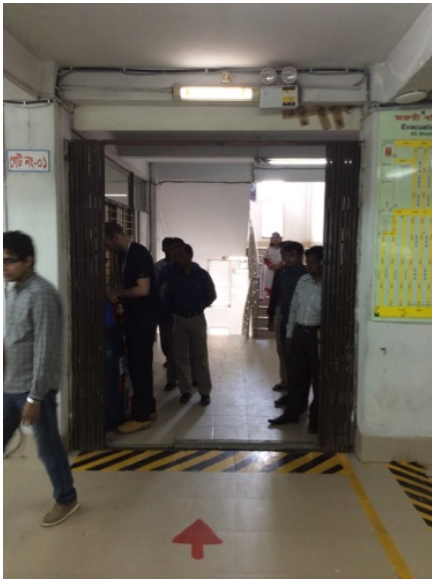
| F-8 | Egress | Collapsible gates are provided at all building exits, exit stairs, along egress routes and main exit discharge. | Replace all gates / sliding doors along the means of egress with side-hinged, swinging egress doors. If locks are required for security reasons, utilize special door locking features complying with NFPA 101. | Within 1 month |

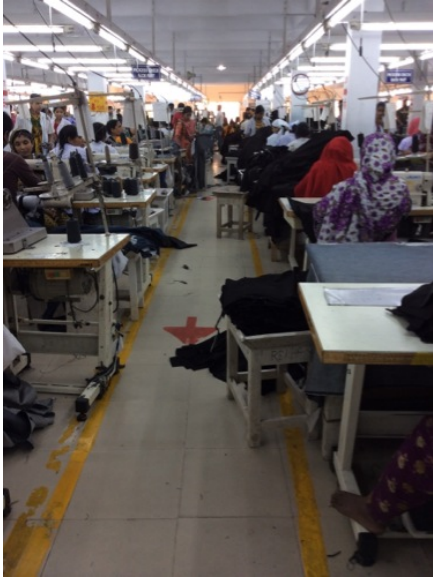
| F-9 | Egress | The width of egress aisles is less than 36-in, due to employees desks and work type storage of completed garments is being placed in a basket on the egress path, this path must be kept clear to a minimum of 36 inch. | Provide minimum aisle widths of 36-in. | Within 3 months |

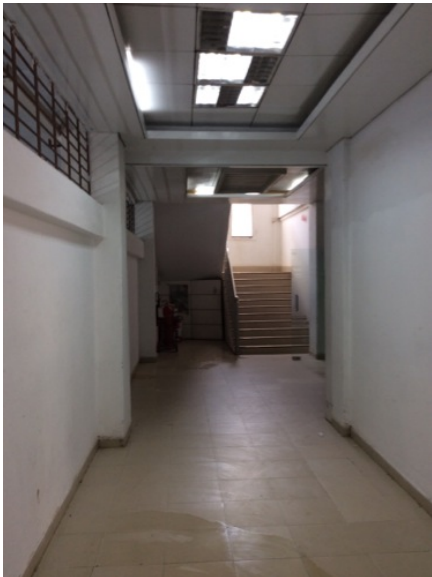
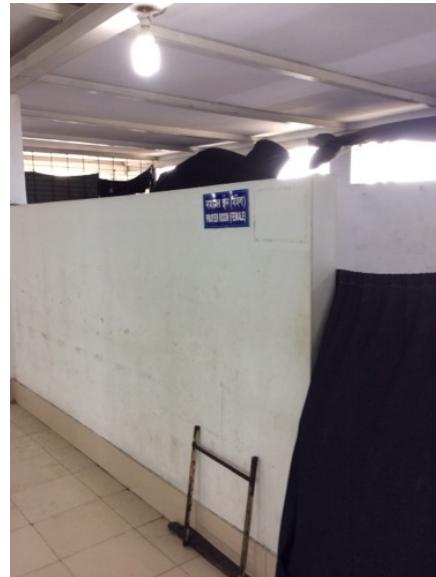
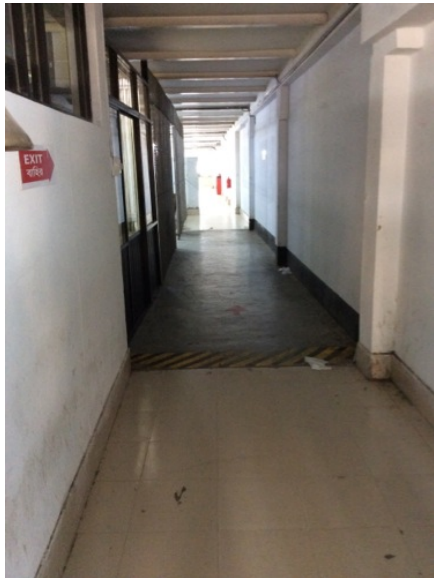
| F-10 | Egress | <p>Two (2) Exit stairs discharge inside the building.</p> <p>The East stairwell discharges to ground floor, the closest main exit is shared with the South stair and is 65ft away with no adequate 2 hour fire protection in place.</p> <p>The North most stair gives egress from the 10th and 9th floor to the 8th floor however this opens to the factory floor and the next main egress is 20 ft away with no adequate fire construction/protection. See attached floor plan for better understanding of layout.</p> | <p>Specify appropriate upgrade based on conditions:</p> <ul style="list-style-type: none"> - Provide 2-hr fire-rated exit passageway leading directly outside (vestibules to separate any storage areas). | <p>Within 6 months</p> |

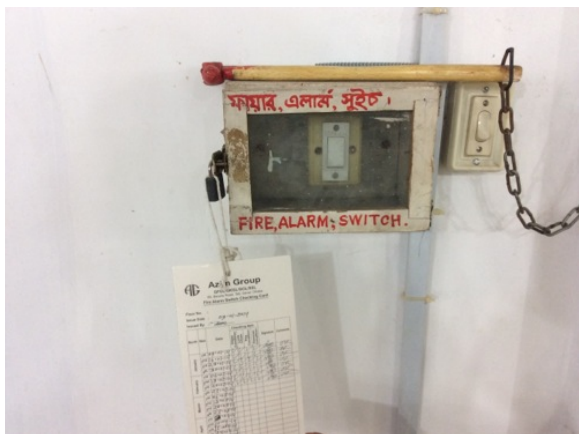
| F-11 | Fire Protection | The fire alarm system is antiquated, not a listed system, and does not provide alarm and notification features consistent with acceptable standards. | Replace the fire alarm system with a new, listed addressable fire alarm system in accordance with NFPA 72. | Design within 4 months, install within 9 months |

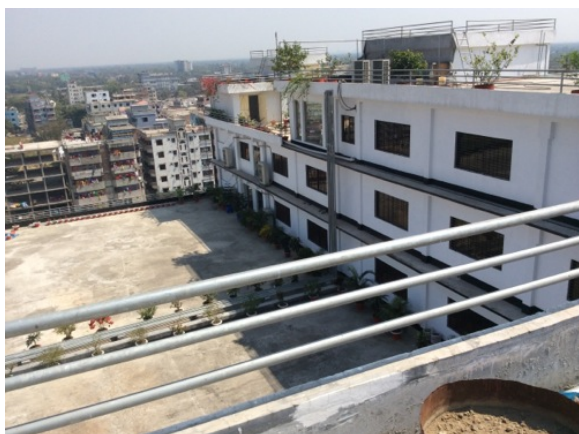
| F-12 | Fire Protection | It was observed that the high-rise building has an occupied floor greater than 23m (75 ft) and is not provided with automatic sprinkler protection. The large occupant loads, heavy fuel loading, and anticipated extended egress times warrant sprinkler protection. | Provide automatic sprinkler protection throughout the building in accordance with NFPA 13. | Design within 6 months, install within 12 months |

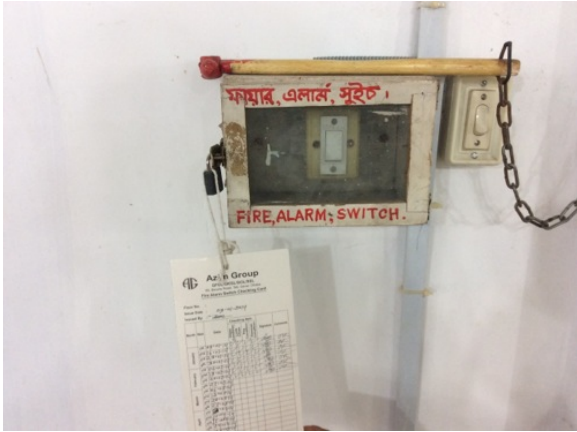
| F-13 | Fire Protection | Inspection, testing, and maintenance records for the fire alarm system were not available. | Inspect, test and maintain the fire alarm system, and keep written records on-site, in accordance with NFPA 72. | Within 3 months |

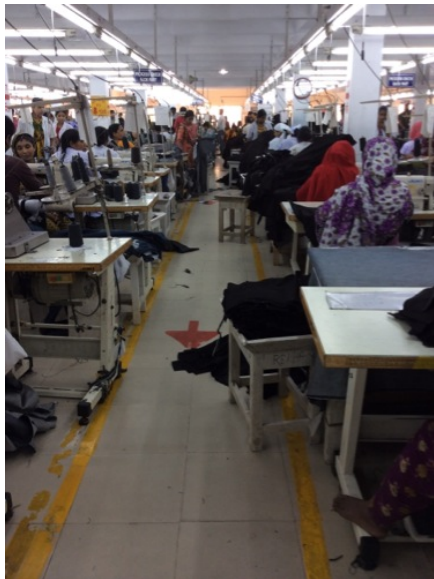
| F-14 | Fire Protection | The fire alarm system does not appear to provide adequate audible notification coverage. | Provide additional notification appliances such that the fire alarm system is audible throughout the building in accordance with NFPA 72. | Within 6 months |

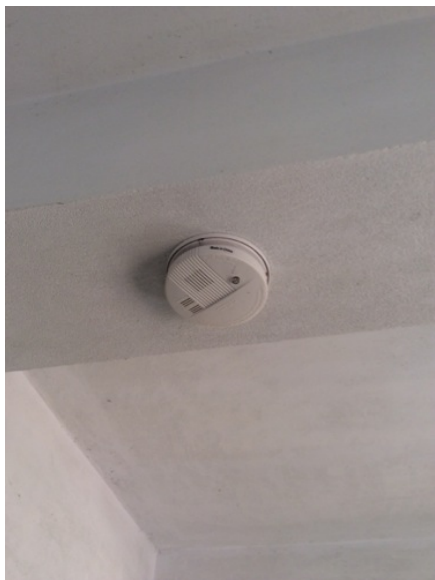
| F-15 | Fire Protection | The building is equipped with single-station smoke alarms. Smoke alarm activation sounds only a local alarm and does not provide automatic fire alarm notification of occupants. | Replace the single-station smoke alarms with automatic smoke detectors tied into the fire alarm system. Configure the fire alarm system to initiate occupant notification upon activation of any two smoke detectors in addition to the manual fire alarm stations. | Within 6 months |

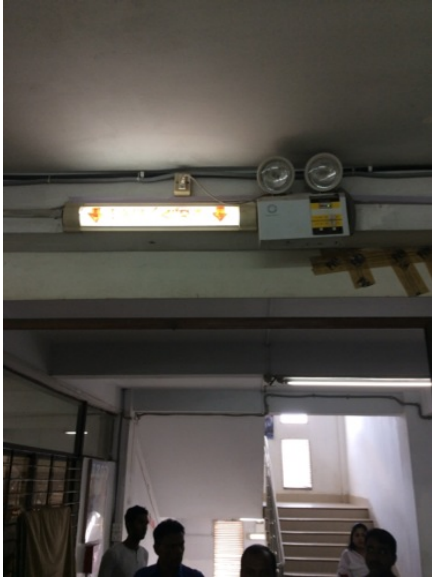
| F-16 | Egress Lighting | Manual on-off switch is provided for battery backup emergency lighting/exit signage units. | Remove manual on/off switches from emergency lighting/exit signage units to prevent them from being switched off. | Within 1 month |

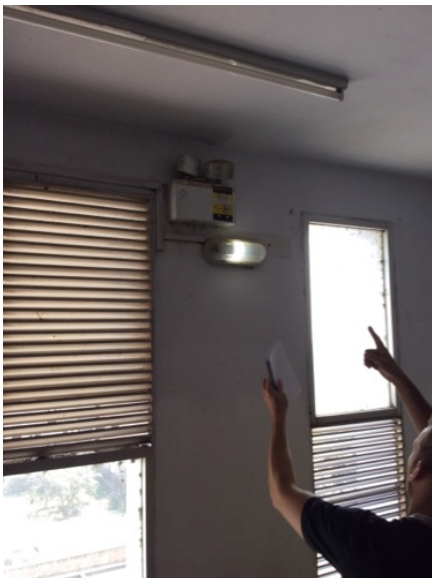
| F-17 | Egress Lighting | Emergency lighting did not function in test mode throughout all stairwells suggesting maintenance plans not being carried out as stated.(burned out, broken, etc. | Regularly test the emergency lighting system on each floor and replace/repair lights as needed. | Within 3 months |
