Vision Composite Knit Ltd (103330)

Vision Garments Ltd

B-47, Purbo Rajashon Road, Savar, Bangladesh

Identified Priority 3 Concerns

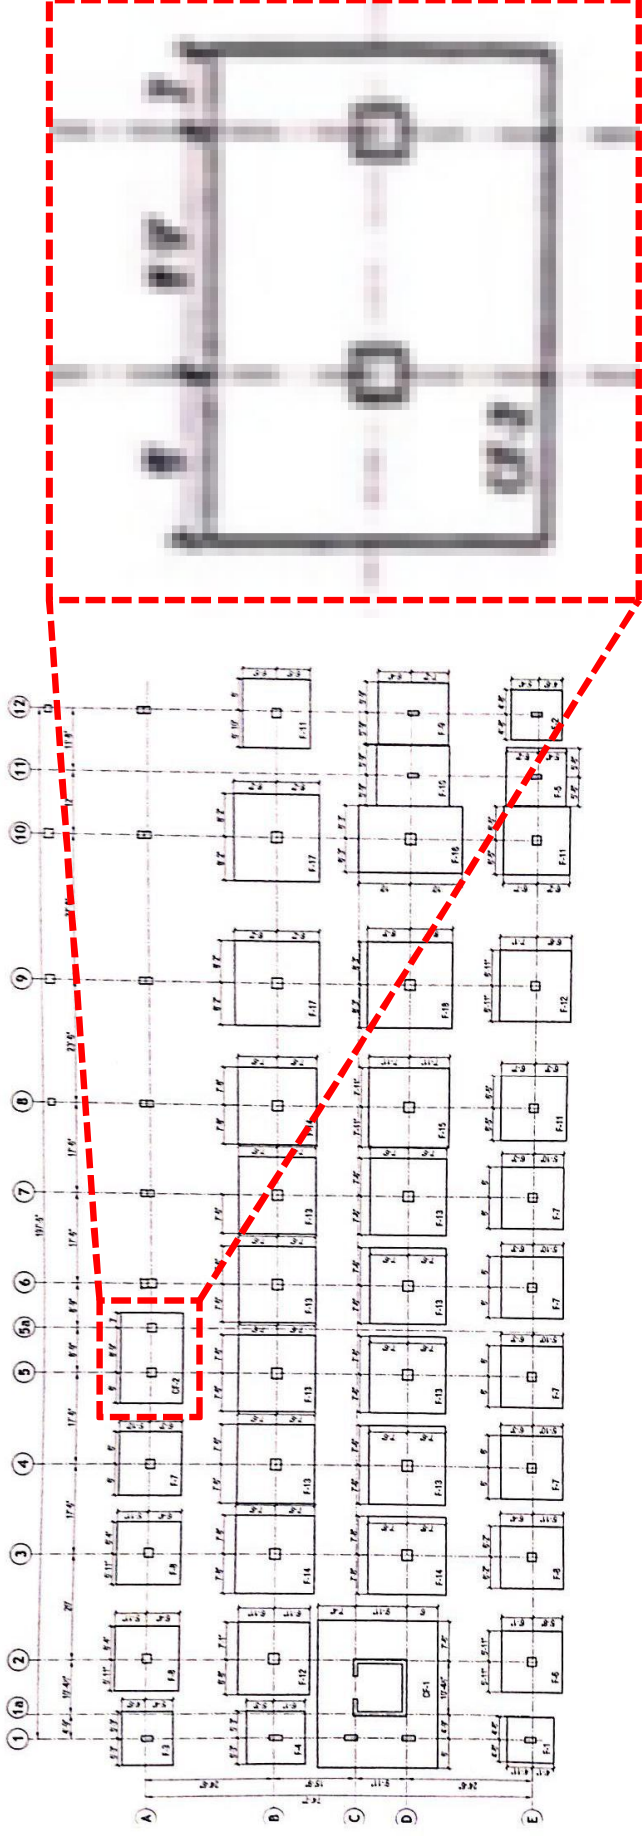
1st Priority 3 Concern

The foundation plans shows a combined footing for the columns at Grid A5 and Grid A5a. However, the detail is missing from the drawings.

Lack of structural information with regard to the combined footing

Item No.	Observation	Recommended Action Plan	Recommended Timeline
1	1st Priority 3 - Lack of information regarding the combined footing.	Building Engineer to advise as-built footing detail If necessary, carry out excavation to ascertain the actual layout of the footing.	6-months
