# **FIRE SAFETY INSPECTION REPORT**

## **RIO FASHION WEAR LTD.**

INDUSTRIAL PLOT NO. 3, MILK VITA ROAD  
SECTION-7, MIRPUR, DHAKA, BANGLADESH

November 2, 2013

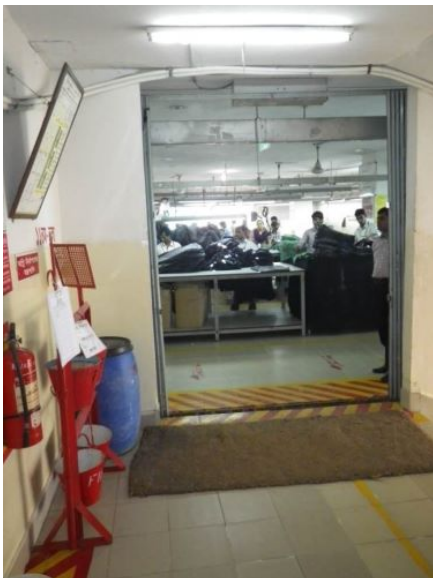
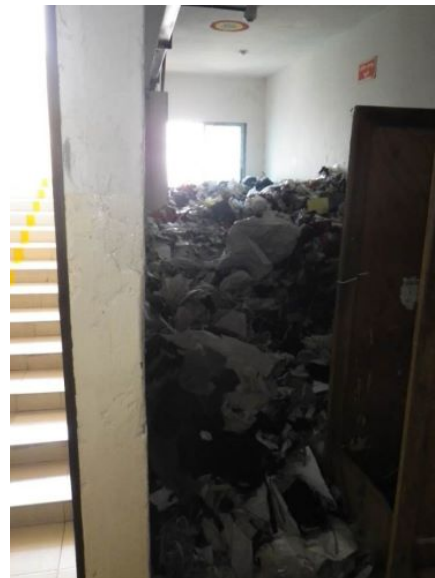
| No. | Category | Finding | Recommendation | Remediation Timeframe |
|---|---|---|---|---|
| F-1 | Fire Rated Construction | The main exit stair is open to the work areas on each floor as well as storage, office and electrical rooms on several floor levels. | <p>Provide minimum 1.5-hr fire rated doors to separate the exit stair from work areas and other building areas. Ensure that the fire doors are self-closing and positive latching and that they are provided with fire exit (panic) hardware where serving production floors.</p> <p>If fire doors are required to be held open for functional reasons, provide automatic-closing devices tied to the fire alarm system.</p> | Within 3 months |

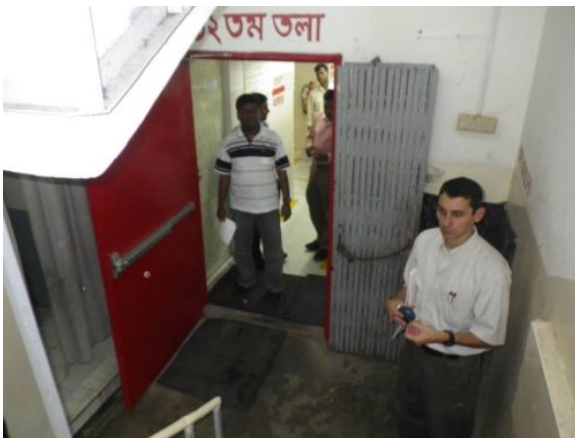
| F-2 | Fire Rated Construction | The rear exit stair has been provided with self-closing steel doors to separate the work areas. However, the stair is open on several floor levels to the bathrooms, which are connected to the general work area compromising the stair enclosure. | Provide minimum 1.5-hr fire rated doors or seal the openings to separate the exit stair from restroom areas on all floor. Ensure that the fire doors separating the work areas are kept closed or are automatic-closing and positive latching. | Within 3 months |

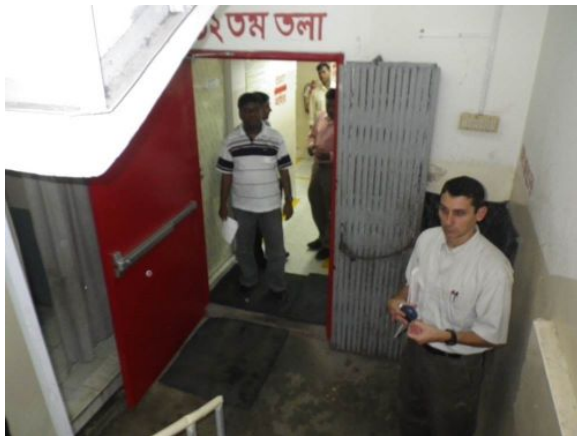
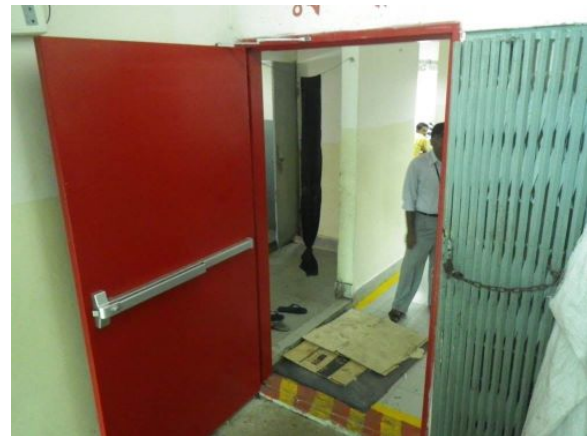
| F-3 | Fire Rated Construction | The self-closing steel doors separating the rear exit stair from the work areas on each floor are normally kept open, reportedly to be closed by workers as they exit. | Maintain the doors separating the exit stair from the work areas in the closed position. If fire doors are required to be held open for functional reasons, provide automatic-closing devices tied to the fire alarm system. | Within 3 months |

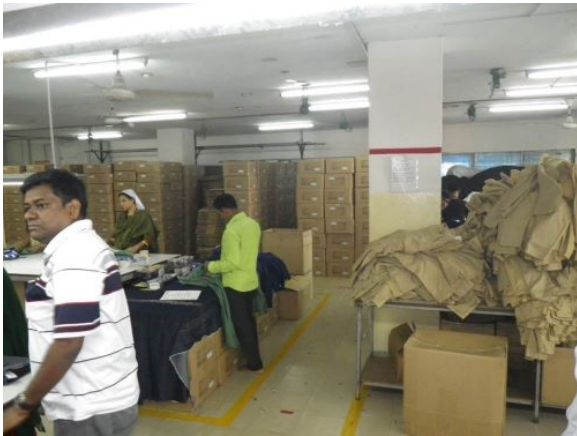
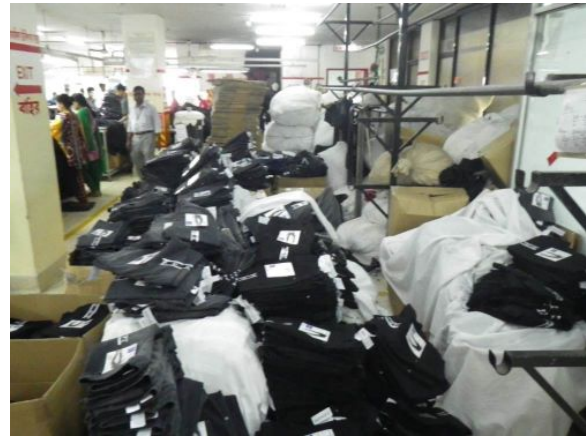
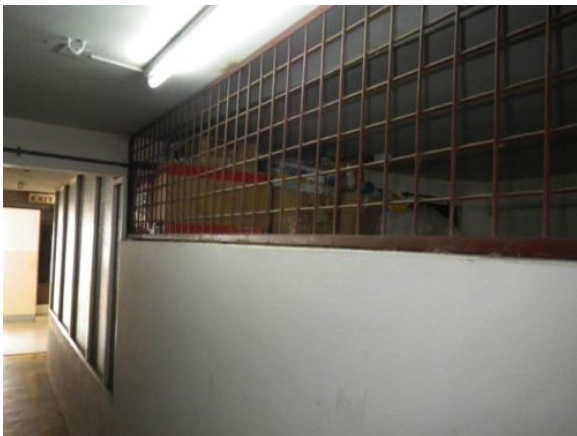
| F-4 | Fire Rated Construction | Areas used for combustible storage on production floors and are not separated by fire-rated construction. | <p>Provide dedicated storage rooms separated by minimum 1 hr fire-rated construction on all production floors where transient storage is required for operations.</p> <p>Where separate storage rooms are not feasible, provide defined storage areas and limit the storage arrangement as follows:</p> <ul style="list-style-type: none"> <li>- Maximum height of 2.4 m and maximum area of 23m<sup>2</sup></li> <li>- If sprinkler protected: maximum height of 3.66m and maximum area of 93m<sup>2</sup></li> </ul> <p>Separate areas of unenclosed combustible storage by a minimum clear distance of 3m.</p> | Within 3 months |

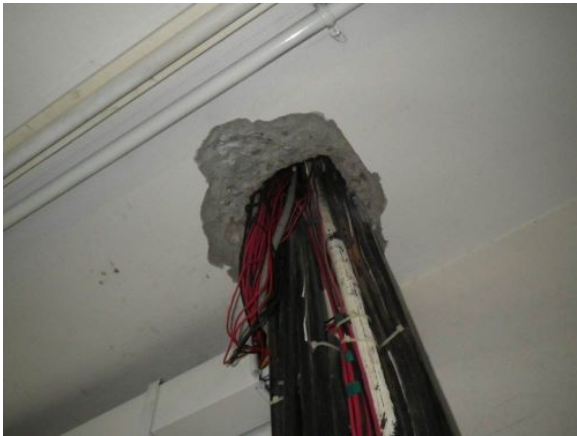
| F-5 | Fire Rated Construction | Unsealed penetrations and openings are located in the fire-rated floor/ceiling assemblies. | Seal all penetrations and openings in floor/ceiling assemblies to maintain the fire separation. | Within 3 months |

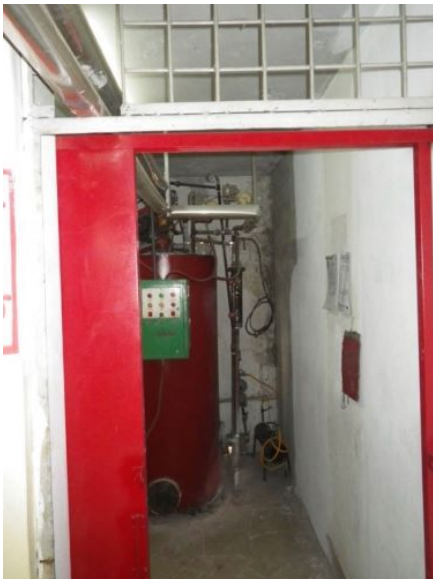
| F-6 | Fire Rated Construction | The boiler room on the 10th floor is not separated from the work area by fire-rated construction (open transom). | Seal and/or protected all openings to provide a minimum 2-hr fire separation of the boiler room. | Within 3 months |

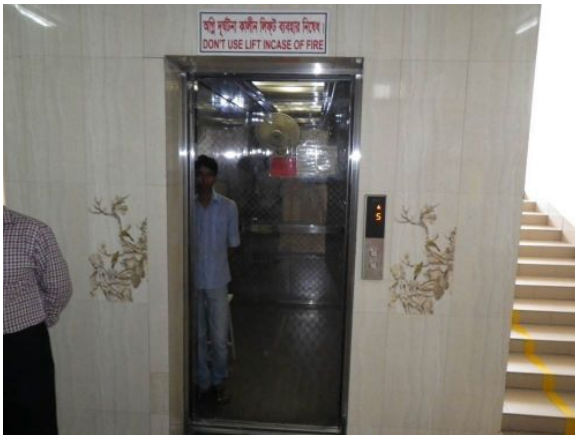
| F-7 | Fire Rated Construction | The elevator hoistway opens directly into the main exit stair enclosure. The machine room atop of the hoistway is not separated by fire-rated construction. | Provide a minimum 2-hr fire separation of the elevator machine room from the exit stair. | Within 3 months |

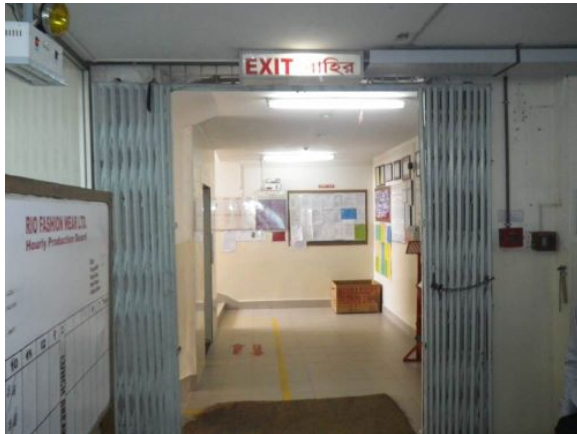
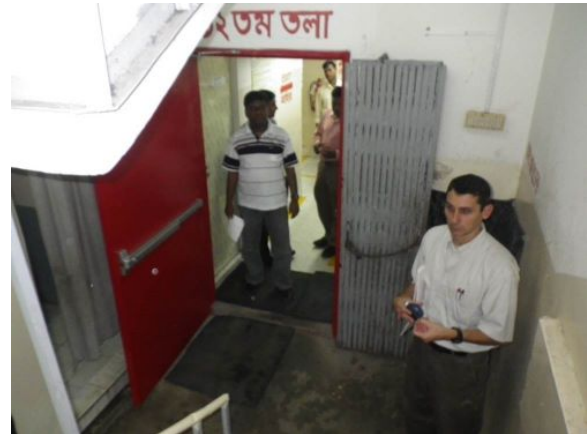
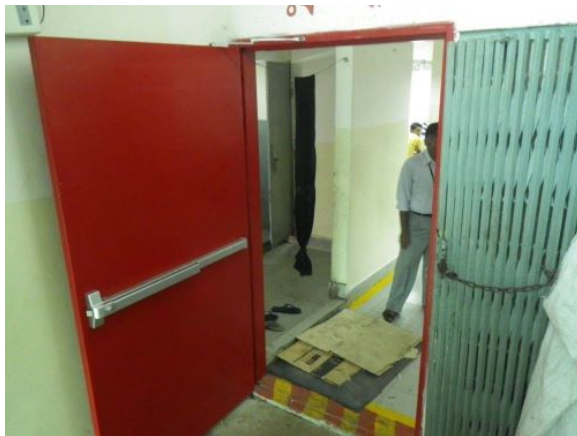
| F-8 | Egress | <p>Collapsible (concertina) gates with locks are provided along means of egress, including exit stairs, exit access, and exit discharge.</p> <p>Note - all gates were open and unlocked during the inspection.</p> | <p>Remove all collapsible gates at exit stairs and along the means of egress.</p> <p>If locks are required for security reasons, utilize special door locking features complying with NFPA 101.</p> | Within 1 month |

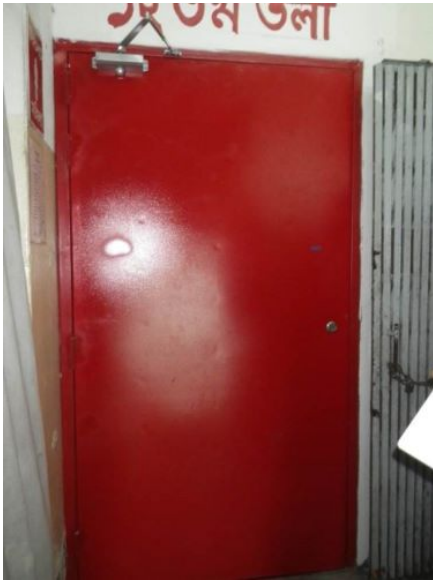
| F-9 | Egress | The rear exit stair does not allow re-entry into the building once the fire doors are closed. | Provide door hardware and appropriate signage to allow re-entry from the exit stair to the main floor areas at not less than every fifth floor level. | Within 3 months |

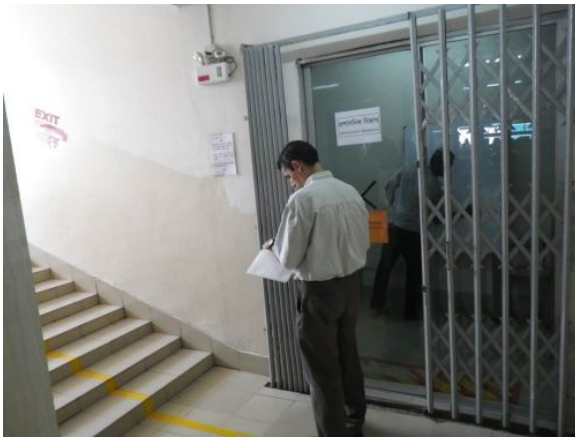
| F-10 | Egress | The main exit stair is not provided with handrails. | Provide handrails on both sides of the exit stair. | Within 3 months |

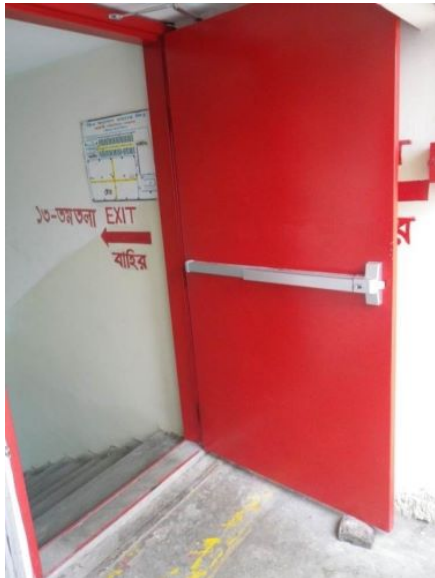
| F-11 | Egress | The door serving the rear exit stair at Level 12 (dining) does not swing in the direction of egress travel. | Modify the stair door to swing in the direction of egress travel. Relocate the door and provide a landing inside the stair at least 1 m in length such that the door does not swing over the stair. | Within 3 months |

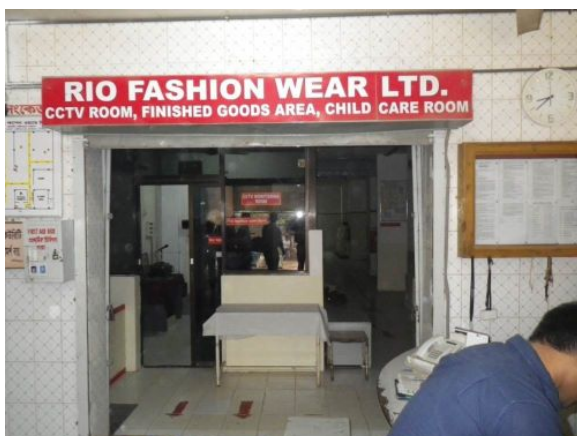
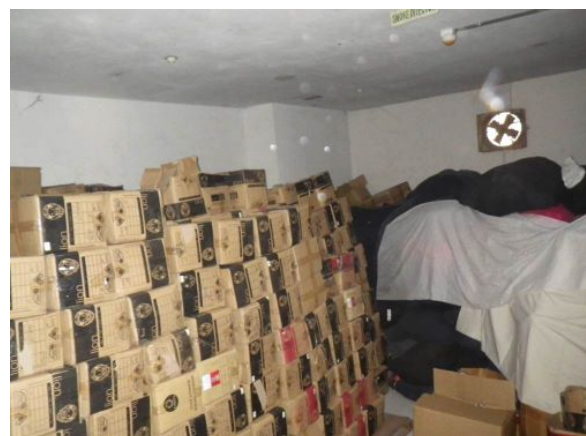
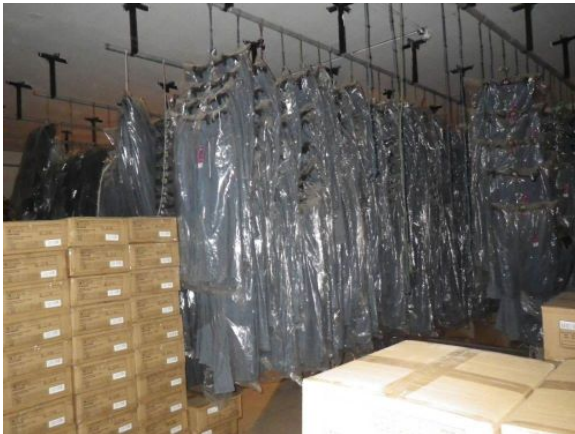
| F-12 | Egress | The main exit stair discharges inside the building on the ground floor. Basement and ground floor areas used for combustible storage are not separated from the exit discharge lobby. | Provide minimum 2-hr fire separation between the exit stair discharge lobby and all storage areas on the basement and ground floors. Provide vestibules with minimum 1.5-hr fire doors to protect any openings in the fire separation walls. | Within 6 months |

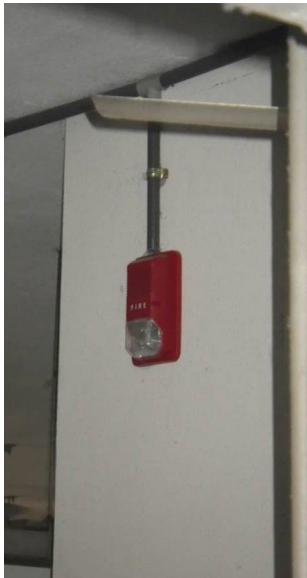
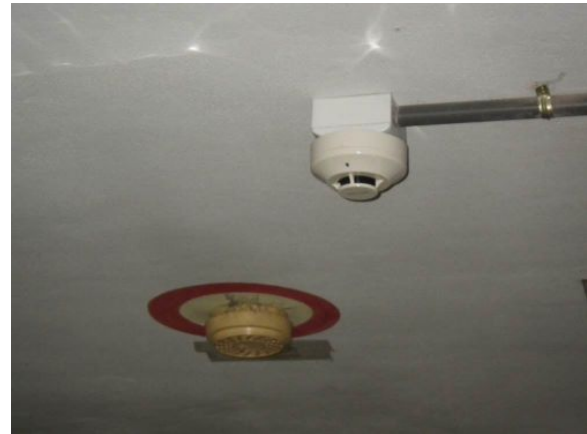
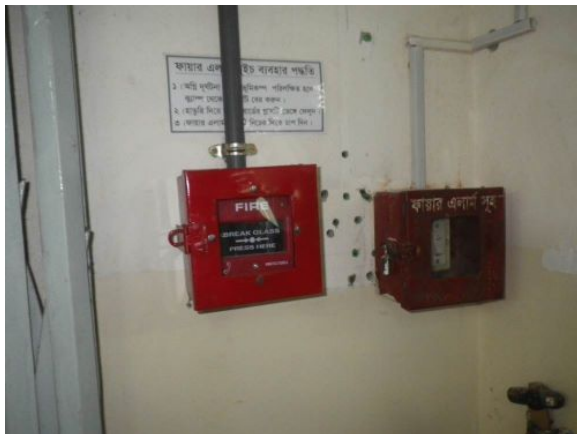
| F-13 | Fire Protection | An older, antiquated fire alarm system is installed along with a newer system. | Remove the fire alarm components of the older system (smoke detectors, fire alarm switches) ensuring that the newer fire alarm system provides adequate smoke detection and manual activation coverage in accordance with NFPA 72. The existing PA system can continue to be used for non-fire alarm related purposes. | Design within 4 months, install within 9 months |

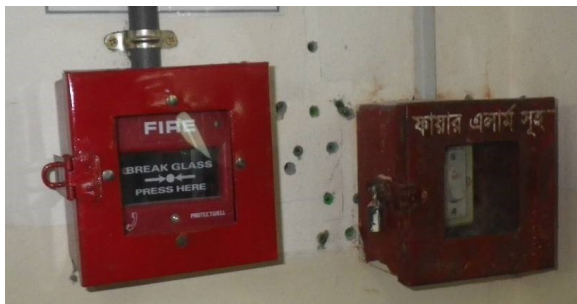
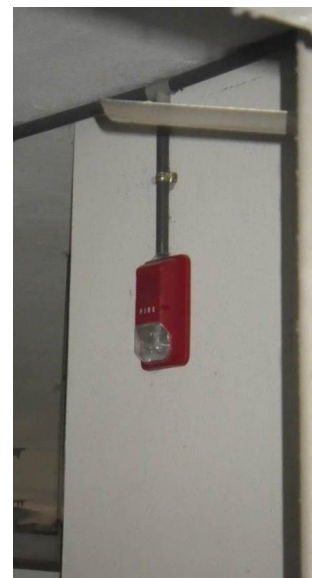
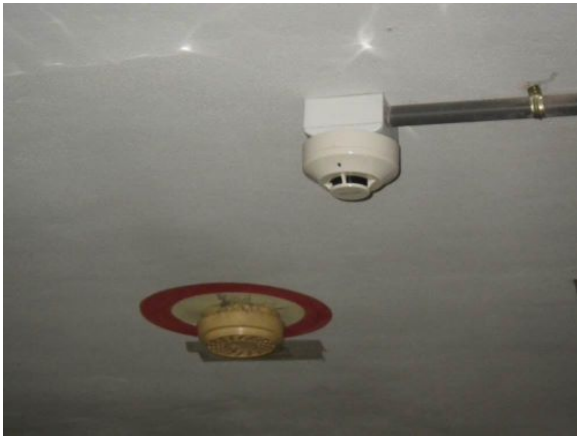
| F-17 | Fire Protection | Based on the number and location of notification appliances observed, the fire alarm system does not appear to provide adequate audible notification coverage on the production floor levels.<br><br>Note – the system was tested on one of the floors and was not audible from all areas. | Provide additional fire alarm appliances to provide audible coverage throughout the building in accordance with NFPA 72 criteria.<br><br>Where required based on ambient noise conditions (during operations), provide visual notification appliances. | Within 6 months |

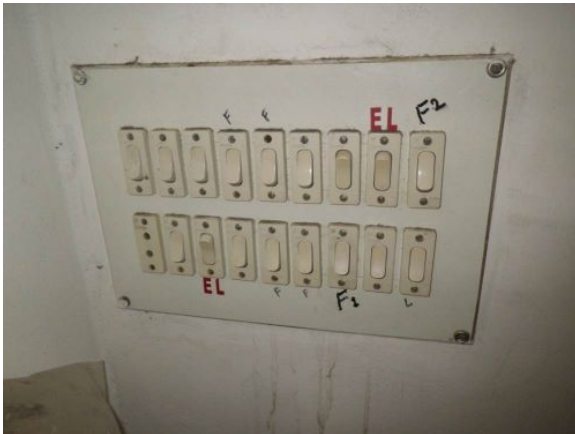
| F-19 | Egress Lighting | A manual switch is provided to turn off illuminated exit signs. | Remove manual switches for exit sign lights and ensure exit signs are illuminated at all times. | Within 1 month |

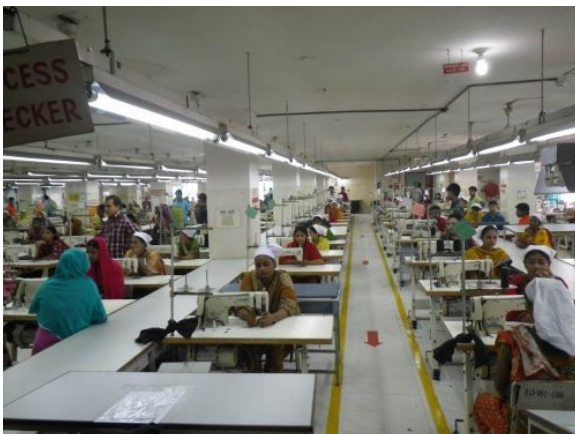
| F-20 | Egress Lighting | Emergency lighting is provided on the floors and in the exit stairs. The adequacy of the system was not fully tested. Based on the number and location of emergency lights observed, adequate illumination levels are not anticipated for all floor levels along egress routes. | Test the emergency lighting system on each floor and provide additional emergency fixtures to provide adequate illumination along the means of egress. Provide a minimum illumination of 10 lux at the floor level within exit stairs and exit discharge paths and minimum 2.5 lux along exit access aisles. | Within 3 months |

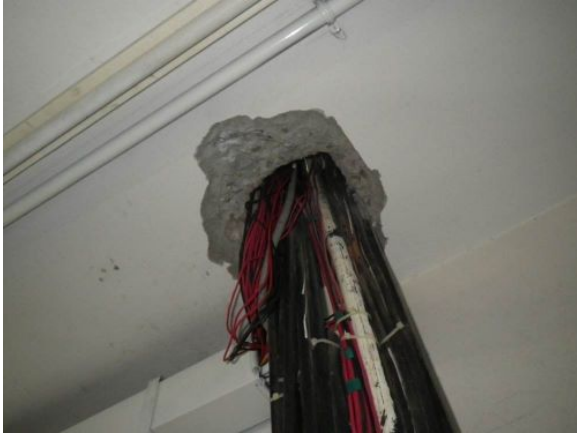
| F-21 | Egress Lighting | The wiring for normal and emergency power of emergency lighting is routed through the same locations via unprotected vertical risers. | Provide separation of normal and emergency power wiring and enclose vertical utility risers between floor levels in shaft construction having a minimum 2-hr fire rating. | Within 3 months |
