# FIRE SAFETY INSPECTION REPORT

## Moonlux Knit Garments Ltd. (NEW)

ACCORD ID: 23465

Date: 17 September 2018

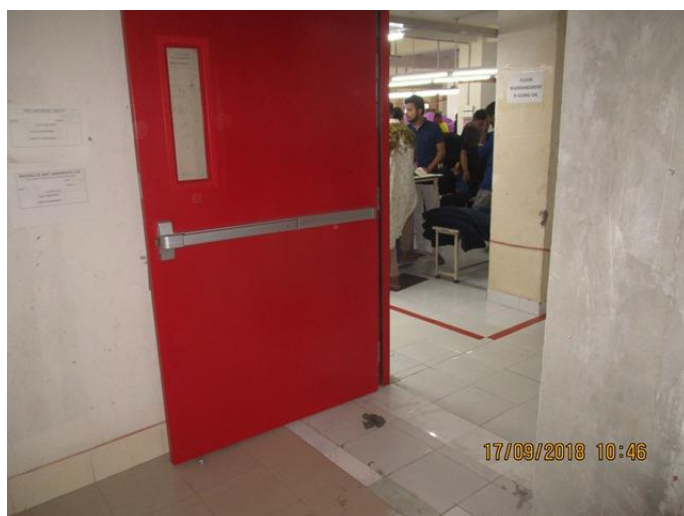
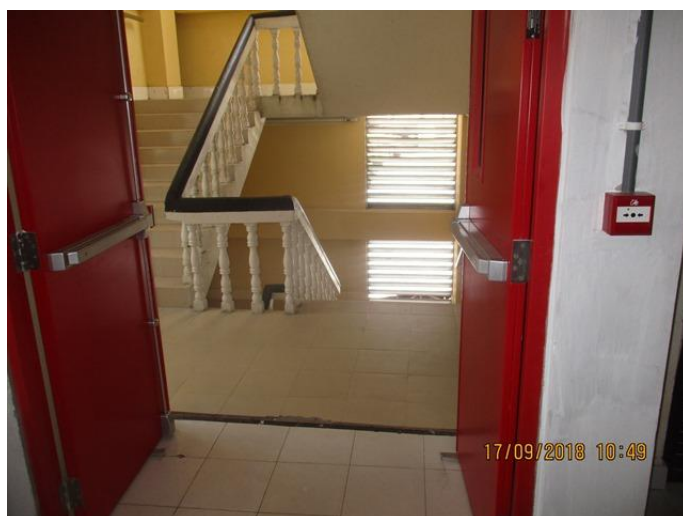
| No. | Category | Finding | Recommendation | Remediation Timeframe |
|---|---|---|---|---|
| F-1 | Fire Rated Construction | Exit stairs separated from all other spaces on each floor by fire-rated construction and installed fire doors were not interfaced with Fire Alarm system. | <p>Ensure that all fire doors are self-closing and positive latching, and are provided with fire exit (panic) hardware where serving production floors or assembly</p> <p>If fire doors are required to be held open for functional reasons, provide automatic-closing devices tied to the fire alarm system.</p> | Within 1 month |

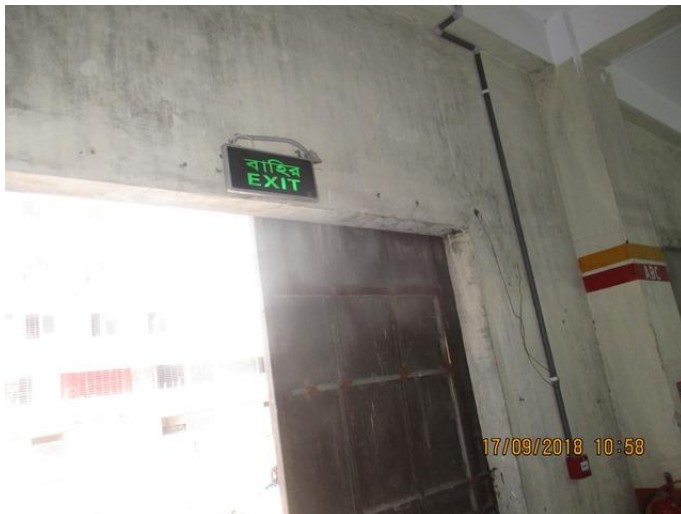
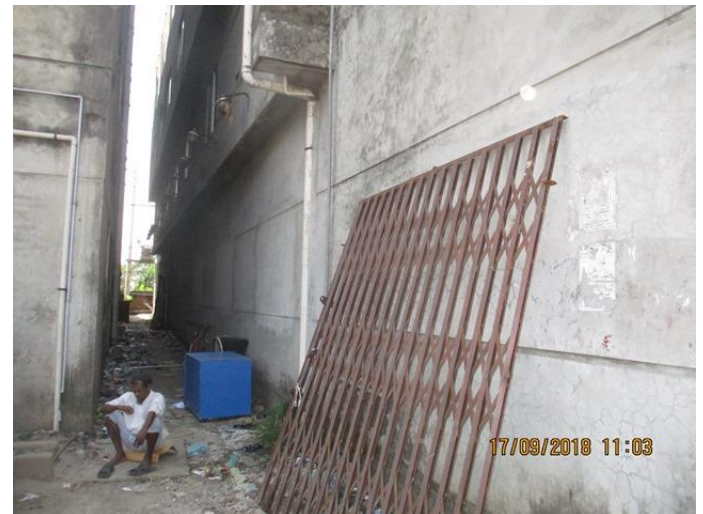
| F-2 | Egress | Sliding gate on the ground floor with locking features are provided at west exit door.<br>Also collapsible door installation provision is available at ground floor. | Remove locking features from all egress gates.<br><br>Replace all gates / sliding doors along the means of egress with side-hinged, swinging egress doors.<br><br>If locks are required for security reasons, utilize special door locking features complying with ACCORD standard 6.8.2. | Immediately |

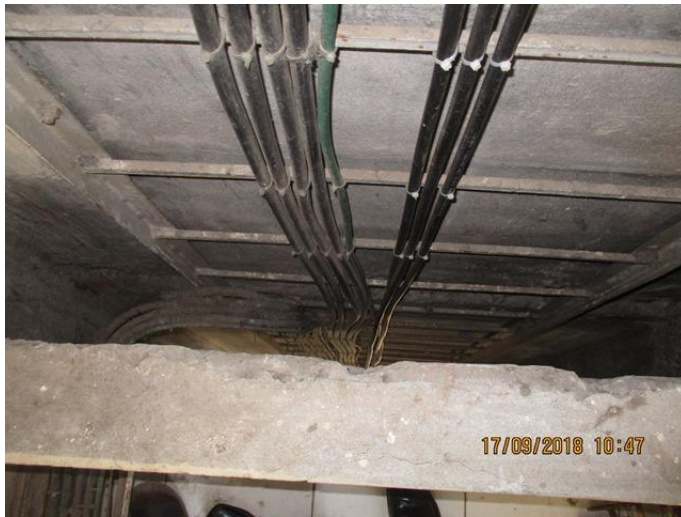
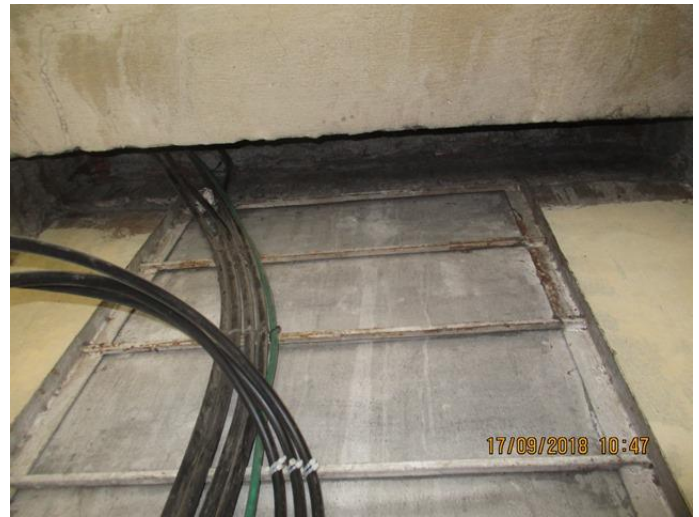
| F-3 | Fire Rated Construction | Unsealed electrical shaft is located in the fire-rated floor/ceiling assemblies. | Provide a minimum 2-hr fire-rated shaft to separate the utility risers from each floor level and seal all penetrations in floor/ceiling assemblies to maintain the fire separation. | Within 3 months |

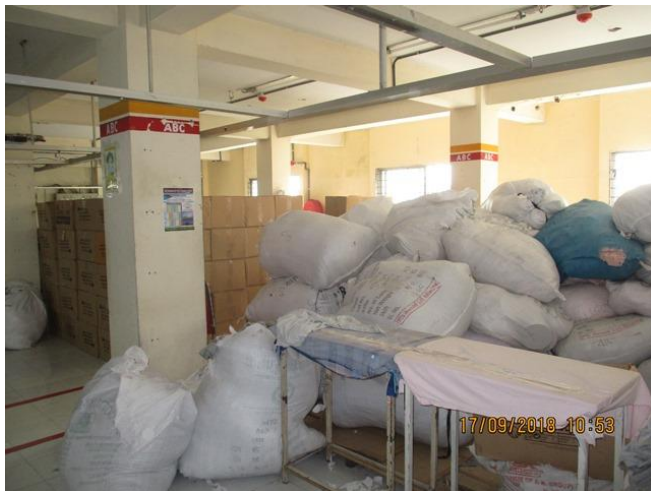
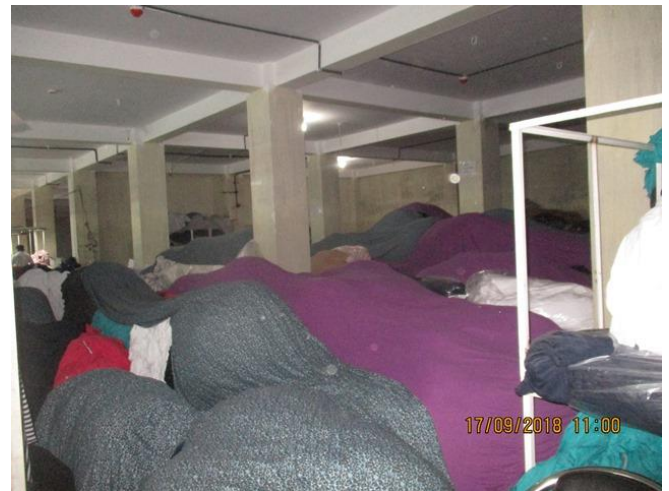
| F-4 | Fire Rated Construction | Areas on the ground and 2nd floor used for combustible storage open to the factory are not properly separated and/or not within limits. | <p>Provide dedicated storage rooms separated by minimum 1-hr fire-rated construction.</p> <p>Where separate storage rooms are not feasible, Provide defined storage areas and limit the storage arrangement as follows:</p> <p>Maximum height of 2.45m (8 ft) and maximum area of 23 m<sup>2</sup> (250 ft<sup>2</sup>).</p> <p>Separate the areas of unenclosed combustible storage by a minimum clear distance of 3 m (10 ft).</p> | Within 3 months |

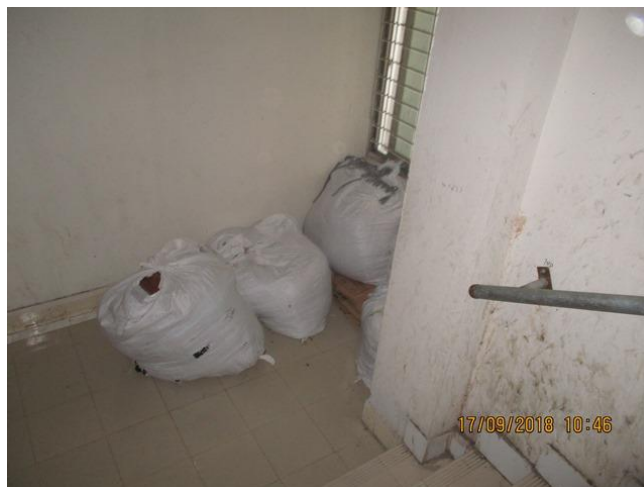
| F-5 | Egress | Storage was located in the exit stairs and egress paths. | Remove all storage from exit stairs and egress paths. | Immediately |

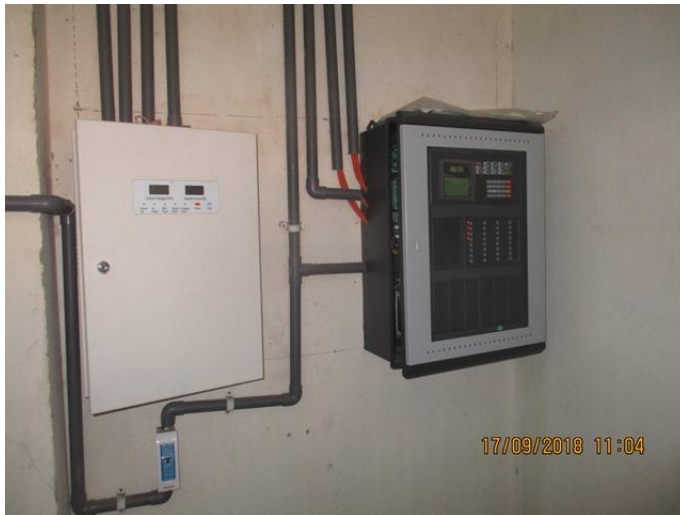
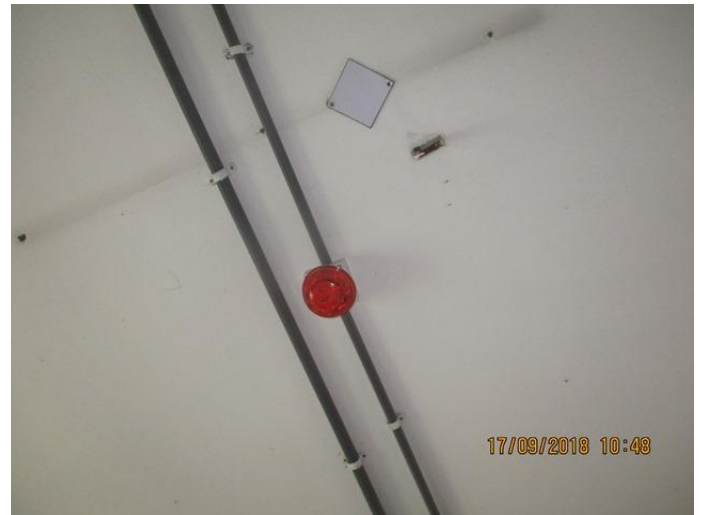
| F-6 | Fire Protection | Fire alarm & detection system installation requires on-site testing and commissioning verification to confirm compliance with NFPA 72 and ACCORD standard. | Submit as-built drawings, testing records, equipment certification and other relevant documentation to ACCORD for review and final testing & commissioning. | Within 3 months |

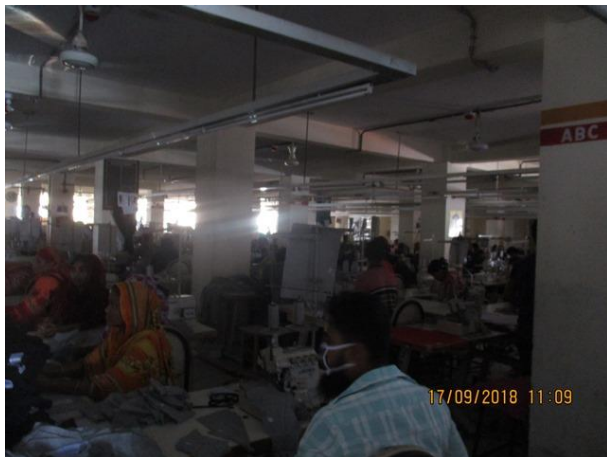
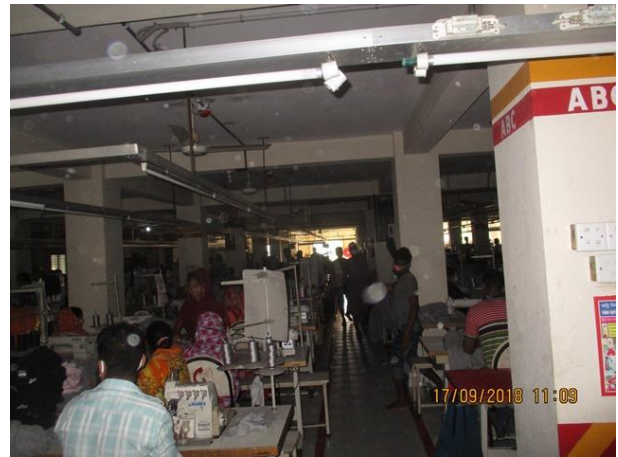
| F-8 | Egress Lighting | Based on the number and location of emergency lights observed, adequate illumination levels are not anticipated along egress routes. | Test the emergency lighting system on each floor and provide additional emergency fixtures to supply adequate illumination along the means of egress. Provide a minimum illumination of 10 lux at the floor level within exit stairs and along exit discharge paths and a minimum 2.5 lux along exit access aisles. | Within 1 month |
