# **FIRE SAFETY INSPECTION REPORT**

**Kimberly Fashions LTD**

**ACCORD ID: 23036**

**South Panishail, Zirani Bazar, Kashimpur, Gazipur**

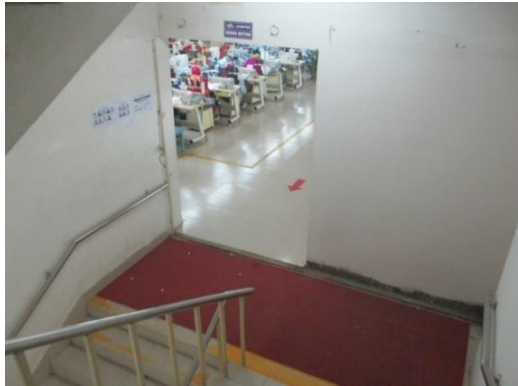
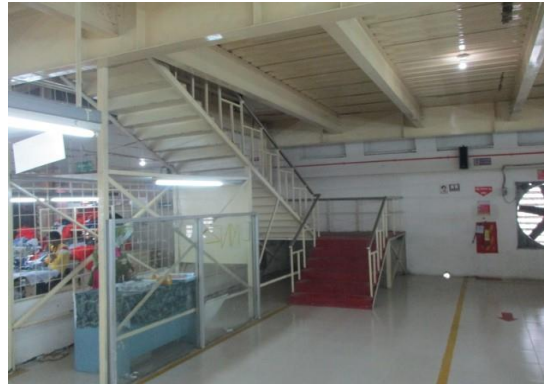
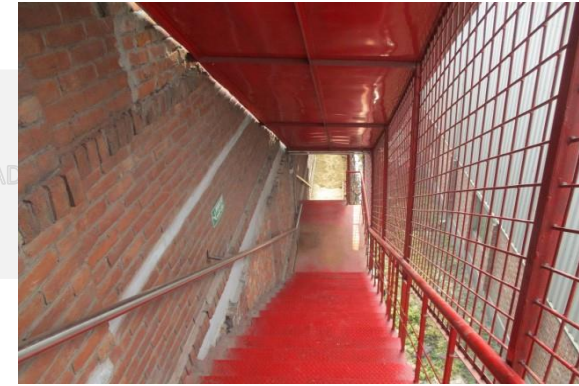
| Sl No. | Category | Findings | Required Action | Remediation Time Frame |
|---|---|---|---|---|
| 1 | Fire Rated Construction | The exit stairs enclosures are not separated from work areas and other spaces on each floor by fire-rated construction(Non rated doors, unsealed penetrations and openings etc.). | Provide minimum 1-hr rated doors for buildings with 3 or fewer stories and 1.5-hr fire rated doors for buildings that are 4 or more stories. Seal all unprotected openings to separate the exit stairs from work areas and other building spaces on all floor levels. Ensure that the fire doors are self-closing and positive latching and that they are provided with fire exit (panic) hardware where serving production floors. If fire doors are required to be held open for functional reasons, provide automatic closing devices tied to the fire alarm system. Once fire doors are installed, every door in a stair enclosure serving more than 5 stories shall be provided with re-entry unless it meets. | Within 3 months |

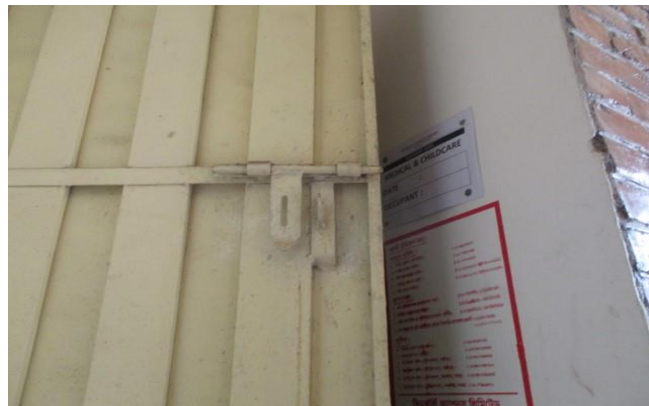
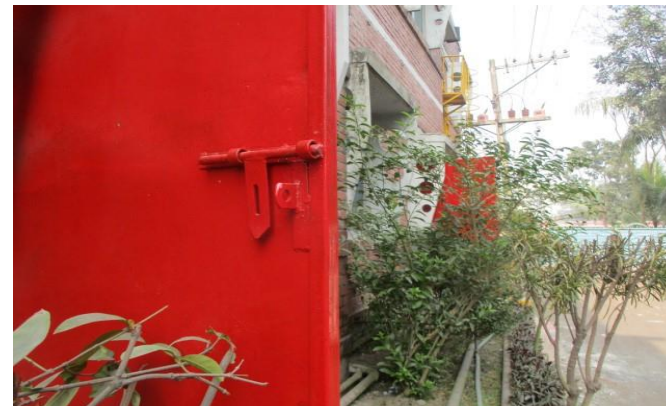
| 2 | Egress | Egress doors/gates with locking features not complying with NFPA101 are provided at building. | Remove locking features from all egress doors/gates. If locks are required for security reasons, utilize specialized door locking features complying with NFPA101. | Immediate |

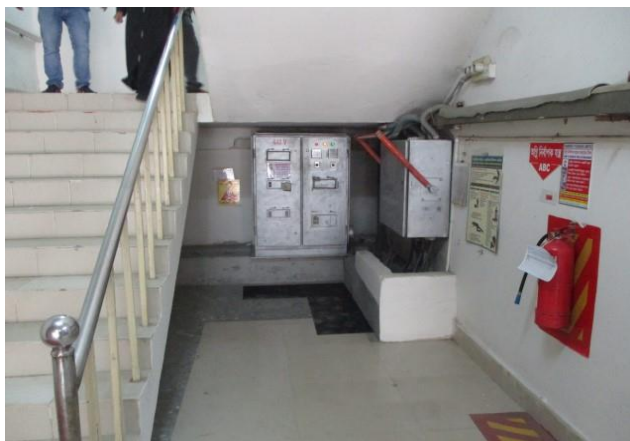
| 3 | Egress | Electrical panel box was located in all exit stairs.<br>Location: Ground floor. | Remove Electrical panel box from the exit stairs and egress path. | Immediate |

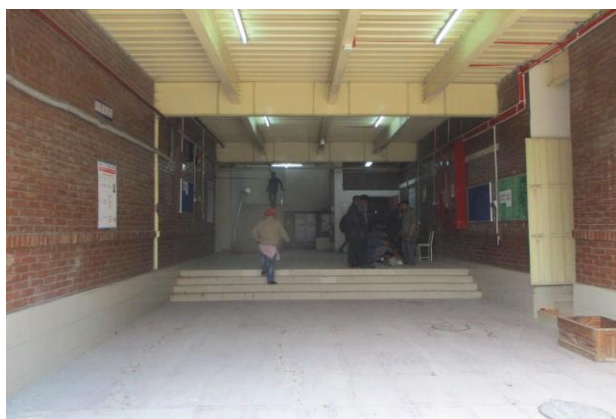
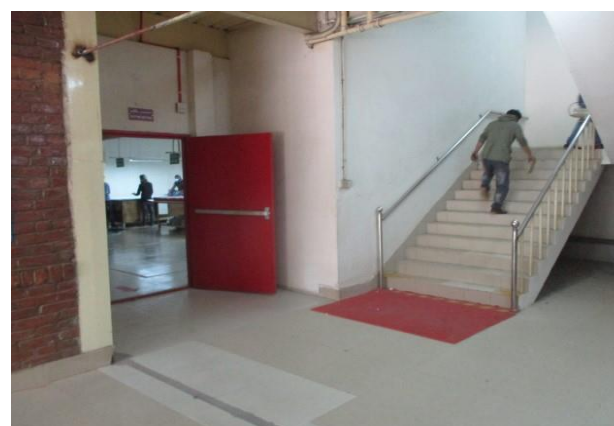
| 4 | Interior Exit Discharge | Exit stair(s) is discharge the occupants inside the building.<br>Location: Ground floor. | <ol style="list-style-type: none"> <li>1. Modify stair to discharge directly outside.</li> </ol> Or <ol style="list-style-type: none"> <li>2. Provide 2-hr fire-rated exit passageway leading directly outside (vestibules to separate any storage areas).</li> </ol> Or <ol style="list-style-type: none"> <li>3. Provide sprinkler protection for discharge floor in accordance with NFPA 13.</li> </ol> | Within 3 months |

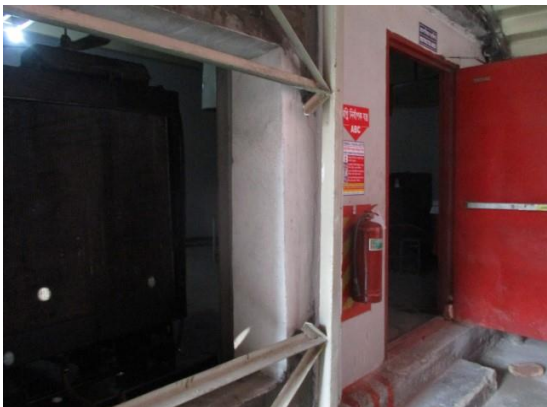
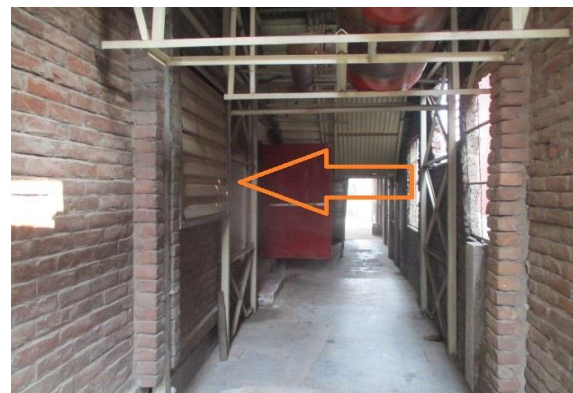
| 5 | Generator Room | Generator room is not properly separated by fire rated construction with other Occupancies/Areas. | <p>1. Generator room shall be separated from other occupancies by a minimum 2-hr fire rated construction (wall, floor, slab etc.). Seal all penetrations and openings (door, window etc.) should be protected by 1.5-hr fire rated materials to maintain the fire separation if required. All exhaust systems shall discharge to the exterior of the building in a safe location.</p> <p>Or</p> <p>Relocate it to exterior of the building and maintain a minimum 3m (10 ft.) spatial separation distance from the building.</p> | Within 3 months |

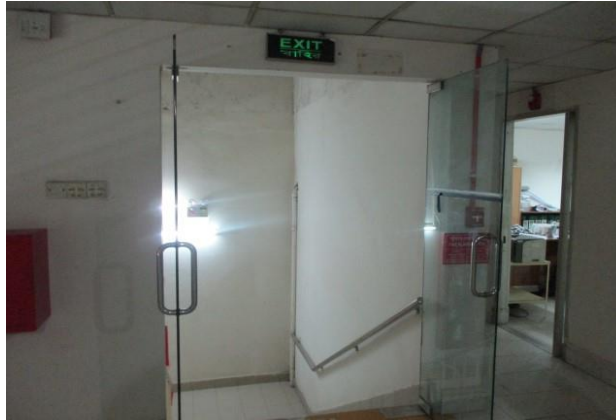
| 6 | Swing direction | Exit doors at ground floor serving 50 or more occupants does not swing in the direction of egress travel. | Modify the egress door to swing in the direction of egress travel. | Within 3 months |

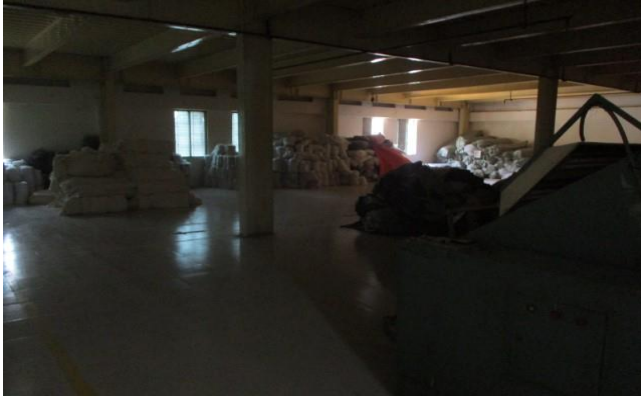
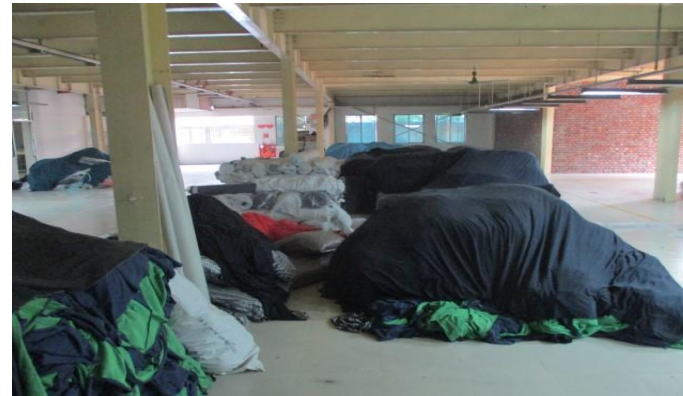
| 7 | Store | Rooms used for combustible storage on the ground floor are not separated by fire-rated construction. Location: Office building. | Provide dedicated storage rooms separated by minimum 1-hr fire-rated construction. | Within 3 months |

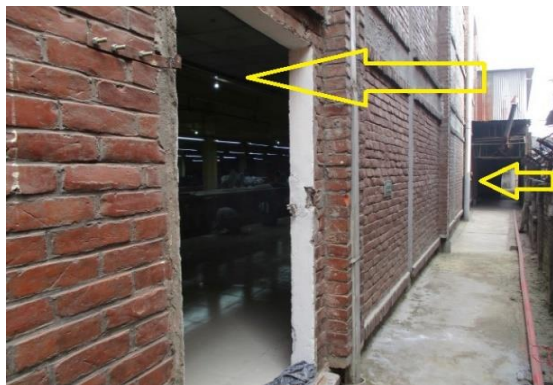
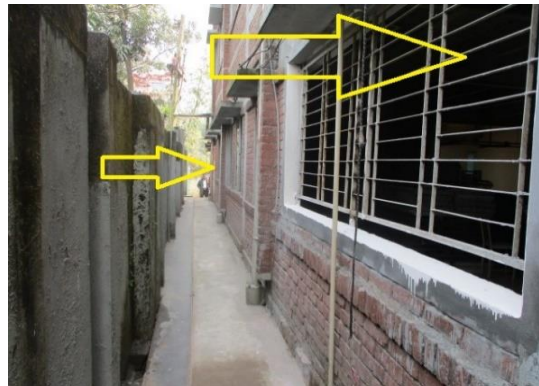
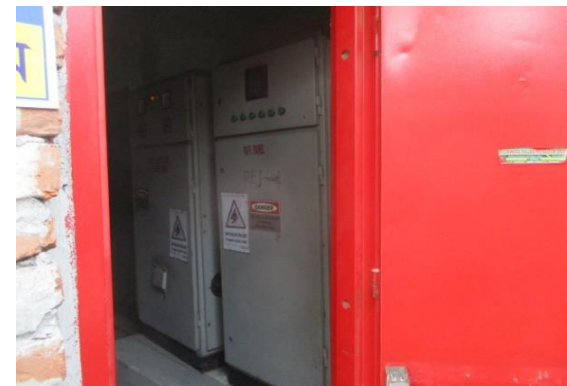
| 8 | Discharge path | The exit discharge paths serving the West and North exit stairs were less than 10 ft wide and were not separated from the building interior. | Seal all penetrations and openings to the interior of the building along the discharge path, up to a height of 10 ft., to provide a minimum 1-hr fire separation.<br>Alternatively, provide a second remote discharge path to the public way (only include this if feasible) | Within 3 months |

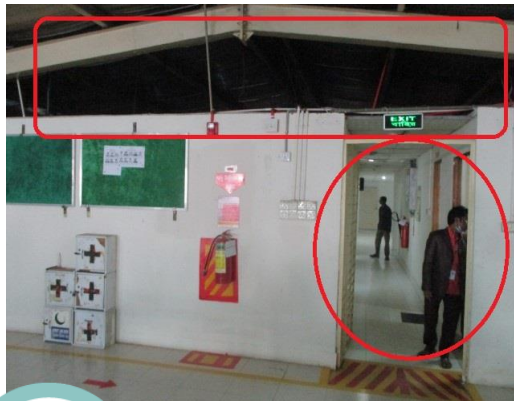
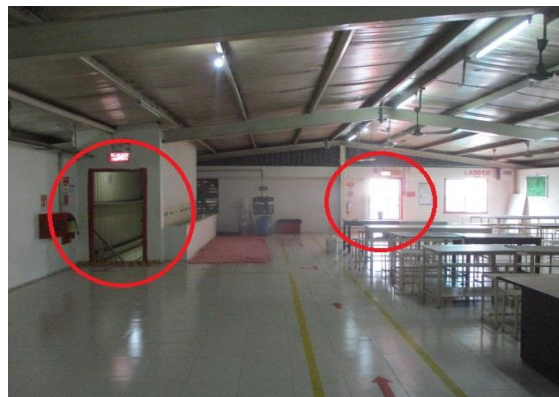
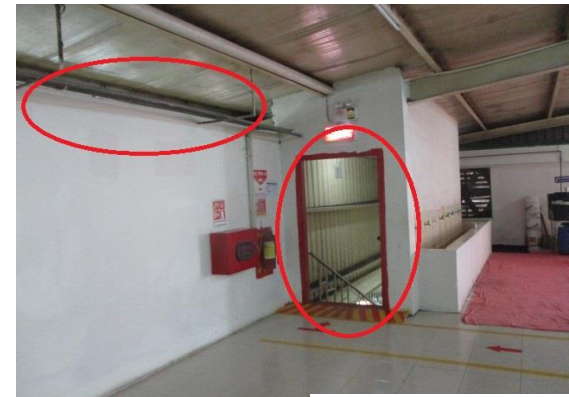
| 9 | Fire Rated Construction | Dining area is not separated from other occupancies with fire rated assemblies | Re-locate the dining area or separate the dining area from other occupancies with 2-hr fire rated construction. | Within 3 months |

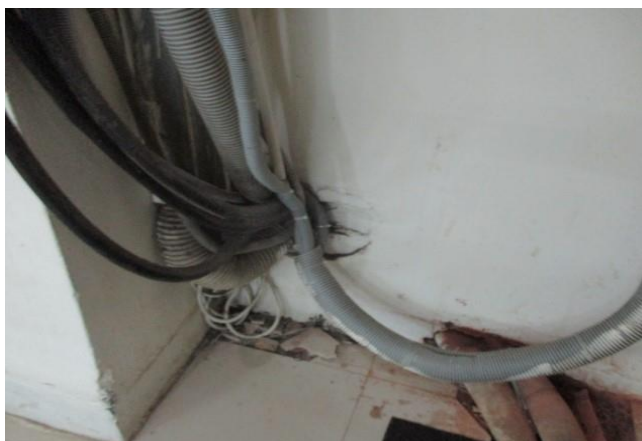
| 11 | Opening/Penetration to Exit enclosure | Unsealed penetrations and openings are located in exit stair enclosures. | Seal all penetrations and openings in the wall of exit enclosure walls (full thickness of the wall) by fire rated materials to maintain the fire resistance rating. | Within 3 months |
