# **FIRE SAFETY INSPECTION REPORT**

**Designtex Knitwear Ltd.**

**ACCORD ID: 23440**

**Date: 16 September, 2018**

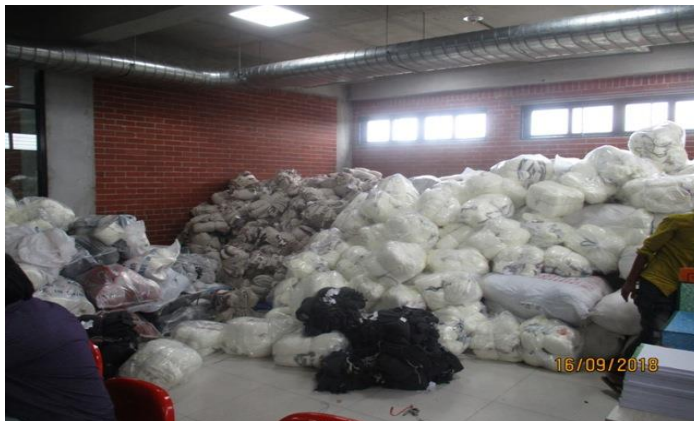
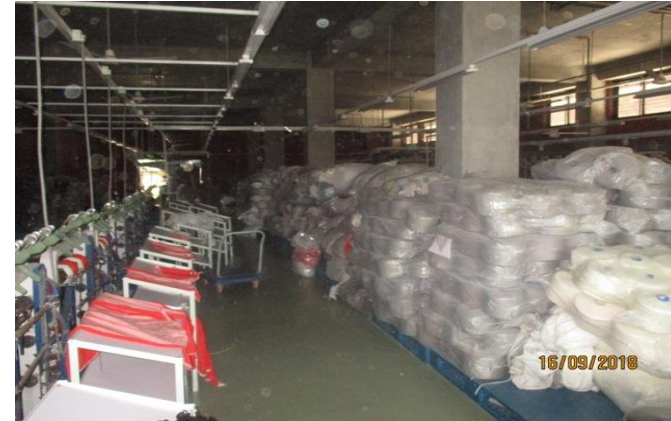
| SI No. | Category | Findings | Required Action | Remediation Time Frame |
|---|---|---|---|---|
| F-1 | Fire Rated Construction | <p>Areas used for combustible storage are not separated by fire-rated construction.</p> <p>Location: 2nd &amp; 3rd Floor.</p> | <p>Provide dedicated storage rooms separated by minimum 1-hr fire-rated construction. Where separate storage rooms are not feasible, provide defined storage areas and limit the storage arrangement as follows:-</p> <ol style="list-style-type: none"> <li>1.Maximum height of 2.4m and maximum area of 23m<sup>2</sup></li> <li>2.If sprinkler protected: maximum height of 3.66m and maximum area of 93m<sup>2</sup></li> </ol> <p>Separate areas of unenclosed combustible storage by a minimum clear distance of 3m.</p> | Within 1 month |

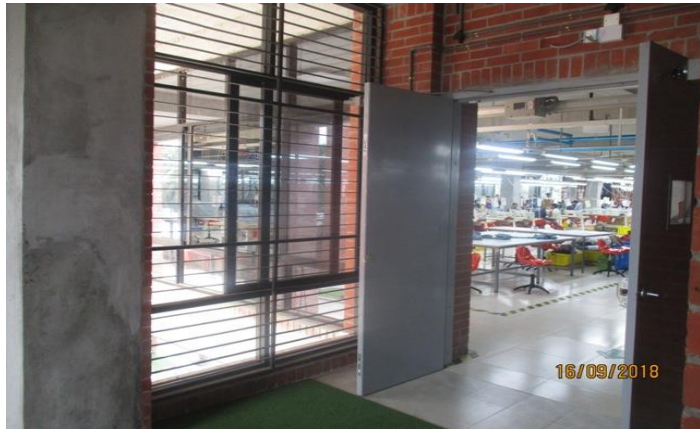
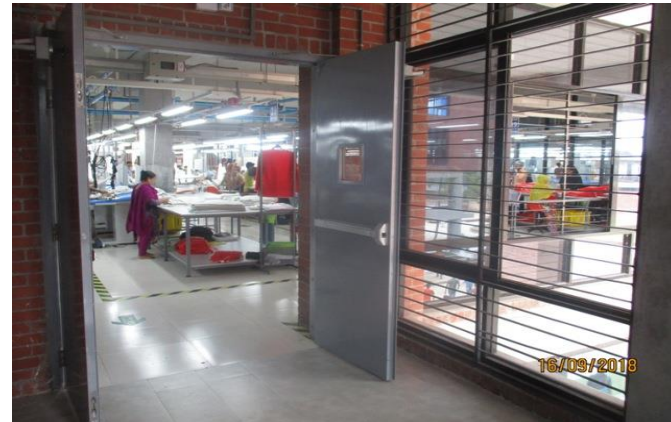
| F-2 | Fire Rated Construction | Exit Stair enclosure is not fire separated from the interior of the production area on 1st Floor (Stair A & Stair B) | separate the exit stairs from the work areas and other building spaces with 2 hr. fire rated materials. | Within 3 months |

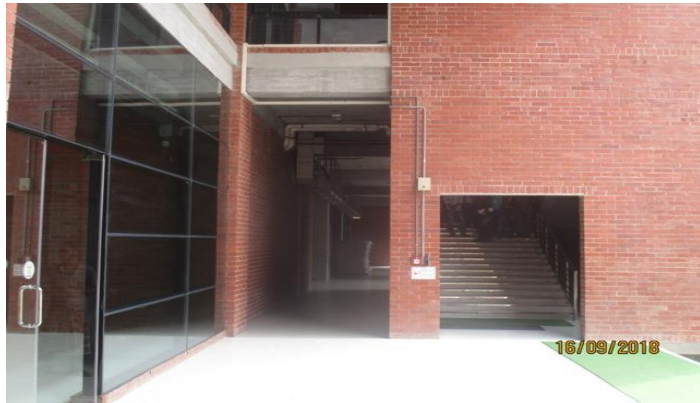
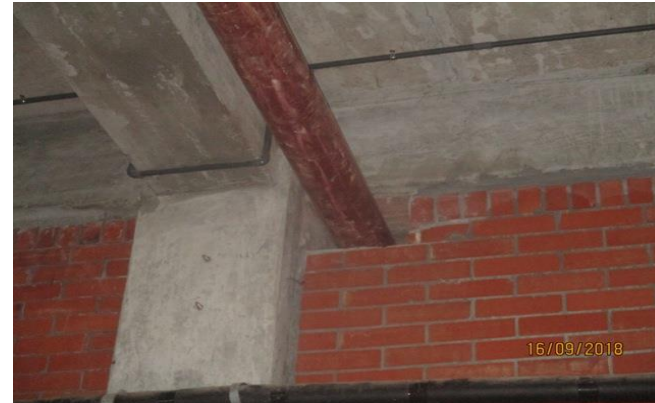
| F-3 | Fire Rated Construction | <p>Exit stair Discharge point (Stair A &amp; B) on ground floor do not discharge the occupants directly outside the factory building.</p> <p>Moreover, unsealed penetration from the storage room (Bonded Warehouse) &amp; Production area (Washing Section) was present with the exit stair discharge path.</p> | <p>Either modify the discharge point to discharge directly outside the building</p> <p>or, provided 2 hr. fire rated exit passageway to discharge directly outside the building.</p> <p>Seal all the penetration with 2 hr. fire rated materials.</p> | Within 3 months |

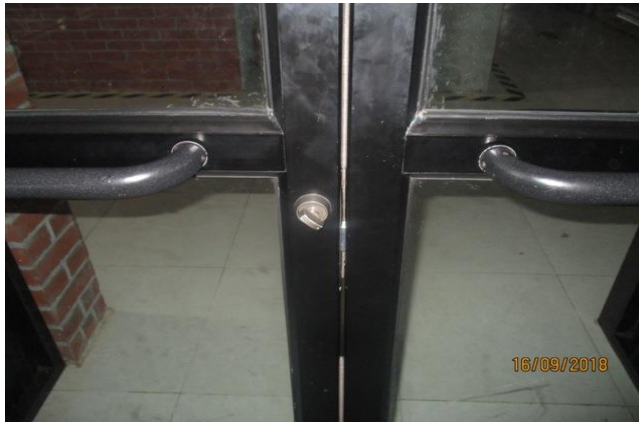
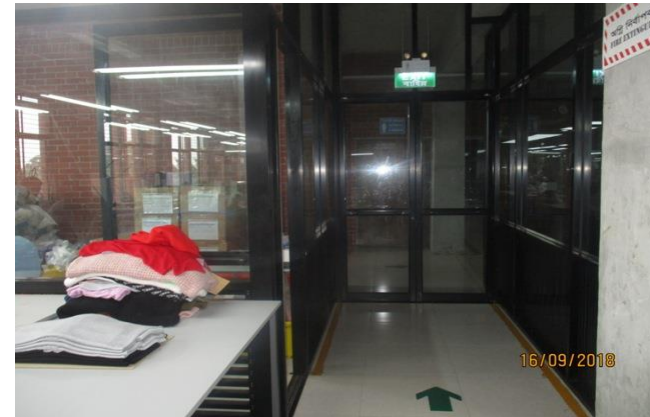
| F-4 | Means of Egress | Non-compliant Locking features were noted along the means of egress on 1st, 2nd & 3rd Floor | Replace all the non-compliant locking features with the compliant locking features as per NFPA 101 | Immediate |

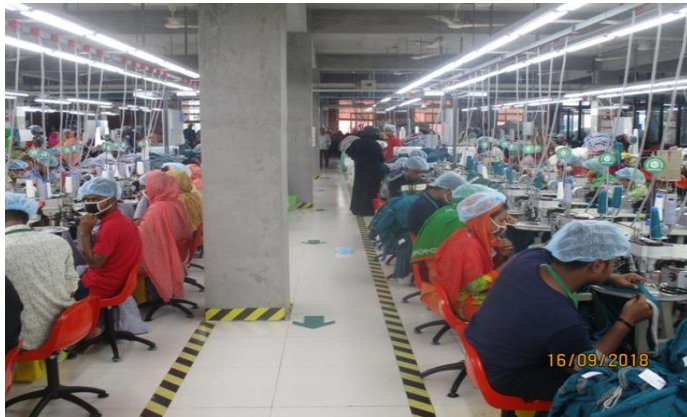
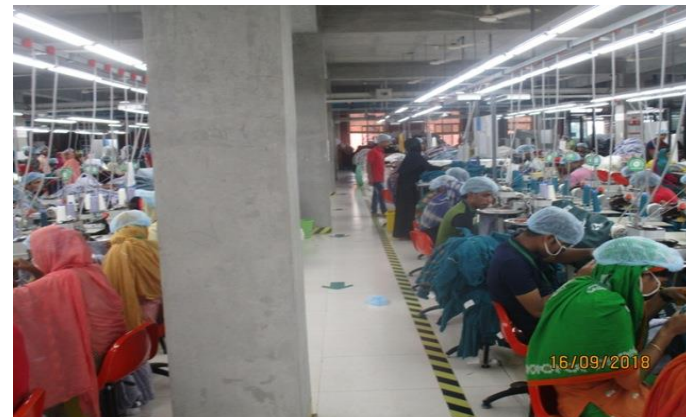
| F-5 | Means of Egress | Clear Width of aisles was less than 36 in. | Provide 36 in. width of aisles along the means of egress | Immediate |

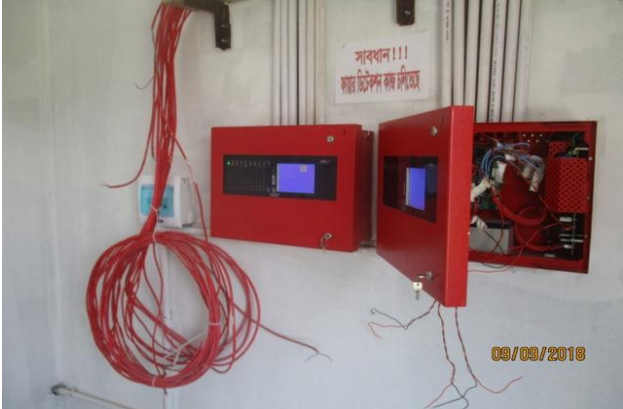
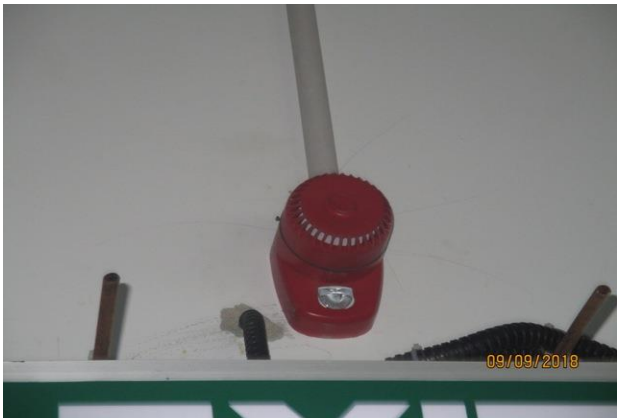
| F-8 | Fire Alarm & Detection System | Fire alarm system installation requires detailed review to confirm compliance with NFPA 72 and ACCORD standards. | <p>Submit as-built drawings, testing records, equipment certification and other relevant documentation to the ACCORD for review and approval.</p> <p>If installed system requires modification or alteration then all the applicable works shall have to be accomplished as per NFPA-72</p> | Within 3 months |
