# FIRE SAFETY INSPECTION REPORT

**Factory Name: Flaxen Dress Maker Ltd.-1**

**ACCORD ID: 23532**

**Date: 14 November, 2018**

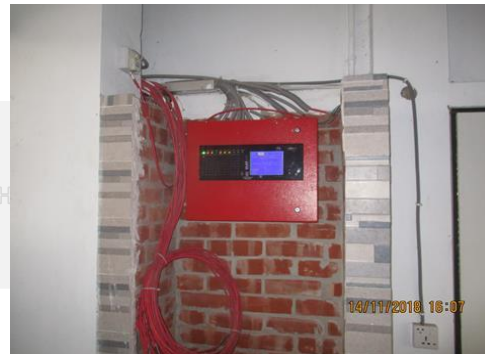
Fire Alarm control panel

The building had an addressable fire alarm system built around a alarm panel. The system supported smoke detectors, heat detectors, manual pull stations, horn and strobe units installed throughout the building. Functional test was not conducted on the system during the inspection. Records of regular testing or maintenance of the fire alarm system were not provided in accordance with NFPA 72.

Type of System	Addressable
Fire Panel Location	Security building (ground floor)
Visible Notification Per NFPA 72	To be verified during functional test
Audible Notification Per NFPA 72	To be verified during functional test
Alarm Annunciation	To be verified during functional test
ITM per NFPA 72	No
Functional Test Conducted	No

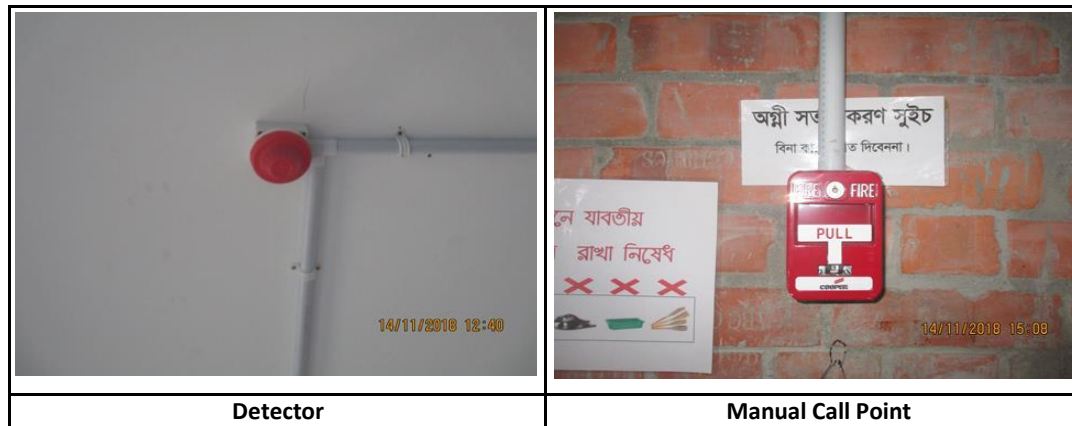
Interconnected smoke and heat detectors are located in various places throughout the factory. These detectors are tied into the fire alarm system. In the event they detect smoke and heat, they will send a signal to the fire alarm control panel to activate the fire alarm. Records of regular testing or maintenance of the fire detection system were not provided in accordance with NFPA 72.

Type of Detector	Addressable
Smoke Detection Per NFPA 72	No

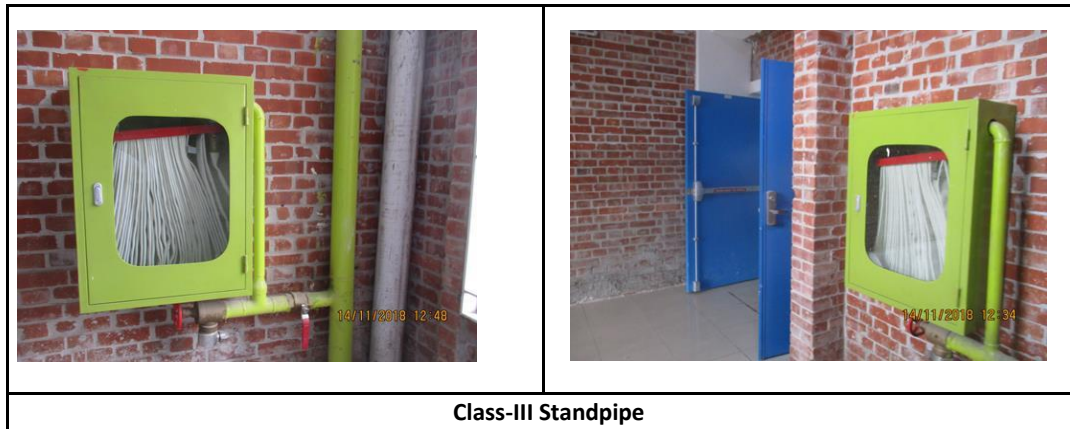
The factory building height was more than 10 m (33 ft) at the highest occupied floor and it requires a standpipe system, however Class-III standpipe system was provided in the factory. Hose reels with 1.5 in. hoses were provided on the factory floor located adjacent to egress doors and 2.5 in landing valves were provided on the exit stairs.

Standpipe System Required	Yes
Type of System Installed	class-III
Hose Connection Locations	Stair enclosure
ITM Per NFPA 25	No

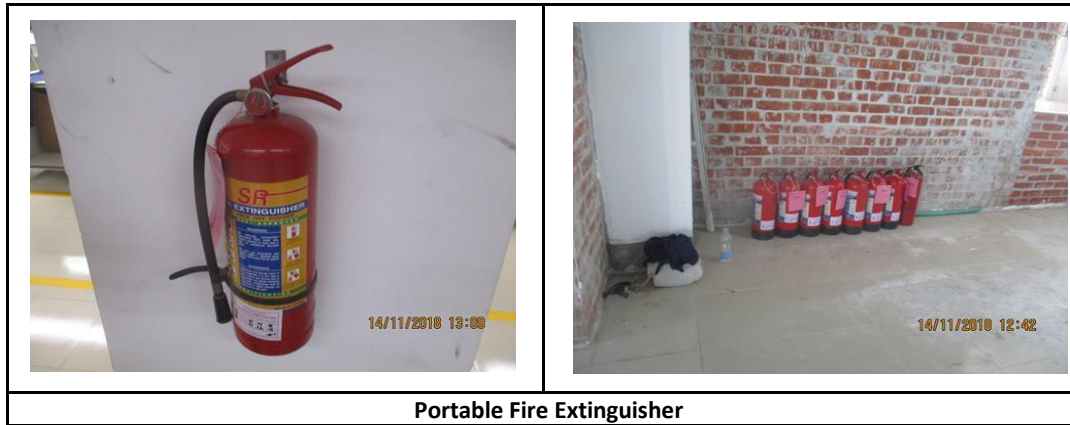
Portable Fire Extinguisher

Types Provided	CO2 & dry chemical extinguishers.
Adequate Number/Spacing	Yes
ITM Per NFPA 10	Yes

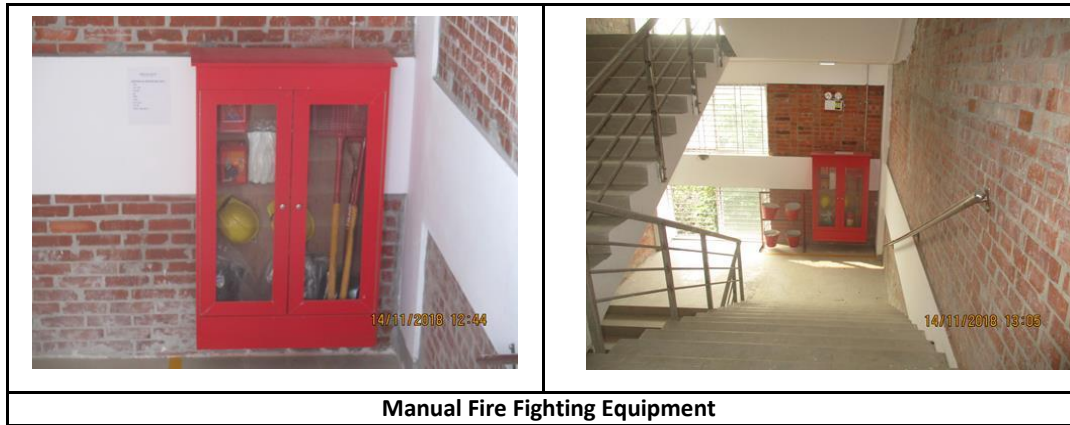
Types Provided	Buckets, escape hoods, bolt/lock cutters, shovels, stretchers and personal protection equipment.
Location of Equipment	Stair landing

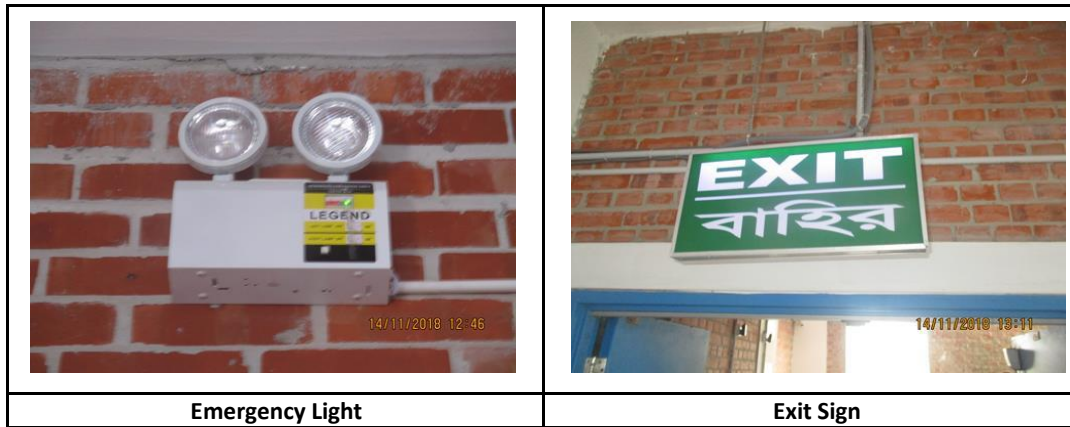
Emergency lighting appliances were located inside the production floor and exit stairs. There were multiple CFL lights that had an alternate “Instant Power Supply” (IPS). Illuminated exit signs, located at exits. The factory management reported that these are all serviced by normal electricity as well as by multiple “Instant Power Supply” (IPS) units. Manual on-off switch were found on all emergency lights & exit signage units. They were keeping records or assertions of regular testing or maintenance of the emergency lighting system which is in accordance with Accord standard.

Exits and Exit Access Properly Marked with Exit Signage	No
Emergency Power	Yes
Adequate Emergency Lighting for Exits & Exit Access	No
Adequate Inspection / Testing (Accord 10.12)	Yes

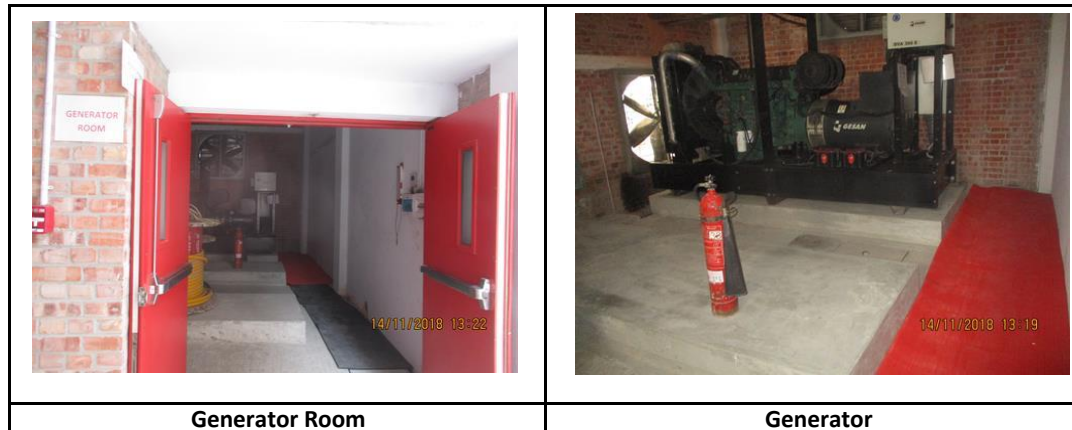
A single 340 kva generator that serves the building is located in the ground floor of a separate (utility) building. Fuel storage was not present. The building have proper fire-rated separations.

Location(s)	Utility Building
Fire Rated Separation	Yes
Generator Area Free of Additional Fuels	Yes

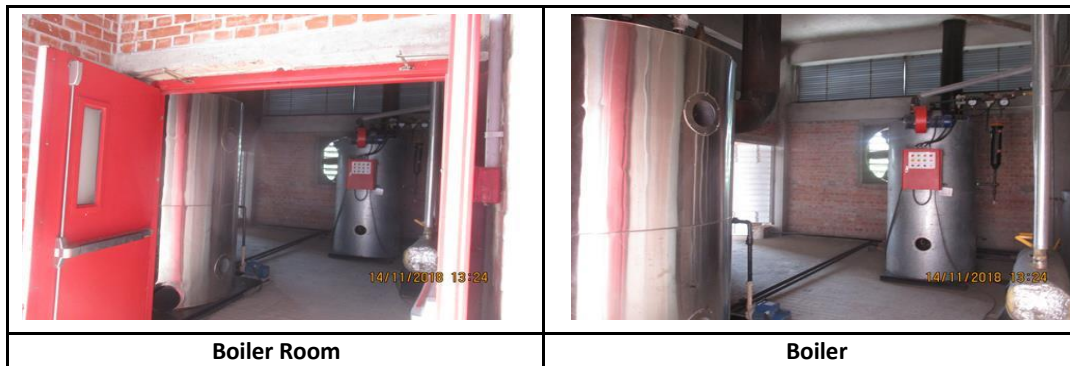
A one (1) ton and a 500 kg boiler that serves the building are located in the utility building with proper fire-rated separation.

**Boiler Room**

**Boiler**

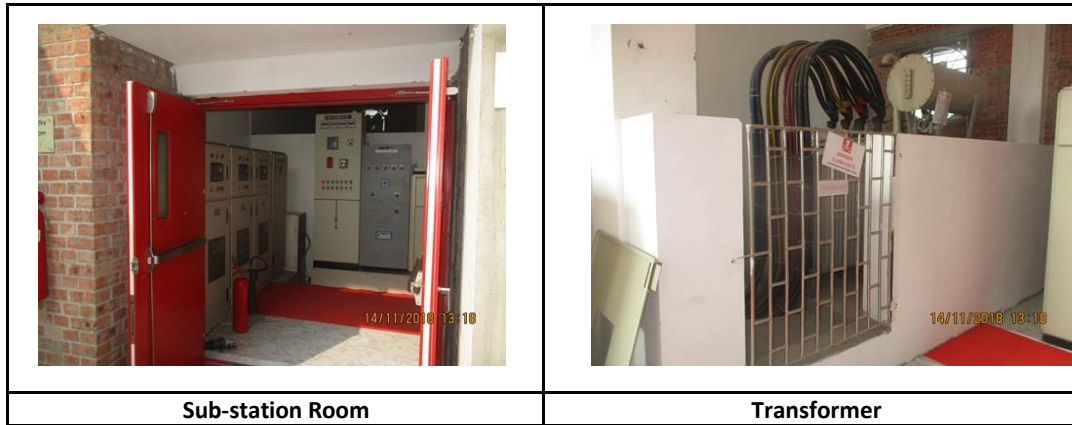
Location(s)	Utility building
Fire Rated Separation (Accord 3.4.2.1.5)	Yes

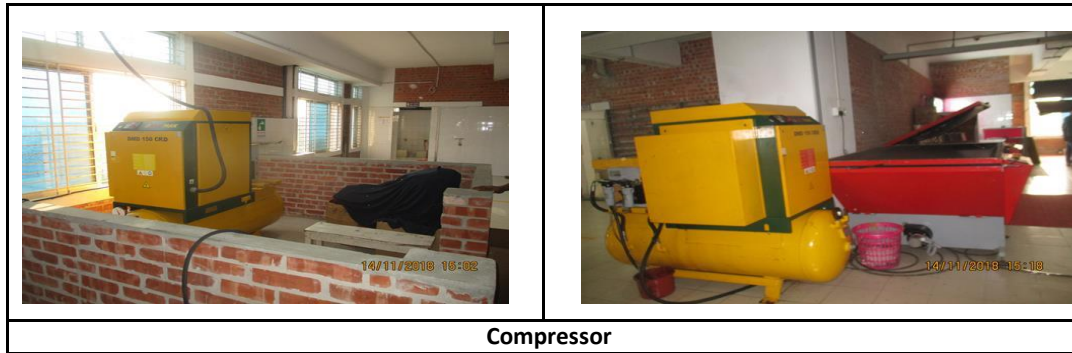
Seven (7) 11 kw compressors serve the factory at various floor without having proper fire separation.

Location(s)	Various floor
Fire Rated Separation (Accord 3.4.2.1.5)	No

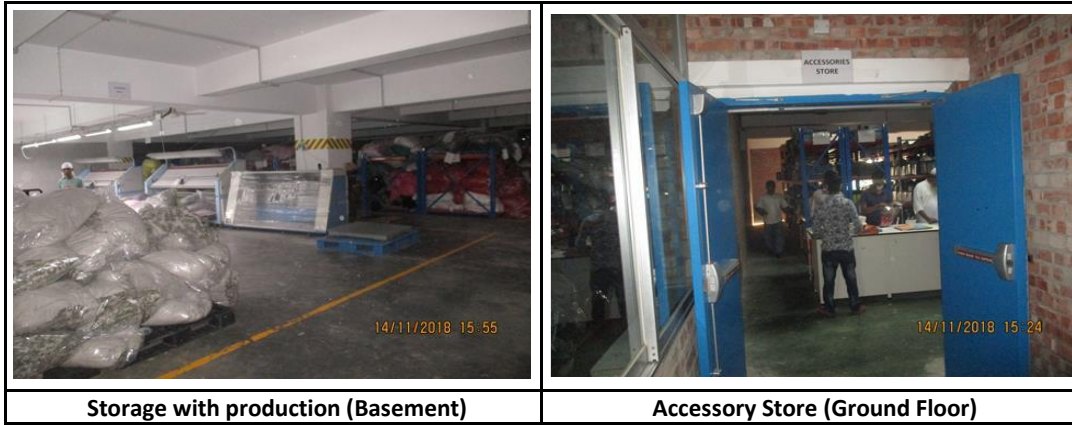
Storage of combustible materials at basement and ground floor was not separated from other occupancies. Hazardous material /flammable liquid storage was not found in the factory building. Additional fuel was not present in the generator area.

Fire Rated Separation (Accord 3.4.2.1.5)	No
Open to Factory Floors?	Yes
Open to Exit Discharge?	Yes

**Storage with production (Basement)**

**Accessory Store (Ground Floor)**

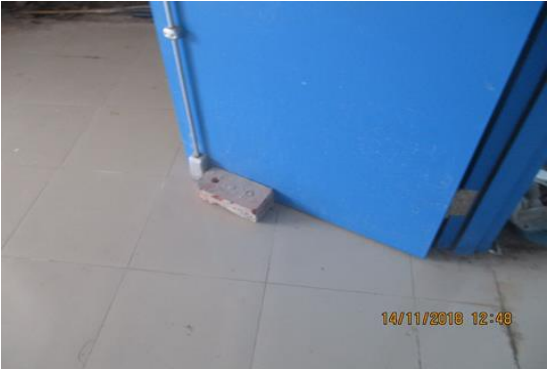
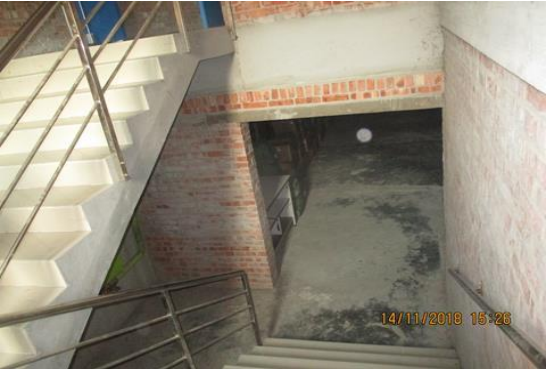
SI No.	Category	Findings	Required Action	Remediation Time Frame
1	Fire Rated construction	The exit stairs are not separated from [work areas, other spaces] on each floor by fire-rated construction.	Provide minimum 1.5-hr fire rated doors and seal all unprotected openings to separate the exit stairs from work areas and other building spaces on all floor levels. Ensure that the fire doors are self-closing and positive latching and that they are provided with fire exit (panic) hardware where serving production floors. If fire doors are required to be held open for functional reasons, provide automatic closing devices tied to the fire alarm system.	Within 3 months
<div style="display: flex; justify-content: space-around;">

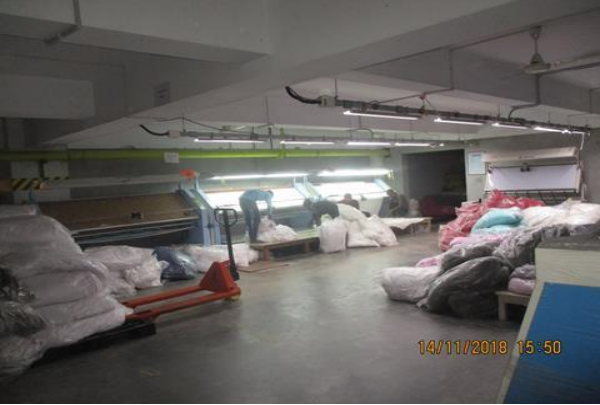
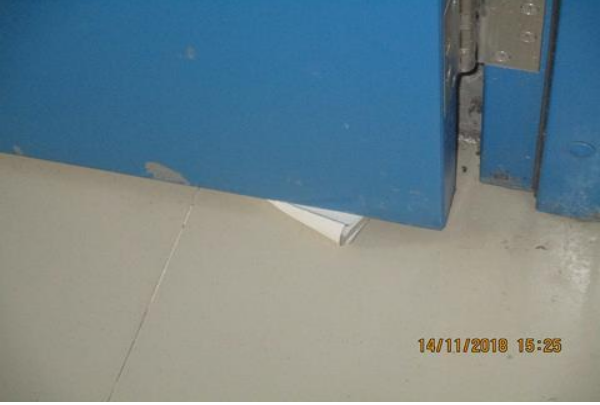
2	Fire Rated construction	Rooms on the basement and ground floor used for combustible storage are not separated by a minimum 1-hr fire-rated construction.	Rooms used for storage of combustible materials shall be separated from the surrounding occupancy with a minimum 1 hour construction.	Within 3 months

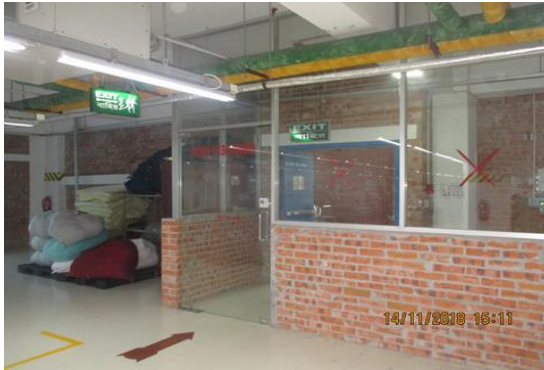
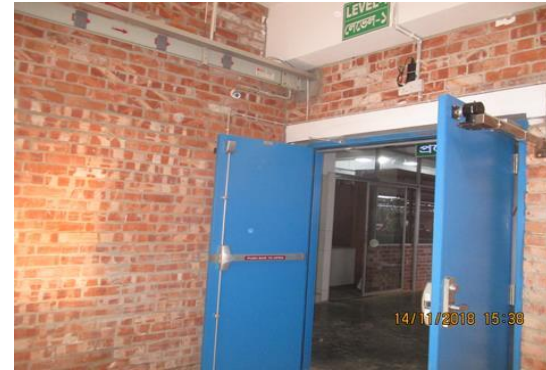
3	Fire Rated construction	Unsealed penetrations (BBT) and openings are located in exit stair enclosures. Location(s): Ground floor, stair-5	Remove/separate the electric riser (BBT) from exit stair enclosure & Seal all penetrations and openings in the wall of exit enclosure walls (full thickness of the wall) by fire rated materials to maintain the fire resistance rating.	Within 3 months

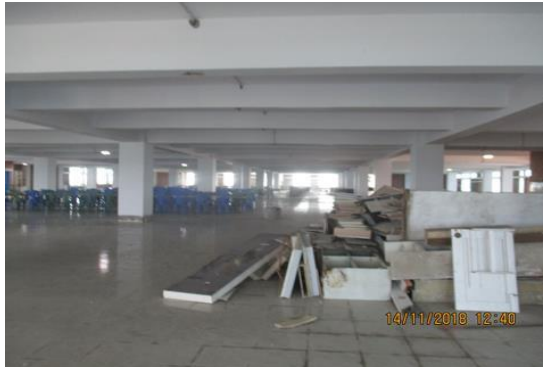
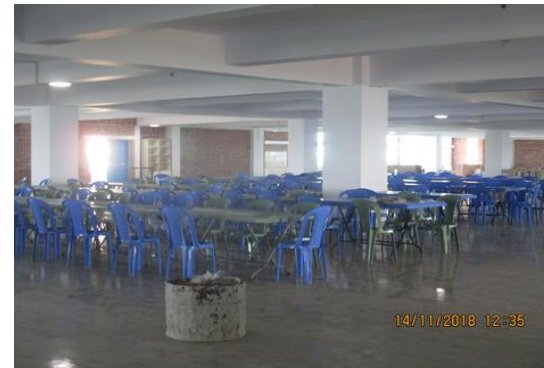
4	Fire Rated construction	Dining area is not separated from other occupancies with fire rated assemblies	Re-locate the dining area or separate the dining area from other occupancies with 2-hr fire rated construction	Within 2 months
---	-------------------------	--	--	-----------------

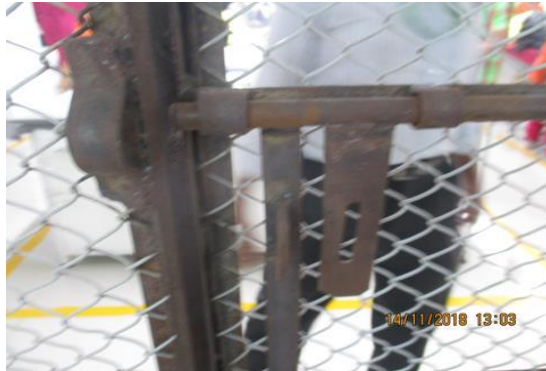
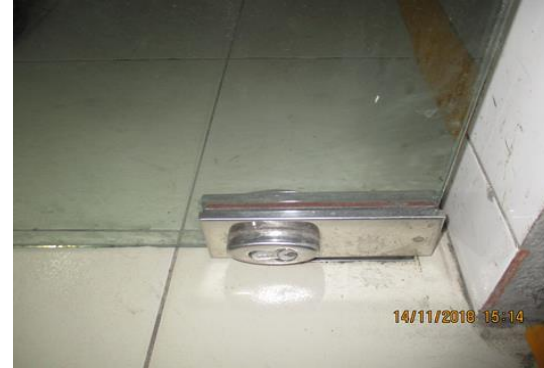
</div>				
6	Egress	Doors along means of egress are provided with non compliant locking system.	<ol style="list-style-type: none"> <li>1. Remove all non compliant locking features from egress doors.</li> <li>2. If locks are required for security reasons, utilize special door locking features complying with NFPA 101.</li> <li>3. Doors may be locked where the latch and lock are disengaged with one motion where the occupant load does not exceed 49 persons.</li> <li>4. Doors may be provided with locking hardware from the ingress side provided that a panic bar is installed on any door with an occupant load exceeding 49 persons.</li> </ol>	Immediate

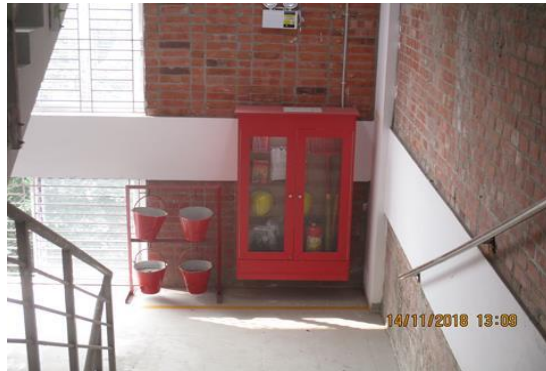
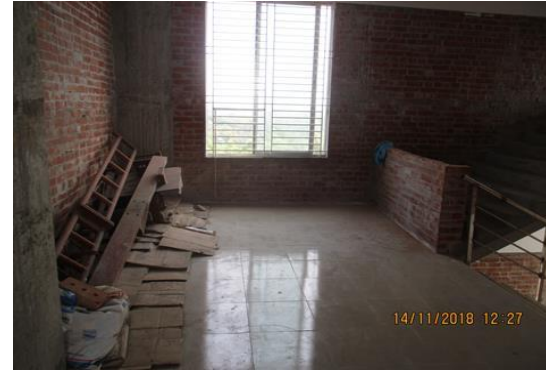
7	Egress	Storage and obstructions was located in the exit stair enclosure.	Remove all storage and obstructions from exit stairs and stair enclosure.	Immediate
---	--------	---	---	-----------

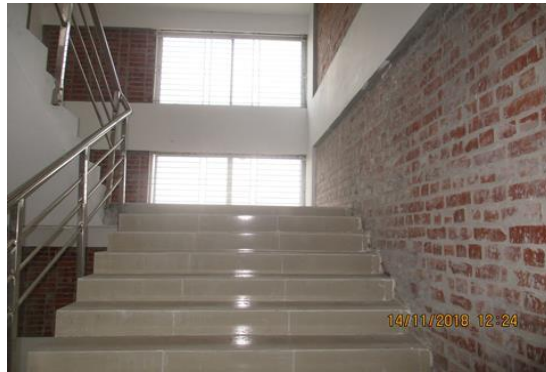
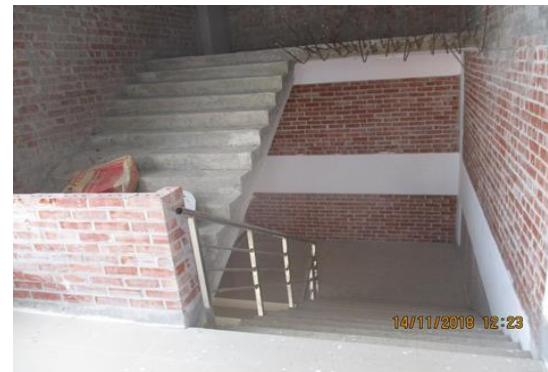
8	Egress	Building did not have stair designation signs and occupant load signs at required locations.	Provide stair designation signs and occupant load signs at required locations.	Within 1 month
9	Egress	Handrails are not provided on both sides of each exit stairs on all floors. Having handrails on one side of said staircase, may pose as a falling hazard during evacuation. Or, Handrails are not provided at exit stairs.	Provide handrails on both sides of the exit stair. New handrails shall have a minimum height of 865 mm (34 in.) and a maximum height of 965 mm (38 in.) as measured from the leading edge of the tread. Intermediate handrails shall be provided when the stair width exceeds 2.2 m (87 in.).	Within 1 month
