Flaxen Dress Maker Ltd-1

40, Meghdubi, Pubail, Hyderabad, Gazipur City, Gazipur
(23.944372, 90.430028)

14th November 2018

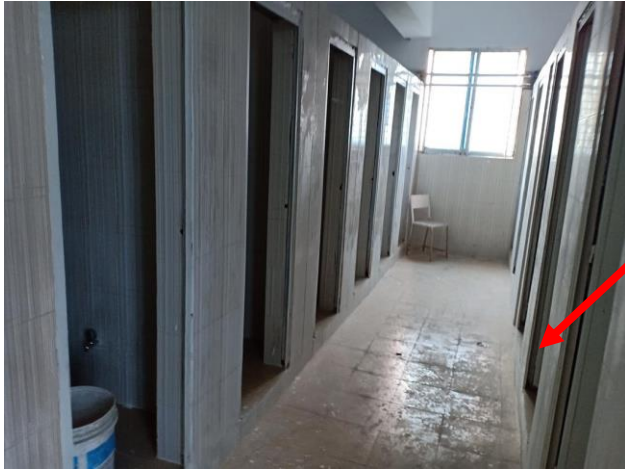
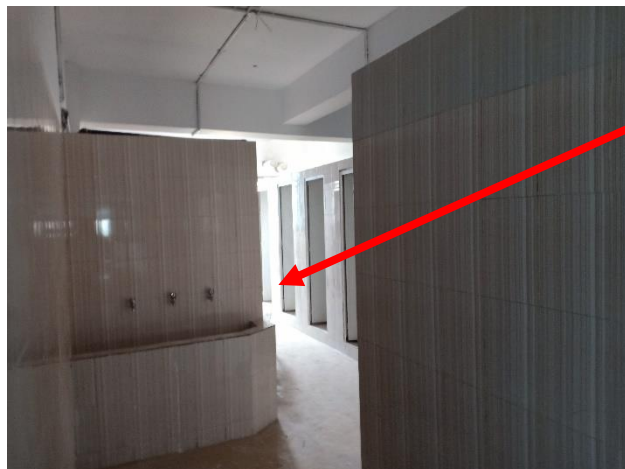
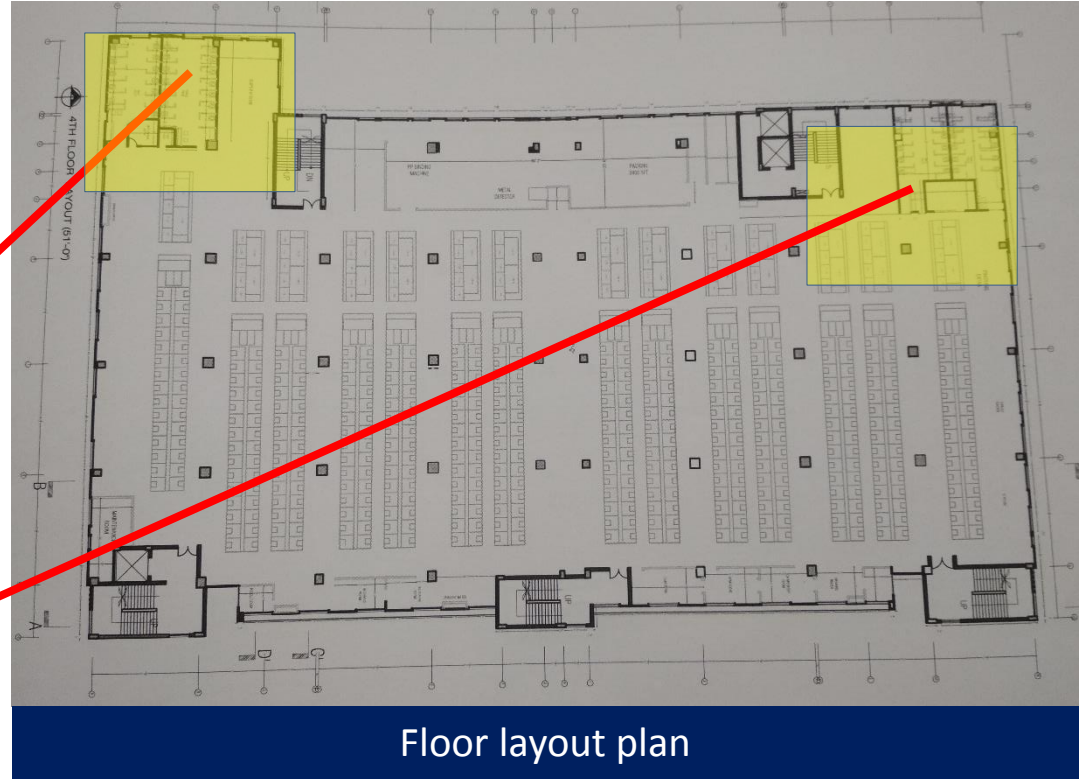
Observation : Main Production Building

**Column to be stressed above normal
design limits**

Cursory calculations indicate that few Columns under toilet area would appear to be stressed in excess of normal design limits, assuming minimum concrete strength. Building Engineer to review design, loads and columns stresses. Also, prepared load plan need to be revised based on floor, column and foundation capacity.

Floor layout plan

Item No.	Observation	Recommended Action Plan	Recommended Timeline
1	Column to be stressed above normal design limits	Factory Engineer to review design, loads, columns stresses.	6-weeks
2	Column to be stressed above normal design limits	Verify in-situ concrete strength and aggregate type by taken min. 4 nos. 100mm dia. core samples from lower tier of the building.	6-weeks
3	Column to be stressed above normal design limits	Produce and actively manage a loading plan for all floor plates within the factory, giving consideration to floor, column and foundation capacity.	6-weeks
4	Column to be stressed above normal design limits	Carry out remedial works resulting from engineering assessment if necessary.	6-months
5	Column to be stressed above normal design limits	Continue to implement loading plan.	6-months
6	Apparently non engineered roof	Prepare an “as constructed” drawings which reflect the actual site dimensions with complete structural information.	6-weeks

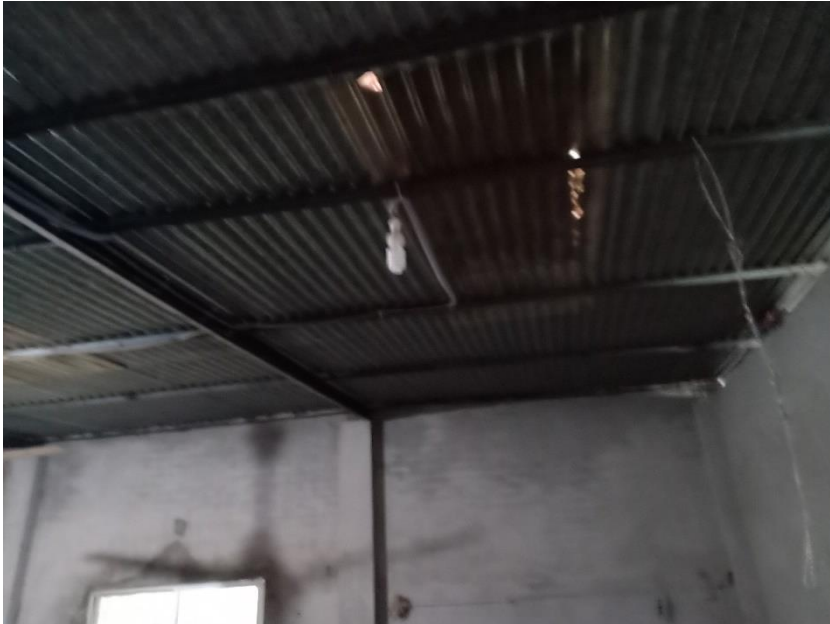
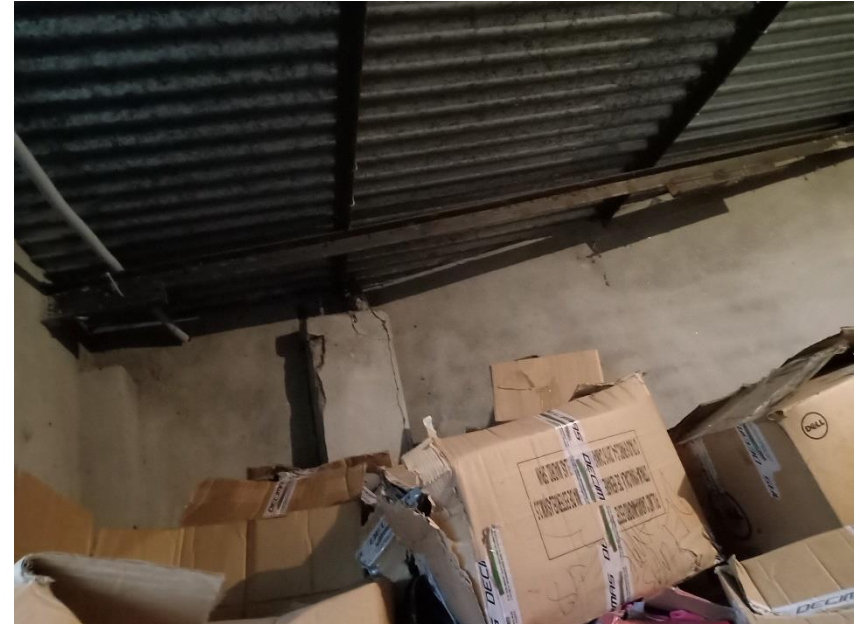
6 **Observation: Semi Building**

Apparently non engineered roof

Connection between steel members and brick walls were appeared to be inadequate. Building engineer to check the connection of the lightweight steel roofs for uplift forces.

Steel shed appeared to be non-engineered

7	Apparently non engineered roof	Building engineer to check the connection of the lightweight steel roofs for uplift forces.	6-weeks
8	Apparently non engineered roof	Carry out remedial works resulting from engineering assessment if necessary.	6-months
