# **FIRE SAFETY INSPECTION REPORT**

**AKH STITCH ART LTD.  
CHANDANPUR, RAJFULBARIA, HAMAYETPUR,  
SAVAR, DHAKA-1340 BANGLADESH.**

May 6, 2014

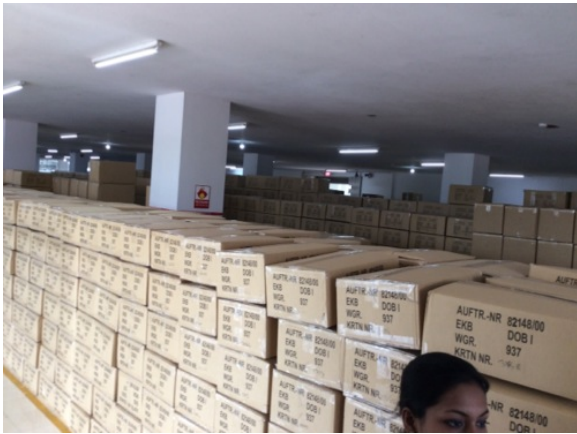
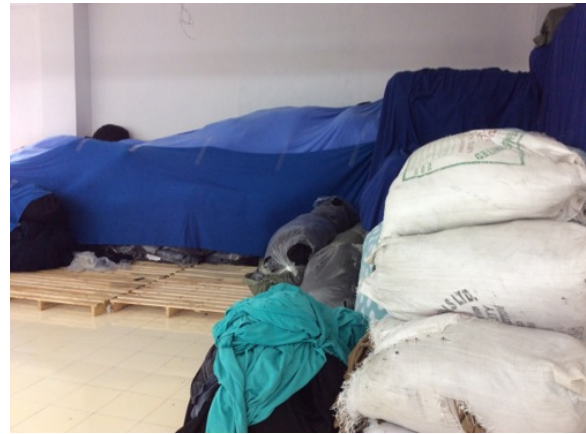
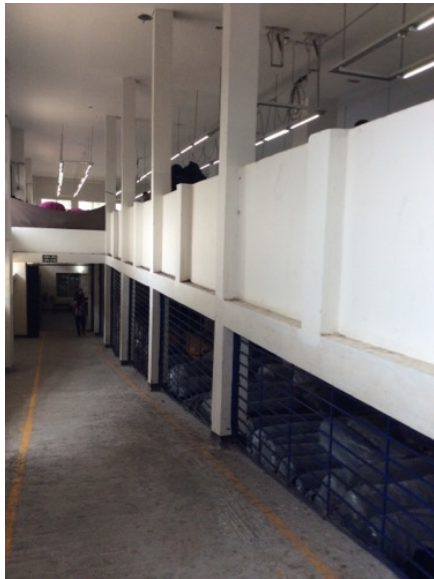
F-2	Fire Rated Construction	Areas used for combustible storage are not separated by fire-rated construction.  Storage areas are located on the basement, ground and 1st floors.	Provide dedicated storage rooms separated by minimum 1-hr fire-rated construction.  Where separate storage rooms are not feasible, provide defined storage areas and limit the storage arrangement as follows: - Maximum height of 2.4m and maximum area of 23m <sup>2</sup> - If sprinkler protected: maximum height of 3.66m and maximum area of 93m <sup>2</sup>  Separate areas of unenclosed combustible storage by a minimum clear distance of 3m.	Within 3 months
-----	-------------------------	---	--	-----------------

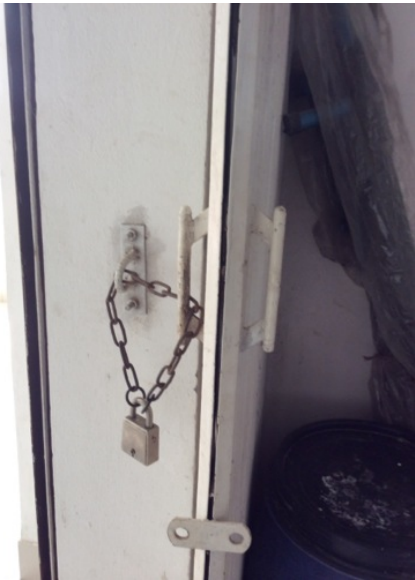
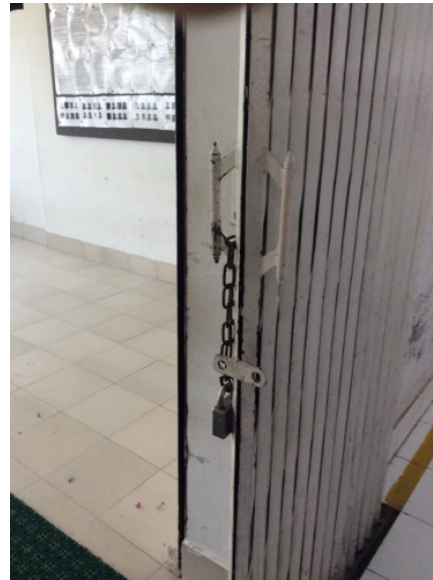
F-3

Egress doors / gates with locking features are provided at all exit stairs and exit discharge.

Remove locking features from all egress doors / gates.

If locks are required for security reasons, utilize special door locking features complying with NFPA 101.

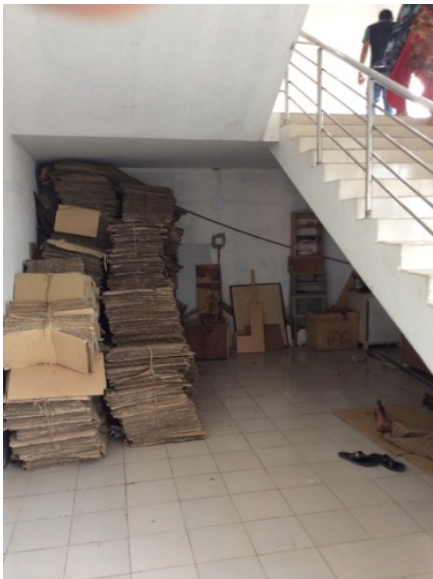
F-4 Egress

Storage was located at the bottom of the central exit stair.

Remove all storage from exit stairs and egress paths.

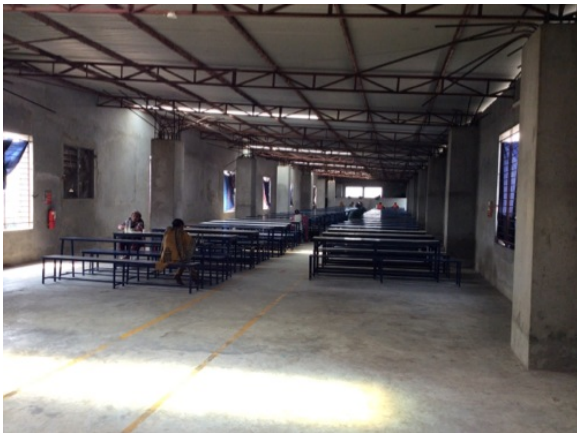
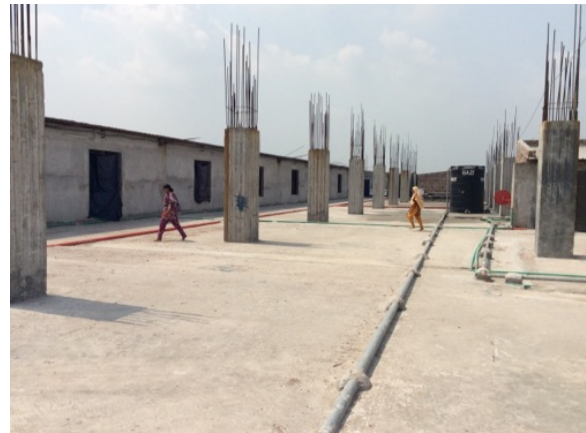
F-5	Egress	<p>Exit capacity is not adequate for the occupant load.</p> <p>Dining area at the 5th floor has only 2 exits for an occupant load of 700.</p>	<p>Reduce occupant load to not more than available exit capacity (500 occupants) and in the future provide an additional exit to increase capacity.</p>	Immediate
-----	--------	---	---	-----------

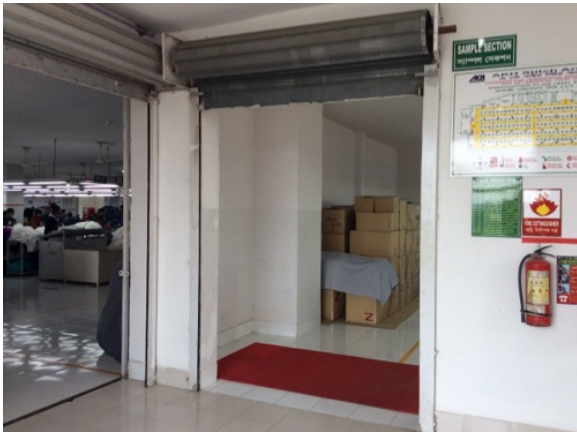
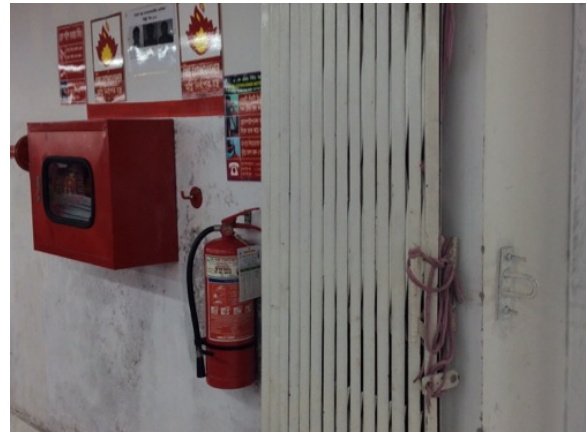
F-6	Egress	<p>Collapsible gates and roll-up doors are provided at all exit stairs and exit discharges.</p>	<p>Replace all gates and roll-up doors along the means of egress with side-hinged, swinging egress doors.</p> <p>If locks are required for security reasons, utilize special door locking features complying with NFPA 101.</p>	Within 1 month
-----	--------	---	---	----------------

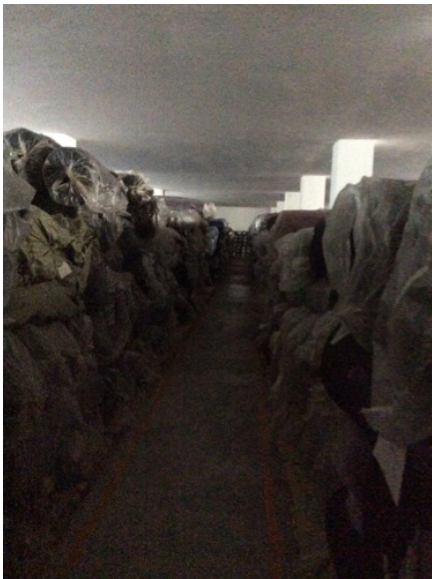
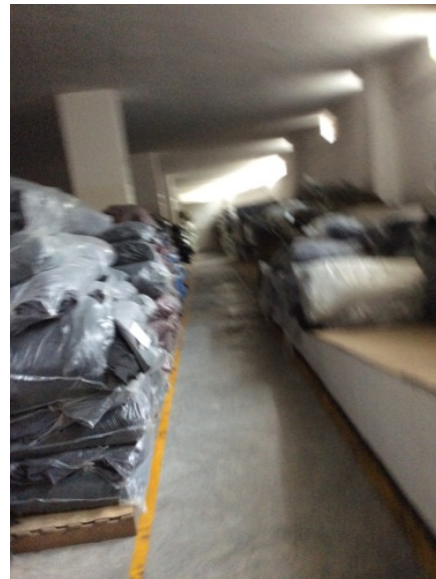
F-7	Egress	<p>Common path of egress travel exceeds 30 m.</p> <p>Storage area in basement.</p>	<p>Reconfigure the egress arrangement to reduce the maximum common path of travel to not more than 30 m.</p>	<p>Within 3 months</p>
-----	--------	--	--	------------------------

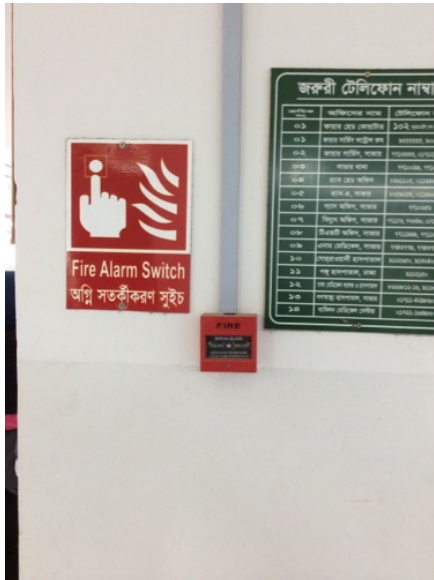
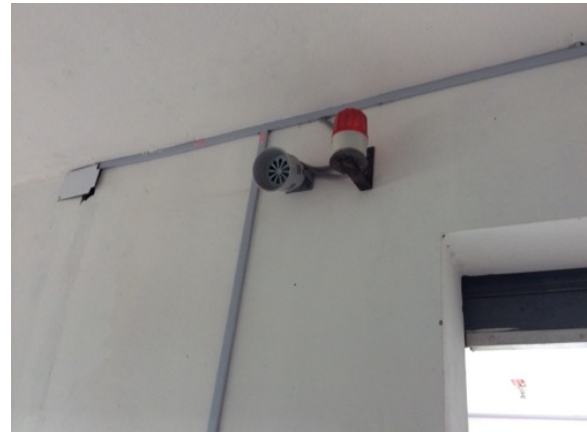
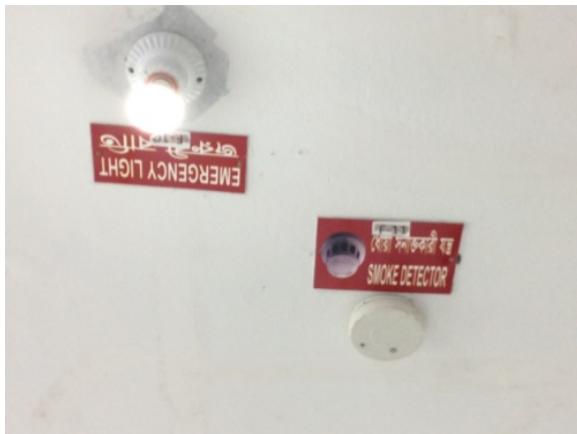
F-8	Fire Protection	<p>The fire alarm system is antiquated, not a listed system, and does not provide alarm and notification features consistent with acceptable standards.</p>	<p>Replace the fire alarm system with a new, listed addressable fire alarm system in accordance with NFPA 72.</p>	<p>Design within 4 months, install within 9 months</p>
-----	-----------------	---	---	--

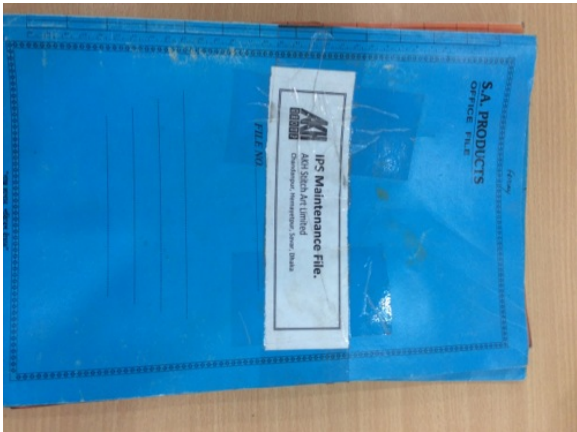
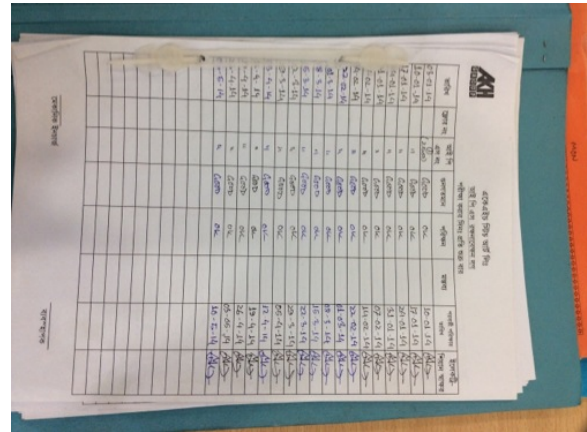
F-9	Fire Protection	Inspection, testing, and maintenance for the fire alarm system was not in accordance with NFPA 72.	Inspect, test and maintain the fire alarm system, and keep written records on-site, in accordance with NFPA 72.	Within 3 months
-----	-----------------	--	---	-----------------

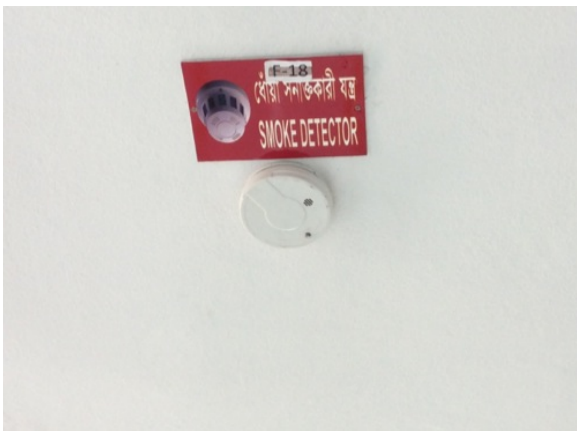
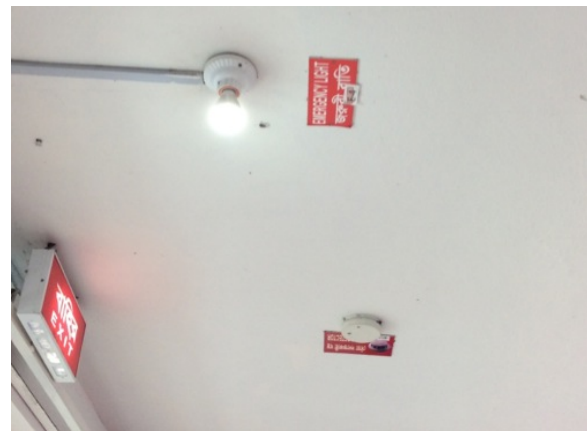
**F-10 Fire Protection** The building is equipped with single-station smoke alarms. Smoke alarm activation sounds only a local alarm and does not provide automatic fire alarm notification of occupants. **Replace the single-station smoke alarms. Provide automatic smoke detection throughout the building in accordance with NFPA 72.** **Within 6 months**

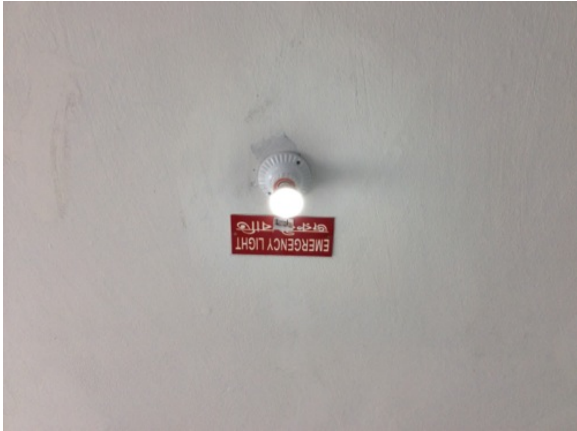
F-11	Egress Lighting	Inspection, testing, and maintenance records for the emergency lighting system were not available.	Inspect, test and maintain the emergency lighting system in accordance with The ACCORD standard. Keep written records on-site.	Within 3 months
------	-----------------	--	--	-----------------
