# Fariha Knit Tex Ltd

Baroibogh, Enayet Nagar Fatullah,  
Narayanganj, Bangladesh  
25 September 2013

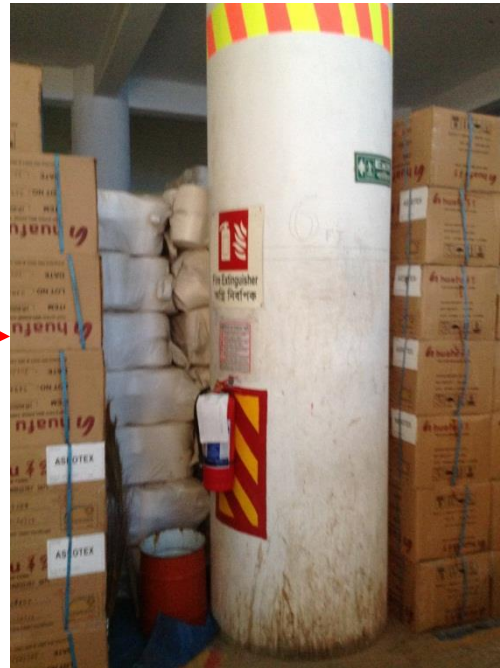
**Uncontrolled loading**

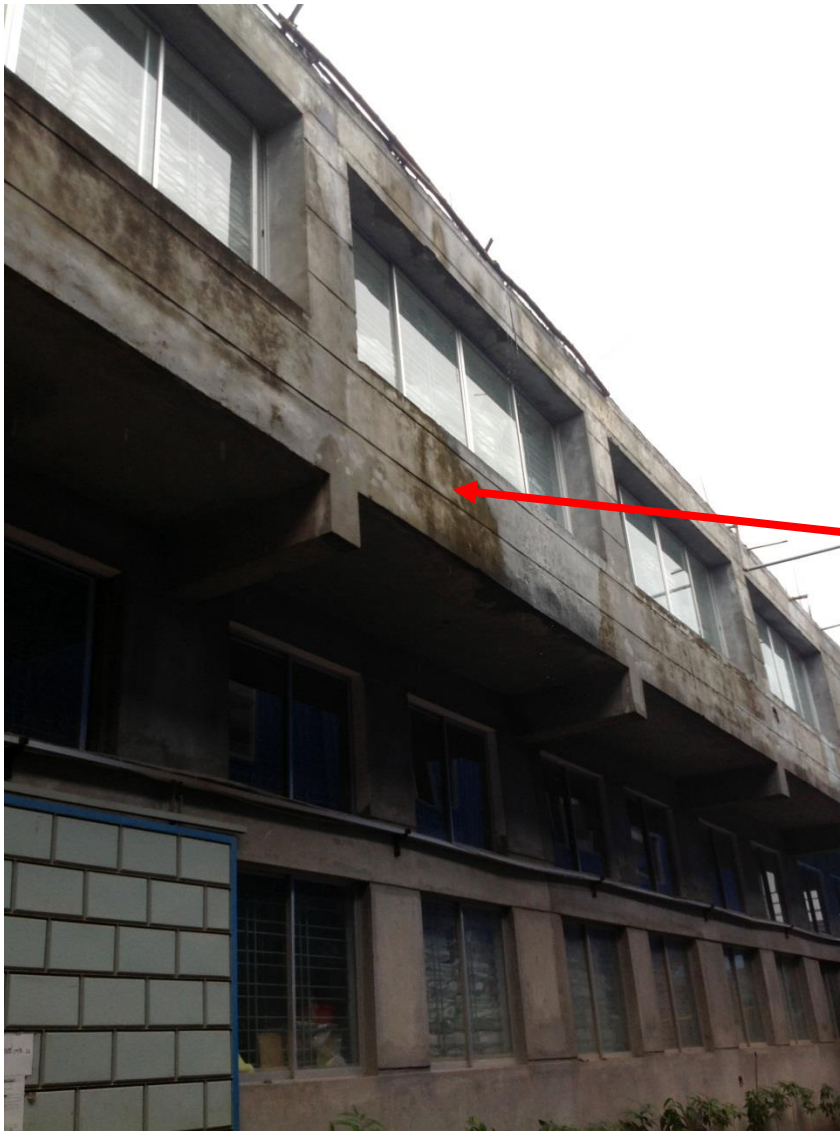
**Unmanaged roof  
drainage causing  
corrosion to façade and  
structure**

**Water causing damage and  
corrosion**

6	Water causing damage and corrosion	Engineer to inspect water damaged structure including the exterior and propose a suitable repair. Roof drainage system to be installed.	6-weeks

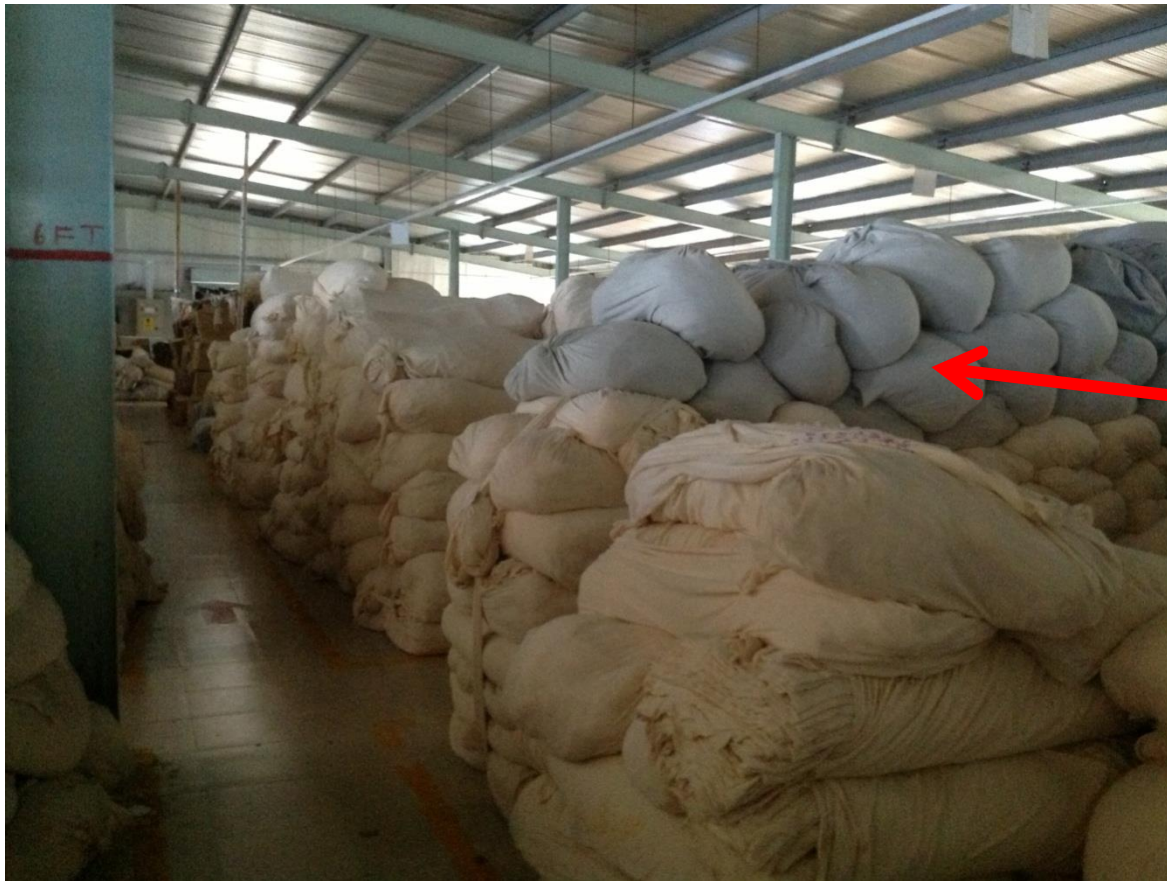
**Material stacked to ceiling within bonded warehouse**

**Plan and height restrictions to be monitored to prevent future overloading.**

Item No.	Observation	Recommended Action Plan	Recommended Timeline
7	Limit density of loading in bonded warehouse	Create controlled loading plans for all floors designating where storage can be placed and can not be placed.	<b>6-months</b>

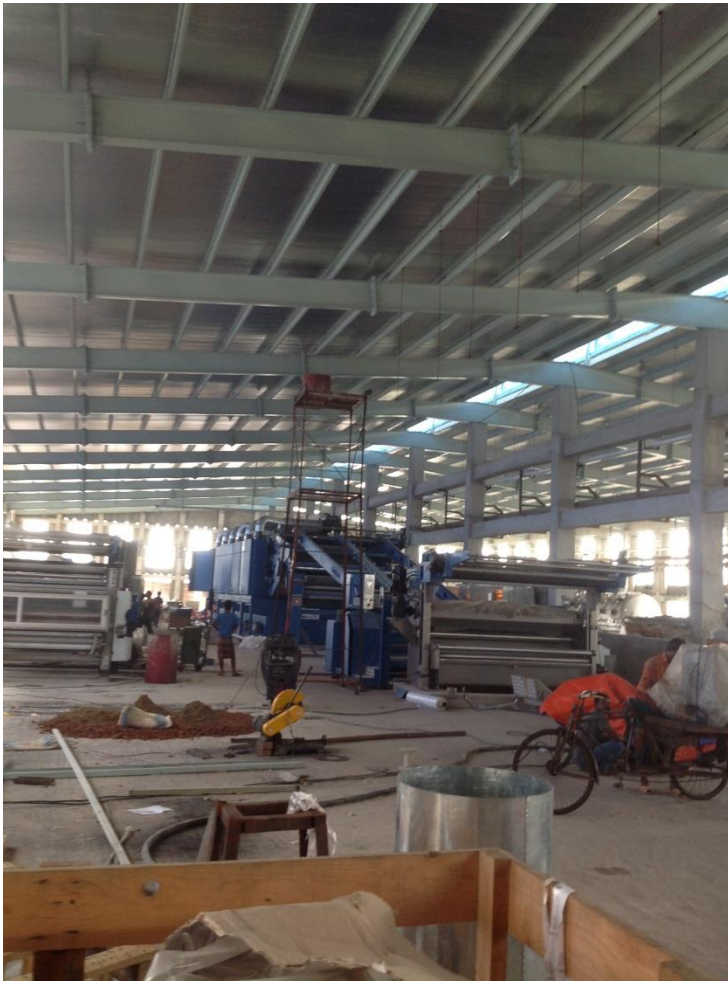
**New steel framed  
warehouse**
