# **FIRE SAFETY INSPECTION REPORT**

## **JEANS PLUS LTD**

**PLOT 398, SREEPUR BUS STAND, GANAKBARI BARI,  
SAVAR, DHAKA**

May 14, 2014

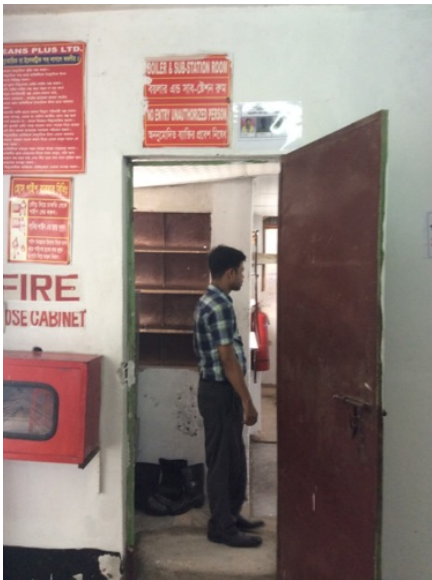
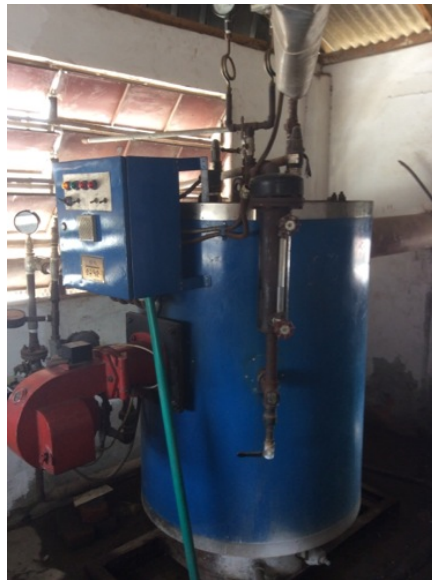
| No. | Category | Finding | Recommendation | Remediation Timeframe |
|---|---|---|---|---|
| F-1 | Fire Rated Construction | The boiler room is not separated by fire-rated construction (openings, non-rated doors, penetrations) on the 1st floor. | Separate the boiler room by a minimum 2-hr fire-rated construction. Seal and/or protected all openings to maintain the required fire separations | Within 3 months |

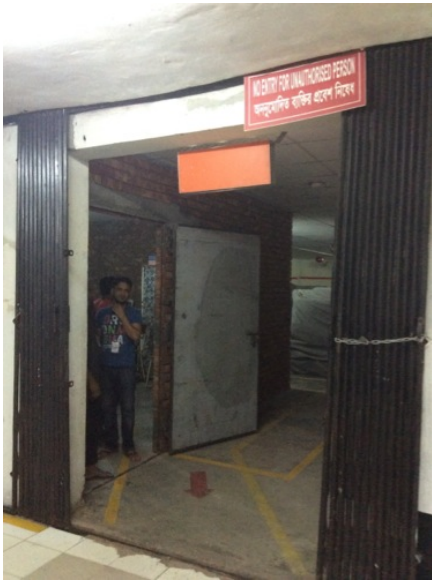
| No. | Category | Finding | Recommendation | Remediation Timeframe |
|---|---|---|---|---|
| F-2 | Fire Rated Construction | Areas used for combustible storage are not separated by fire-rated construction on the ground floor. | Provide dedicated storage rooms separated by minimum 1-hr fire-rated construction. | Within 3 months |

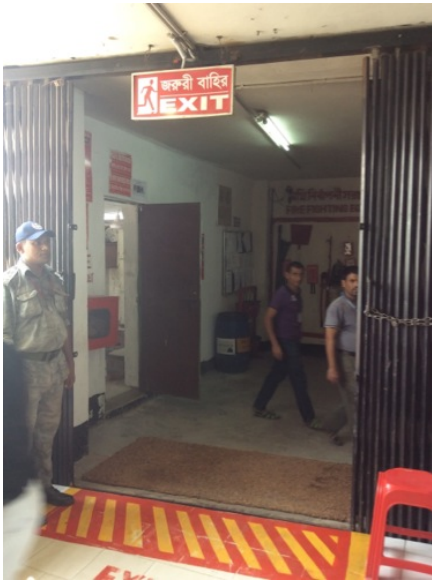
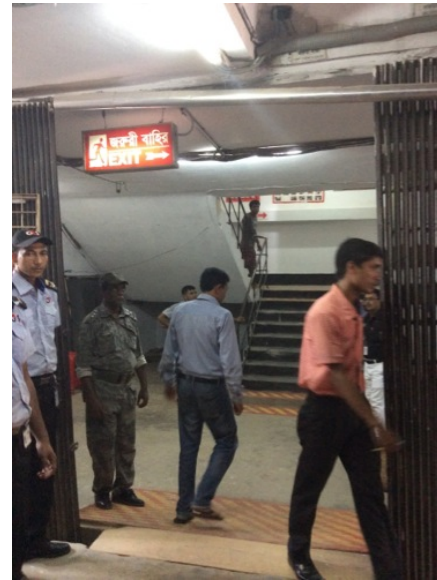
| F-3 | Fire Rated Construction | The exit stairs are not separated from work areas on each floor by fire-rated construction. | <p>Provide minimum 1.5-hr fire rated doors and seal all unprotected openings to separate the exit stairs from work areas and other building spaces on all floor levels. Ensure that the fire doors are self-closing and positive latching and that they are provided with fire exit (panic) hardware where serving production floors.</p> <p>If fire doors are required to be held open for functional reasons, provide automatic-closing devices tied to the fire alarm system.</p> | Within 3 months |

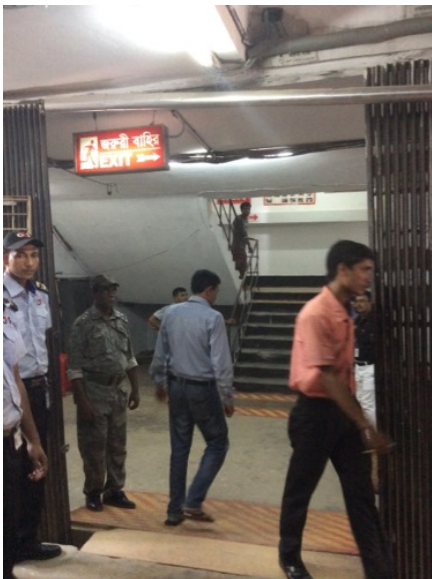
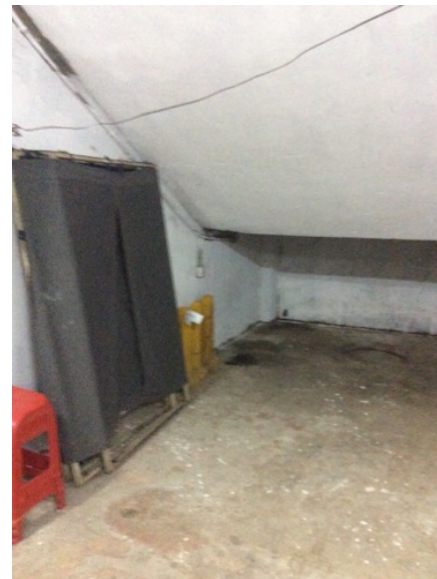
| F-4 | Egress | Storage was located under the SE exit stair on the ground floor. | Remove all storage from exit stairs and egress paths. | Immediate |

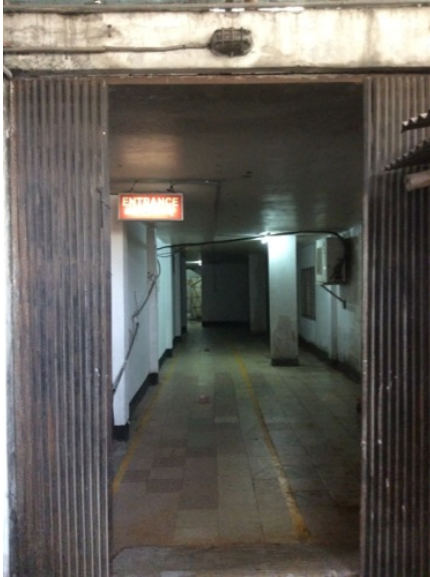
| F-5 | Egress | NW exit stairs discharge inside the building. | Modify stair to discharge directly outside. | Within 6 months |

or

Provide 2-hr fire-rated exit passageway leading directly outside (vestibules to separate any storage areas).

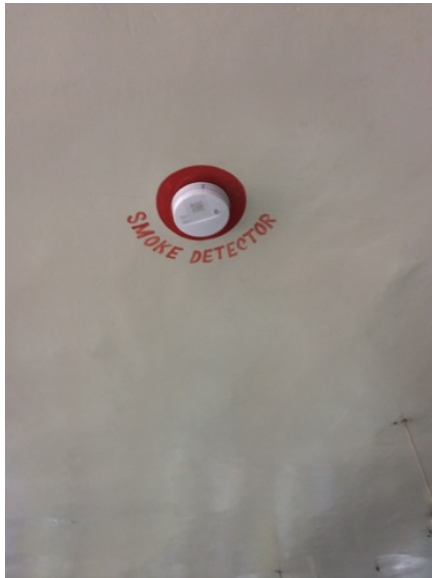
| F-8 | Fire Protection | The building is equipped with single-station smoke alarms. Smoke alarm activation sounds only a local alarm and does not provide automatic fire alarm notification of occupants. | Replace the single-station smoke alarms. Provide automatic smoke detectors throughout the building in accordance with NFPA72. | Within 6 months |
