# **FIRE SAFETY INSPECTION REPORT**

## **DRESS WORLD LTD.**

**VARARI, RAJFULBARIA, TETULJHORA, SAVAR,  
DHAKA**

March 11, 2014

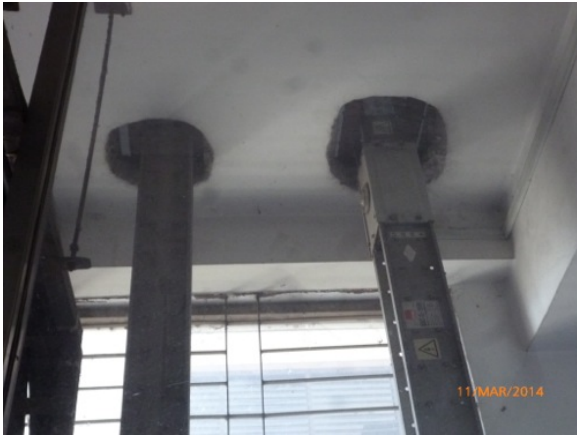
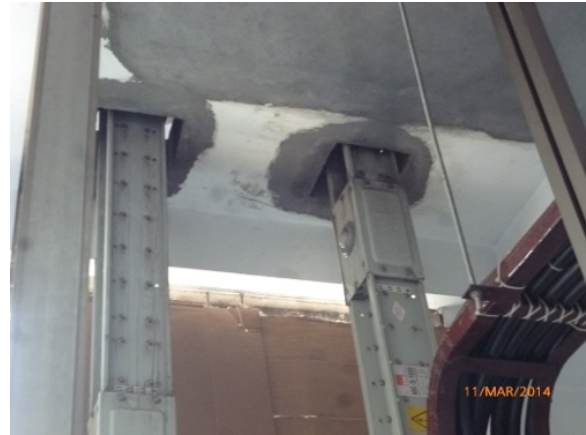
F-1	Fire Rated Construction	Unsealed penetrations and openings are located in the fire-rated floor/ceiling assemblies. (All floors).	Provide a minimum 2-hr fire-rated shaft to separate the utility risers from each floor level.	Within 3 months
-----	-------------------------	--	---	-----------------

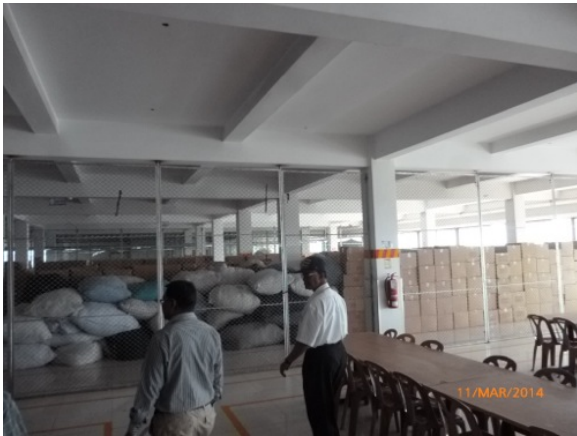
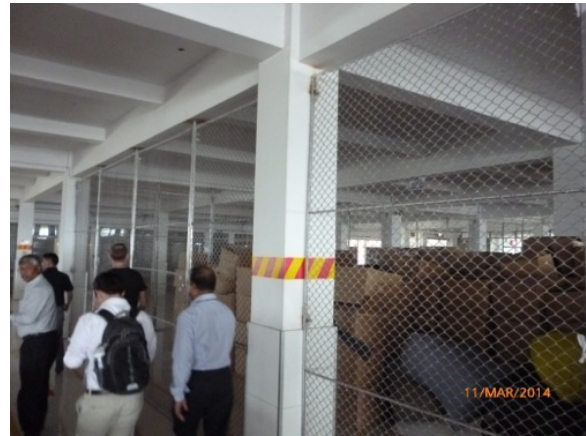
F-2	Fire Rated Construction	Areas used for combustible storage are not separated by fire-rated construction.  Location: 5th floor storages used fence wire as separation on their storages.	Provide dedicated storage rooms separated by minimum 1-hr fire-rated construction.	Within 3 months
-----	-------------------------	---	--	-----------------

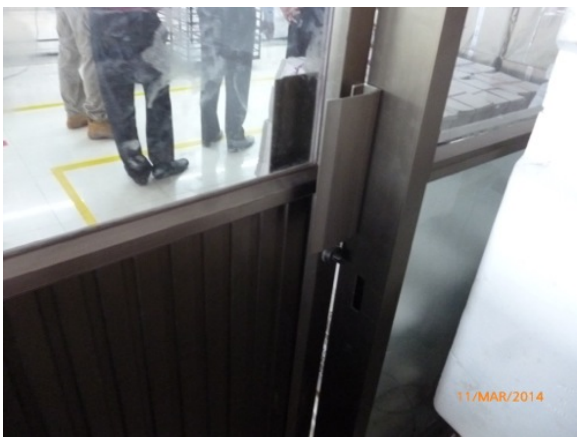
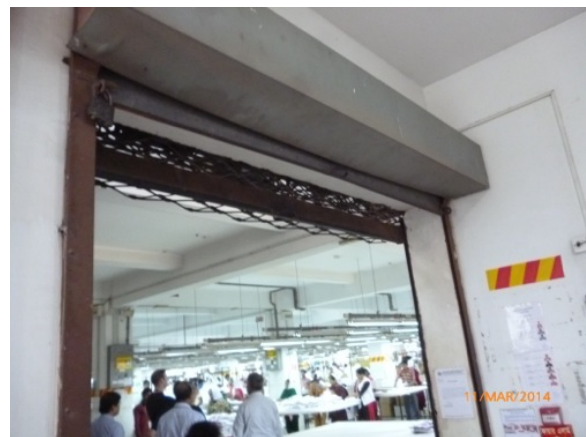
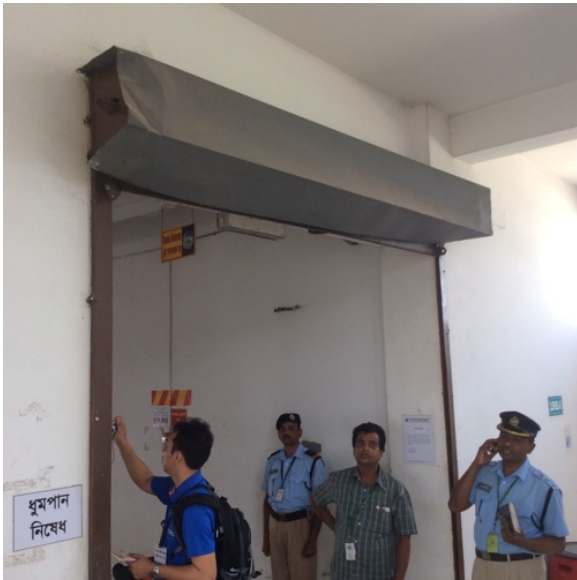
F-3 Egress

Egress doors and gates with locking features are provided at building exits, exit stairs, along egress routes, exit discharge.

All gates/doors were open and unlocked during the inspection.

Remove locking features from all egress doors and gates.

If locks are required for security reasons, utilize special door locking features complying with NFPA 101.

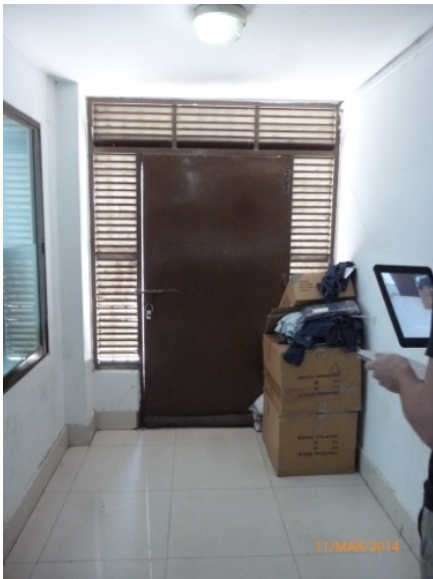
F-4 Egress

Dead-end egress path exceed 30 m.

Location: Ground floor office egress path way

Remove the door locks changes the to panic bar hardware.

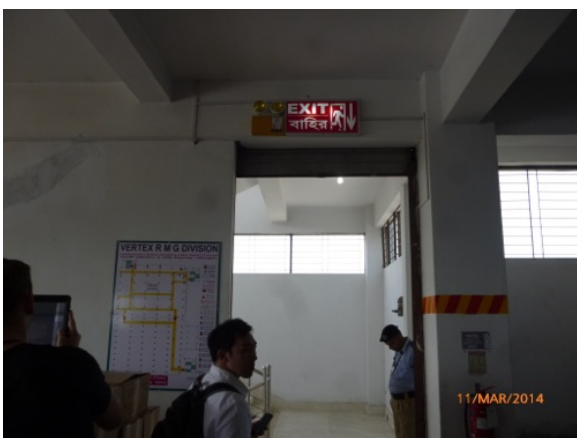
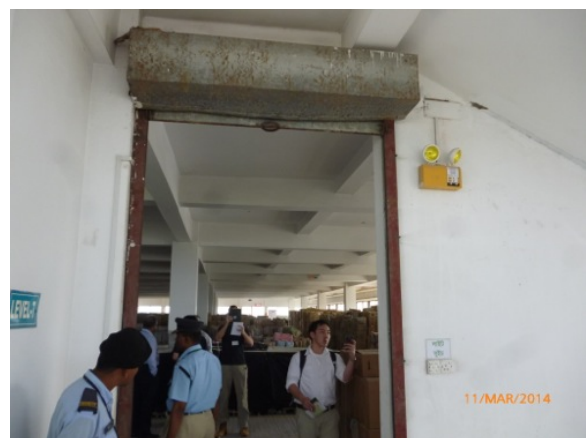
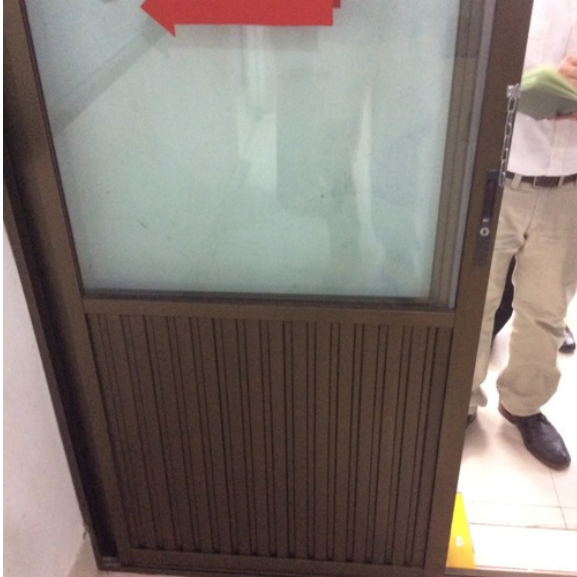
F-6 Egress

Collapsible gates and sliding doors are provided at building exits, exit stairs, along egress routes and exit discharge.

Replace all gates and sliding doors along the means of egress with side-hinged, swinging egress doors.

If locks are required for security reasons, utilize special door locking features complying with NFPA 101.

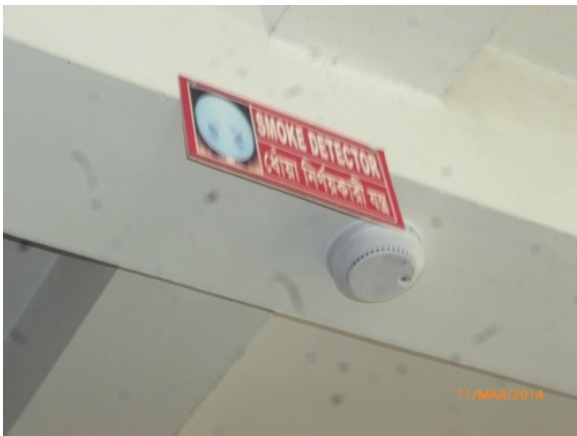
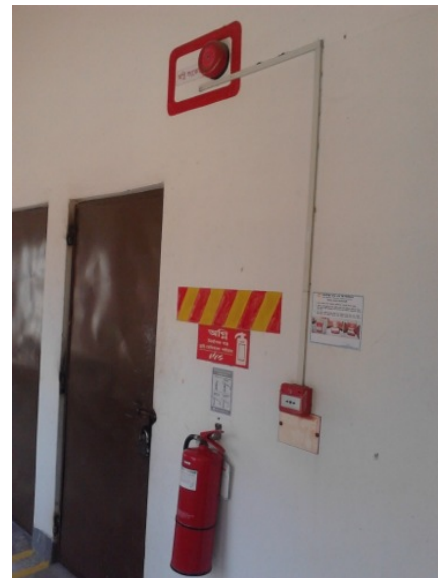
F-7	Fire Protection	The fire alarm system is antiquated, not a listed system, and does not provide alarm and notification features consistent with acceptable standards.	Replace the fire alarm system with a new, listed addressable fire alarm system in accordance with NFPA 72.	Design within 4 months, install within 9 months
-----	-----------------	--	--	---

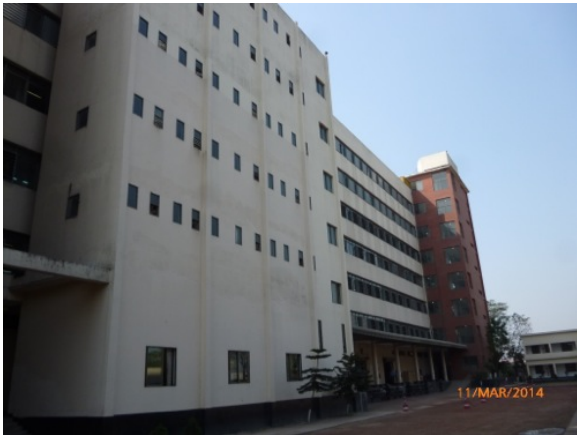
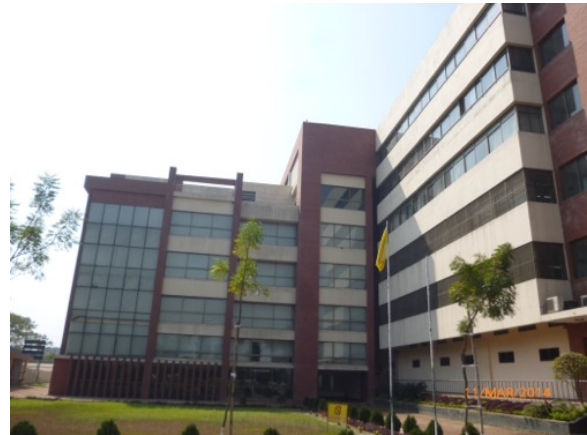
F-8	Fire Protection	The high-rise building has an occupied floor greater than 23m (75 ft) and is not provided with automatic sprinkler protection. The large occupant loads, heavy fuel loading, and anticipated extended egress times warrant sprinkler protection.	Provide automatic sprinkler protection throughout the building in accordance with NFPA 13.	Design within 6 months, install within 12 months
-----	-----------------	--	--	--

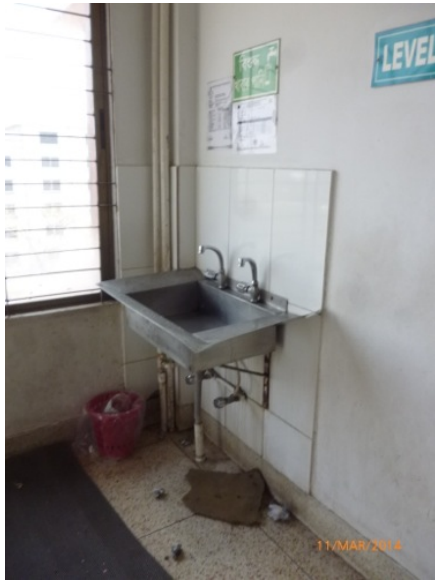
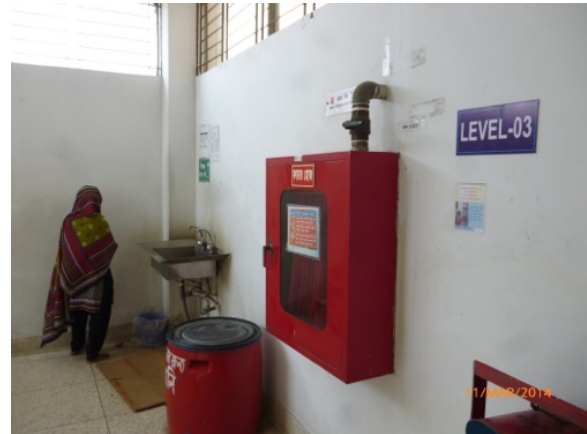
F-9	Fire Protection	Drinking station on stairwell,	Remove all the drinking station on both stairwell, Stairwell should be free from any obstruction.	Immediate
-----	-----------------	--------------------------------	---	-----------

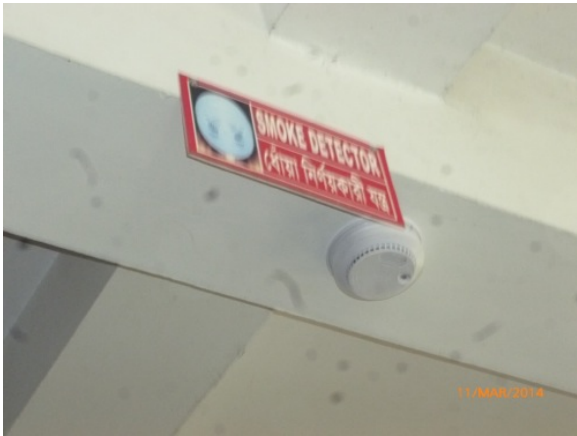
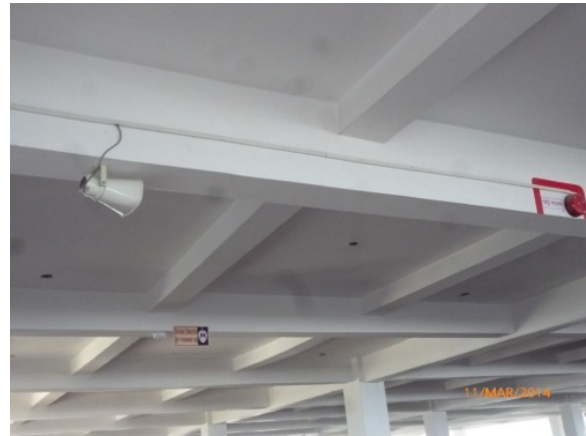
F-10	Fire Protection	Inspection, testing, and maintenance for the fire alarm system was not in accordance with NFPA 72.	Inspect, test and maintain the fire alarm system, and keep written records on-site, in accordance with NFPA 72.	Within 3 months
F-11	Fire Protection	The building is equipped with single-station smoke alarms. Smoke alarm activation sounds only a local alarm and does not provide automatic fire alarm notification of occupants.	Remove single station smoke alarms. Provide automatic smoke detection throughout the building in Accordance with NFPA 72.	Within 6 months

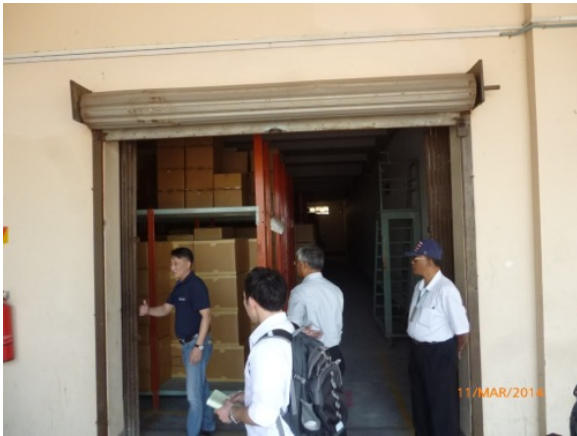
F-12 Egress Lighting

The warehouse in ground floor did not have any emergency lights and exit signs

Provide Emergency lights and exit signs.
