# **FIRE SAFETY INSPECTION REPORT**

## **SAFIA APPARELS LTD.**

**B46/47, BSCIC HOSHIARI INDUSTRIAL AREA,  
SHASHANGAON, FATULLAH**

April 22, 2014

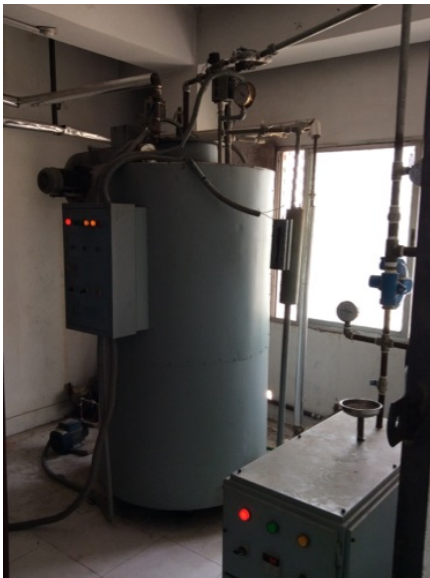
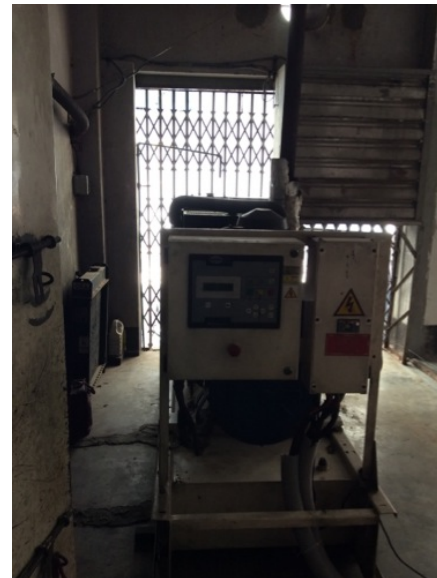
| No. | Category | Finding | Recommendation | Remediation Timeframe |
|---|---|---|---|---|
| F-1 | Fire Rated Construction | The boiler and generator rooms are not separated by fire-rated construction (openings, non-rated doors, penetrations). | Separate the boiler and generator rooms by a minimum 2-hr fire-rated construction. Seal and or protected all openings to maintain the required fire separations | Within 3 months |

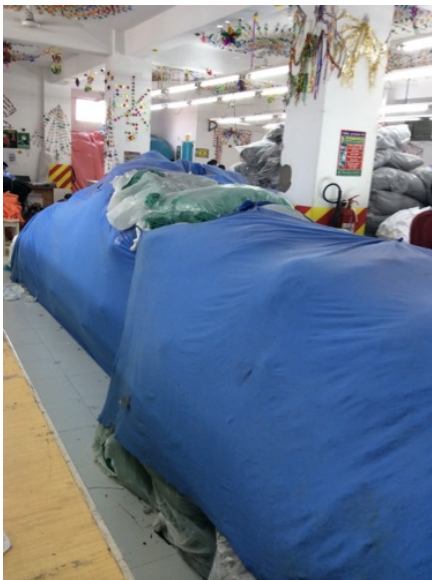
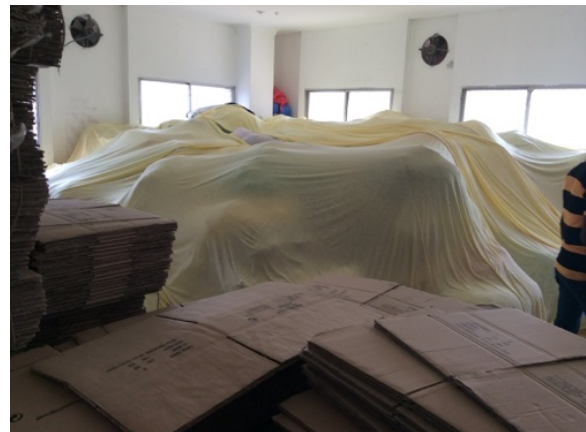
| F-2 | Fire Rated Construction | Areas used for combustible storage in the ground and 5th floors are not separated by fire-rated construction. | <p>Provide dedicated storage rooms separated by minimum 1-hr fire-rated construction.</p> <p>Where separate storage rooms are not feasible, provide defined storage areas and limit the storage arrangement as follows:</p> <ul style="list-style-type: none"><li>- Maximum height of 2.4m and maximum area of 23m<sup>2</sup></li><li>- If sprinkler protected: maximum height of 3.66m and maximum area of 93m<sup>2</sup></li></ul> <p>Separate areas of unenclosed combustible storage by a minimum clear distance of 3m.</p> | Within 3 months |

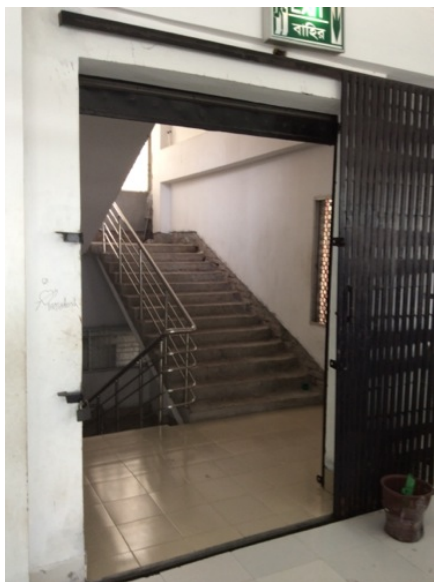
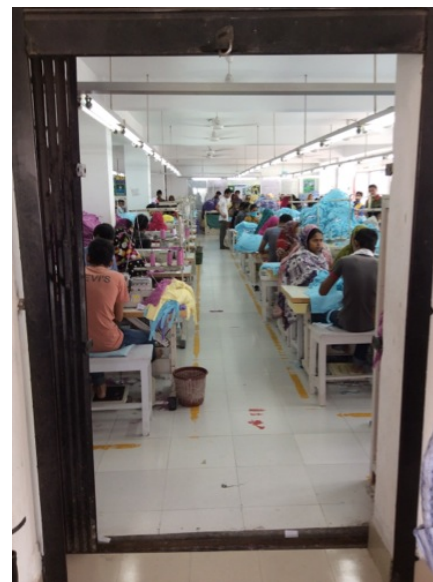
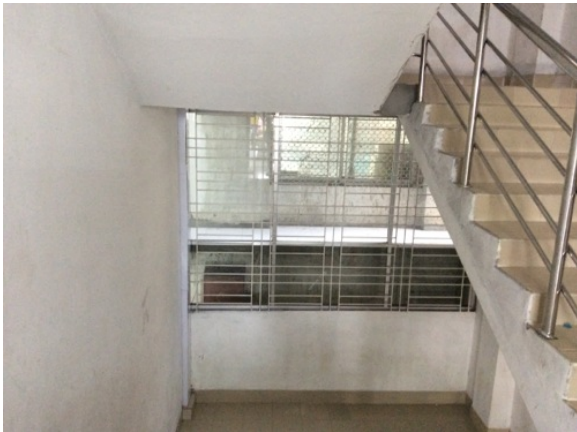
| F-3 | Fire Rated Construction | The exit stairs are not separated from work areas or other spaces on each floor by fire-rated construction. | Provide minimum 1.5-hr fire rated doors and seal all unprotected openings to separate the exit stairs from work areas and other building spaces on all floor levels. Ensure that the fire doors are self-closing and positive latching and that they are provided with fire exit (panic) hardware where serving production floors. | Within 3 months |

| | | | If fire doors are required to be held open for functional reasons, provide automatic-closing devices tied to the fire alarm system. | |

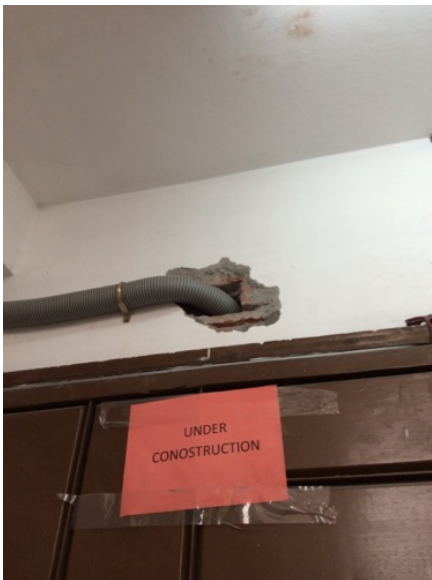
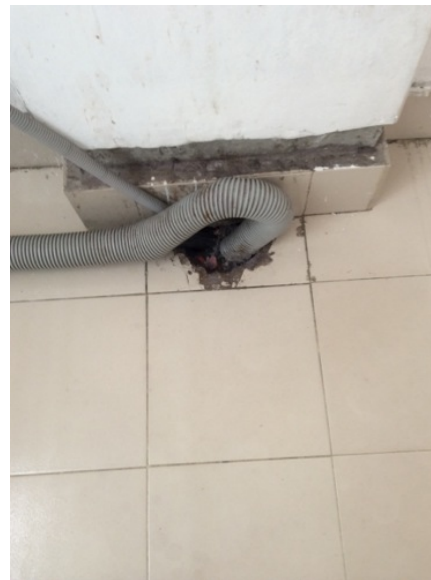
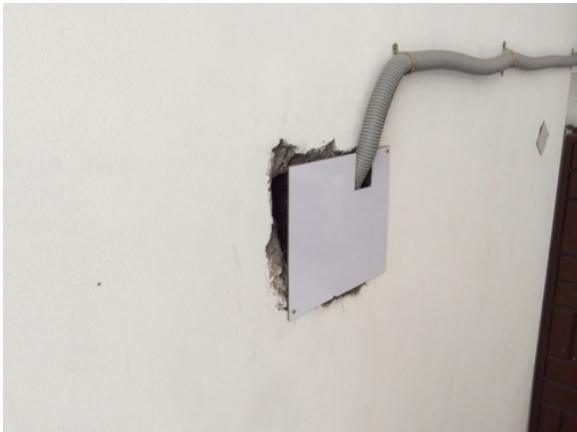
| F-4 | Fire Rated Construction | Unsealed penetrations and openings are located in the exit stair enclosures. | Seal all penetrations and openings in exit stair enclosure walls to maintain the fire separation. | Within 3 months |

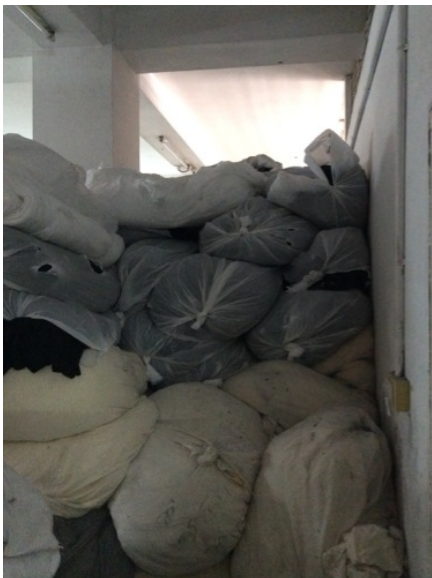
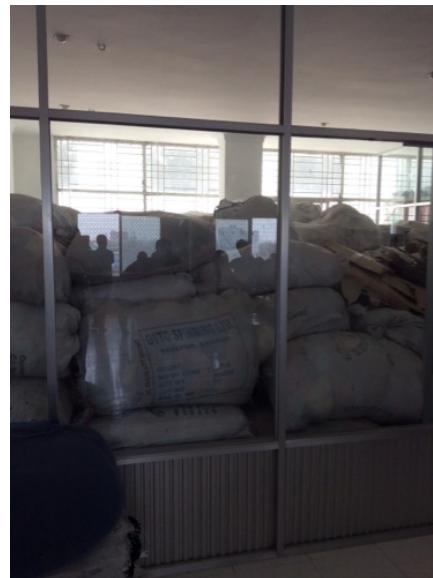
| F-5 | Fire Rated Construction | Areas used for combustible storage room in ground and 5th floors are not separated by fire-rated construction. | Provide dedicated storage rooms separated by minimum 1-hr fire-rated construction. | Within 3 months |

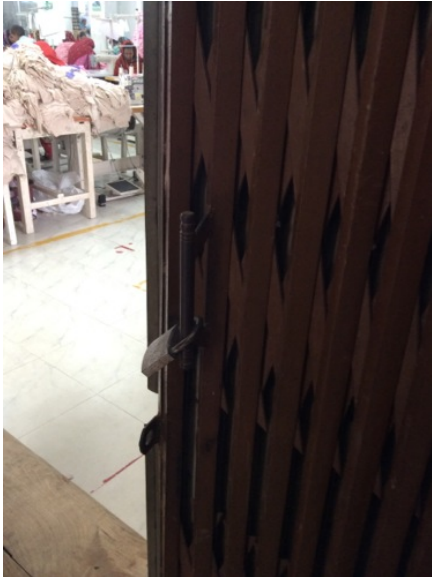
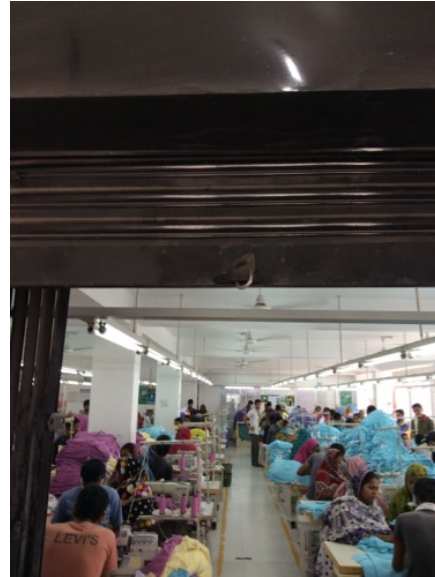
| F-6 | Egress | Egress doors / gates with locking features are provided at building exits and exit stairs.<br><br>All gates/doors were open and unlocked during the inspection. | Remove locking features from all egress doors / gates.<br><br>If locks are required for security reasons, utilize special door locking features complying with NFPA 101. | Immediate |

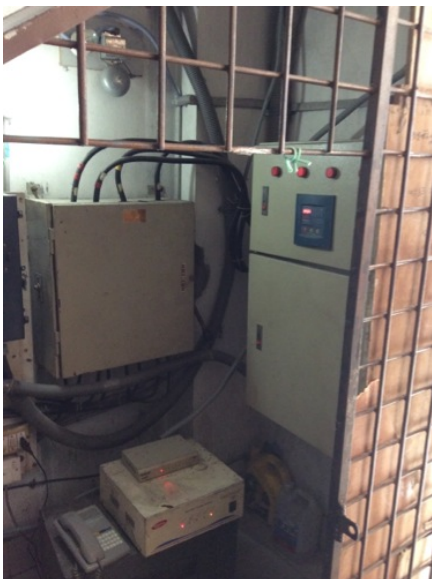
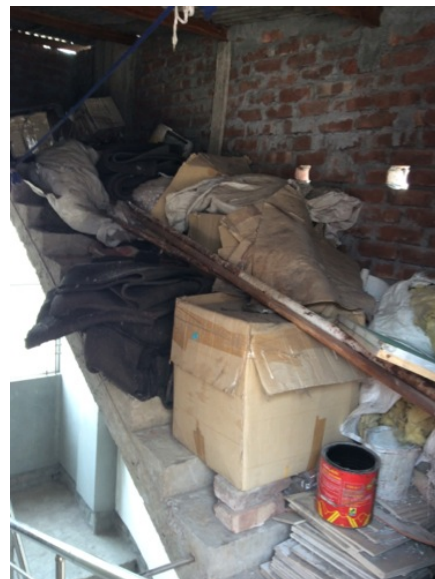
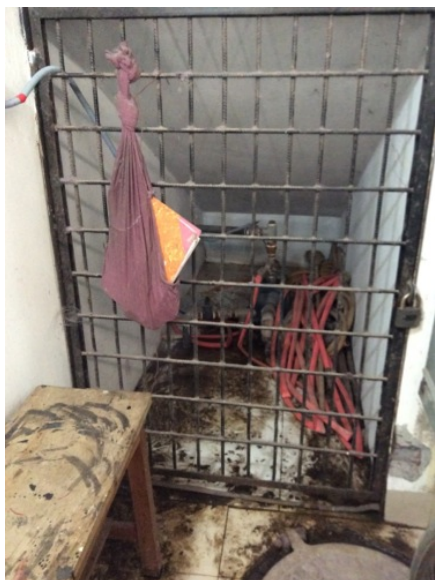
| F-7 | Egress | Storage was located in the exit stairs. | Remove all storage from exit stairs and egress paths. | Immediate |

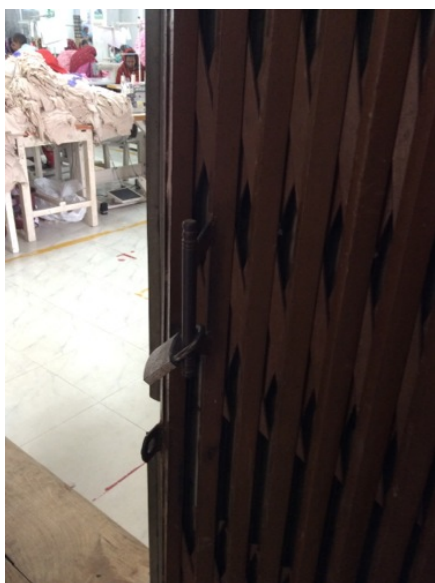
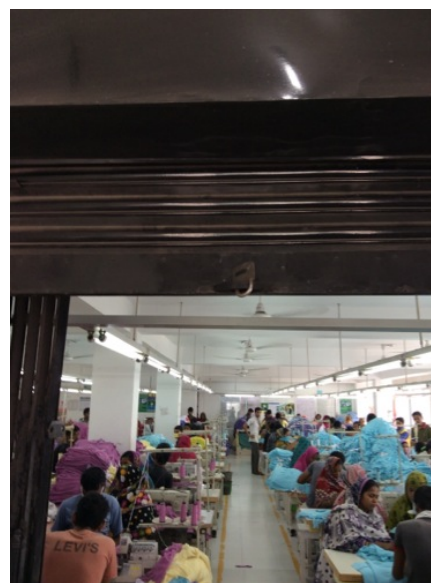
F-8 Egress

Collapsible gates / sliding doors are provided at building exits and exit stairs.

Replace all gates / sliding doors along the means of egress with side-hinged, swinging egress doors.

If locks are required for security reasons, utilize special door locking features complying with NFPA 101.

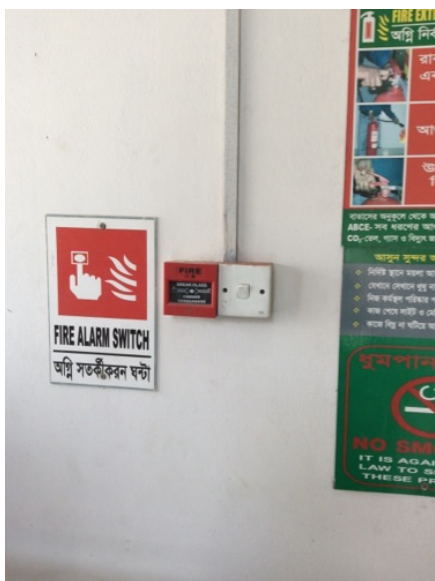
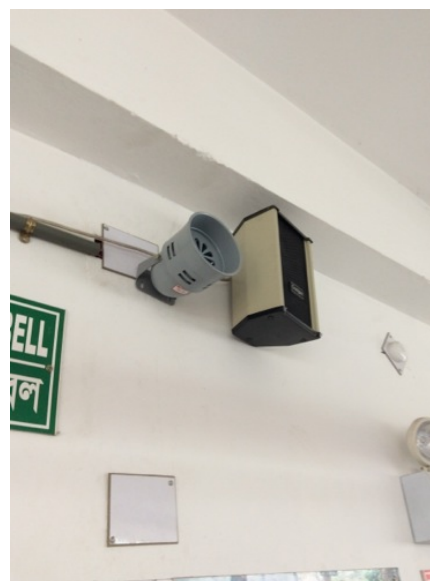
| F-9 | Fire Protection | The fire alarm system is antiquated, not a listed system, and does not provide alarm and notification features consistent with acceptable standards. | Replace the fire alarm system with a new, listed addressable fire alarm system in accordance with NFPA 72. | Design within 4 months, install within 9 months |

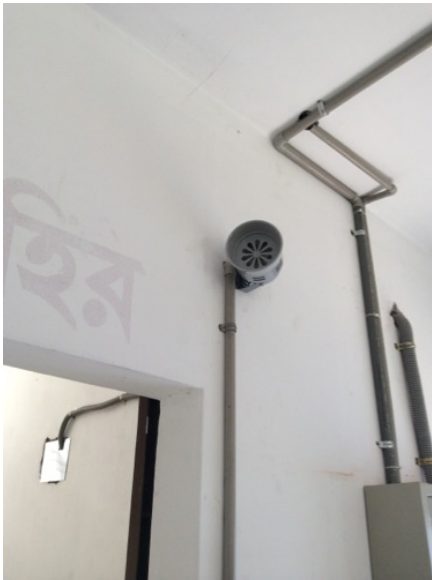
| F-10 | Fire Protection | Activation of the fire alarm system by a manual fire alarm station provides automatic occupant notification only on the floor of alarm and not throughout the building. | Configure the fire alarm system to initiate automatic occupant notification on all floor levels to facilitate whole-building evacuation upon any manual fire alarm station activation. | Within 1 months |

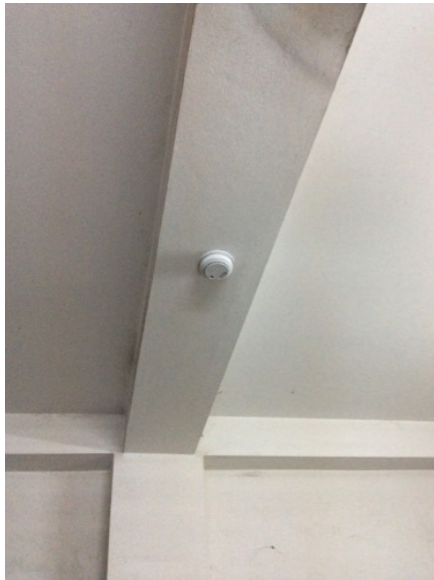
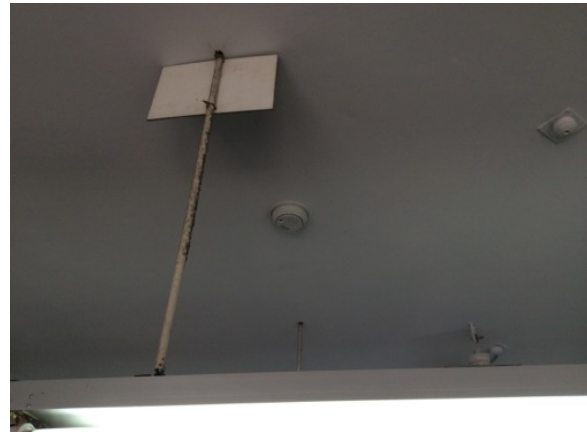
| F-12 | Fire Protection | The building is equipped with single-station smoke alarms. Smoke alarm activation sounds only a local alarm and does not provide automatic fire alarm notification of occupants. | Remove the single-station smoke alarms. Provided automatic smoke detectors throughout the building in accordance with NFPA 72. | Within 6 months |

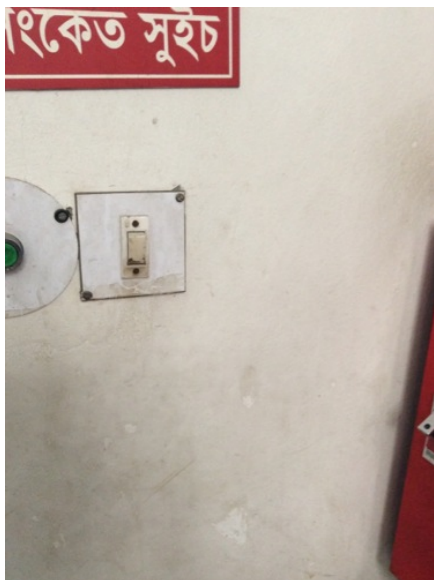
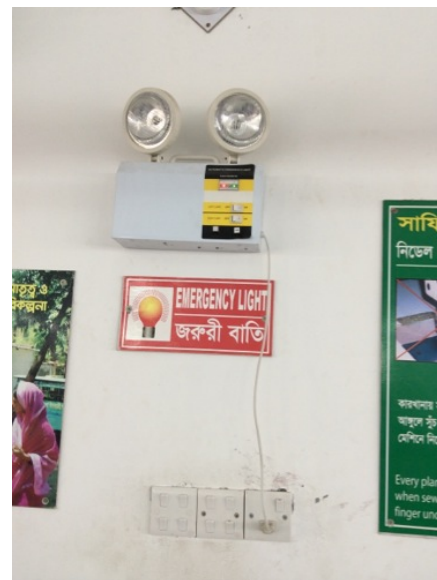
| F-13 | Egress Lighting | Manual on-off switches in several locations are provided for emergency lighting / exit signage units. | Remove manual on/off switches from emergency lighting / exit signage units to prevent them from being switched off. | Within 1 month |

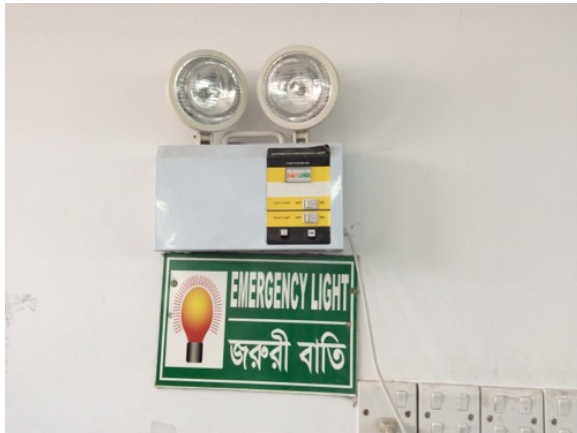
| F-14 | Egress Lighting | Emergency lighting in the 1st floor did not function in test mode (burned out, broken, etc.). | Regularly test the emergency lighting system on each floor and replace/repair lights as needed. | Within 3 months |
