Sabah Designers Ltd.

South Panishail, Kashimpur, Gazipur, Dhaka, Bangladesh.
(23.987508N, 90.307459E)

17th February 2015

Observations

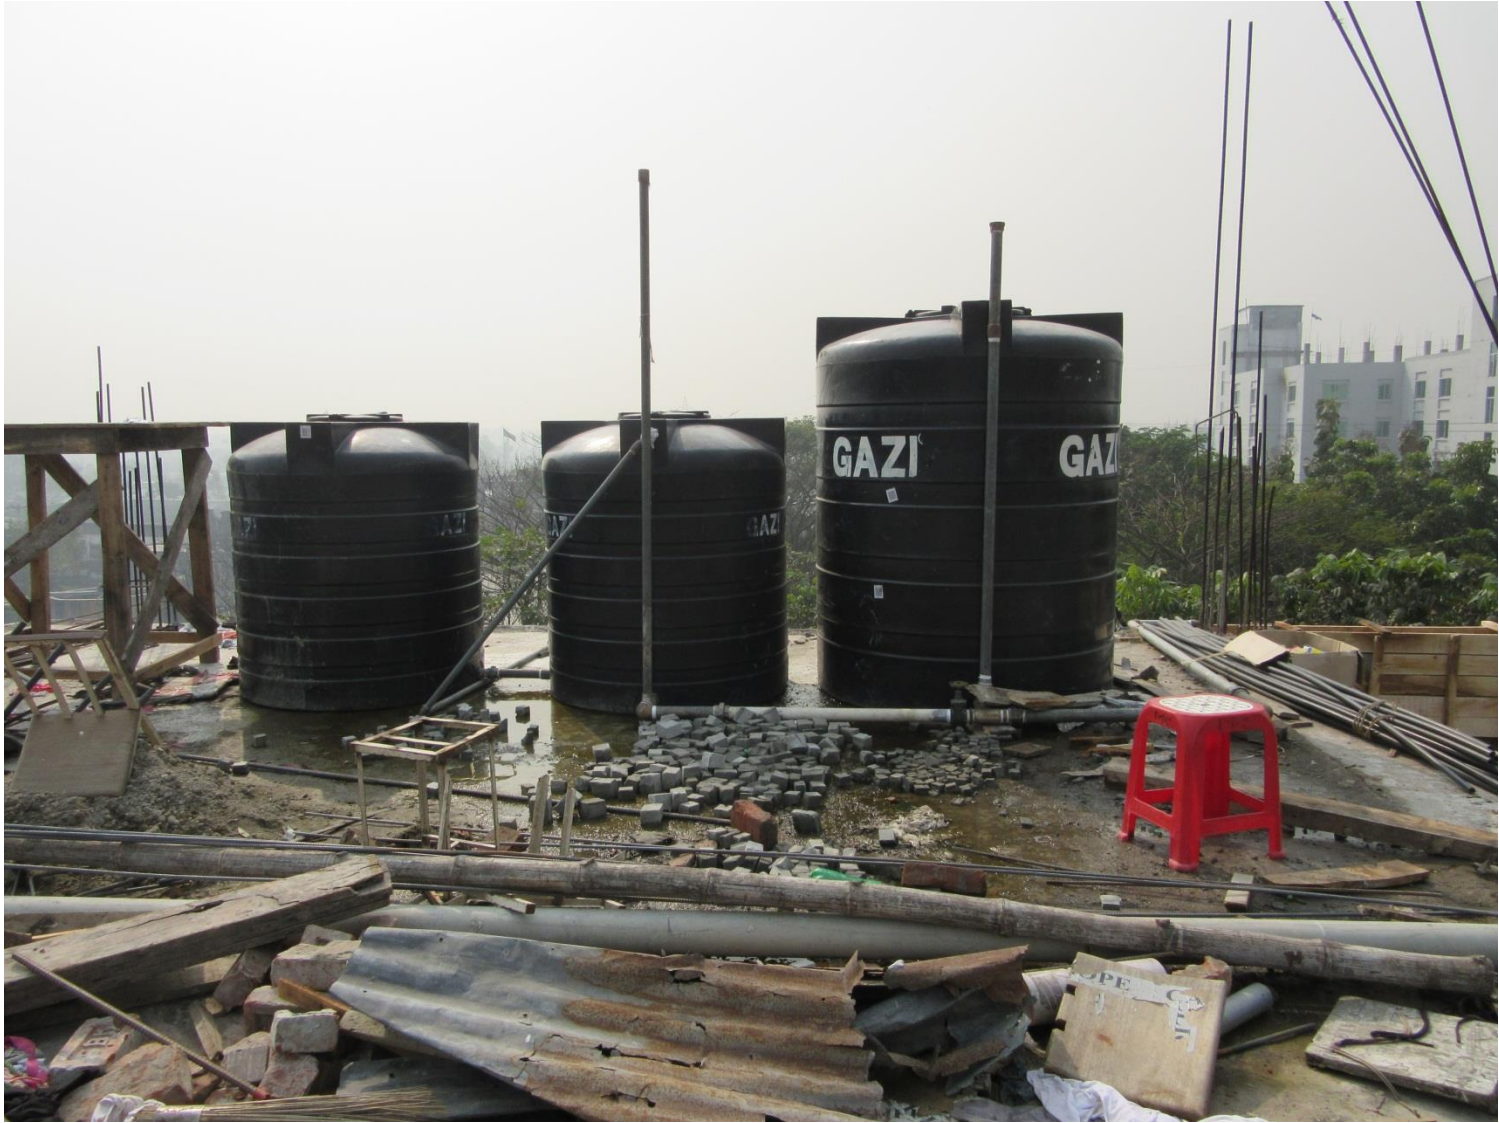
Temporary water tanks on existing roof (new 3rd floor)

3 temporary storage tanks on the roof (2 x 1500 litres and 1 x 2000 litres)

ITEM 1: Temporary water tanks on existing roof (new 3rd floor)

Item No.	Observation	Recommended Action Plan	Recommended Timeline
1	Temporary water tanks on Existing Roof (new 3rd floor)	Factory Engineer to verify design of supporting beams/slab and columns under temporary water tanks.	6-weeks
2	Excess loading on suspended floors	Factory Engineer to remove excess loading on suspended floors. Factory Engineer to develop loading plan for floors to avoid such overloading in future.	6-weeks
3	Excess loading on suspended floors	Continue to implement loading plan	6-months
4	Beam and slab cracking	Factory Engineer to investigate cracking on underside of 1st and 2nd floor slabs, and carry out any necessary structural remedial works, if required.	6-weeks
5	Beam and slab cracking	Factory Engineer to continuously monitor cracking visible on underside of slab, and sides and bottom of beams.	6-months
6	Cracked concrete lintel over ground floor opening	Factory Engineer to check design of cracked concrete lintel over door opening, and repair/replace as necessary	6-months

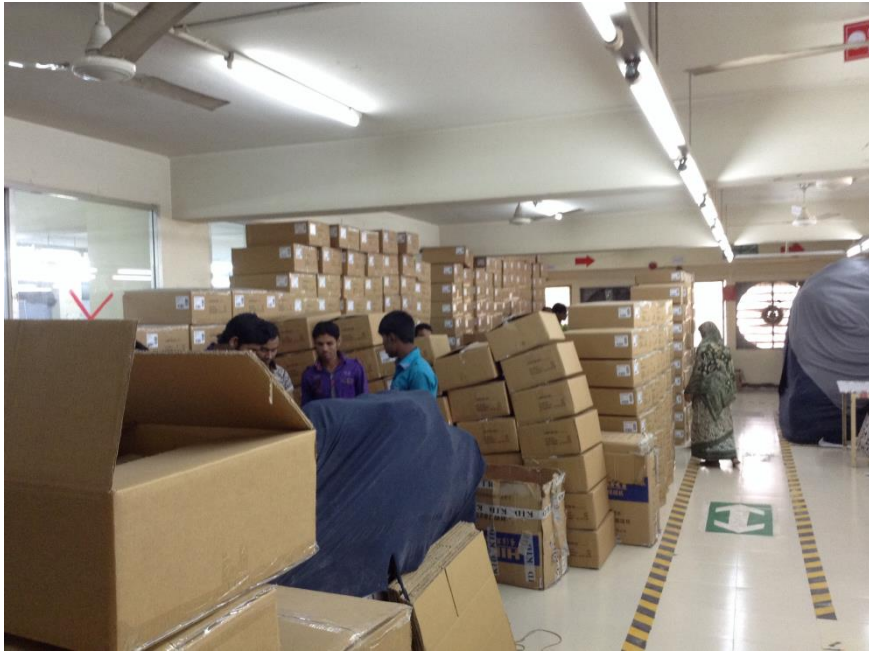
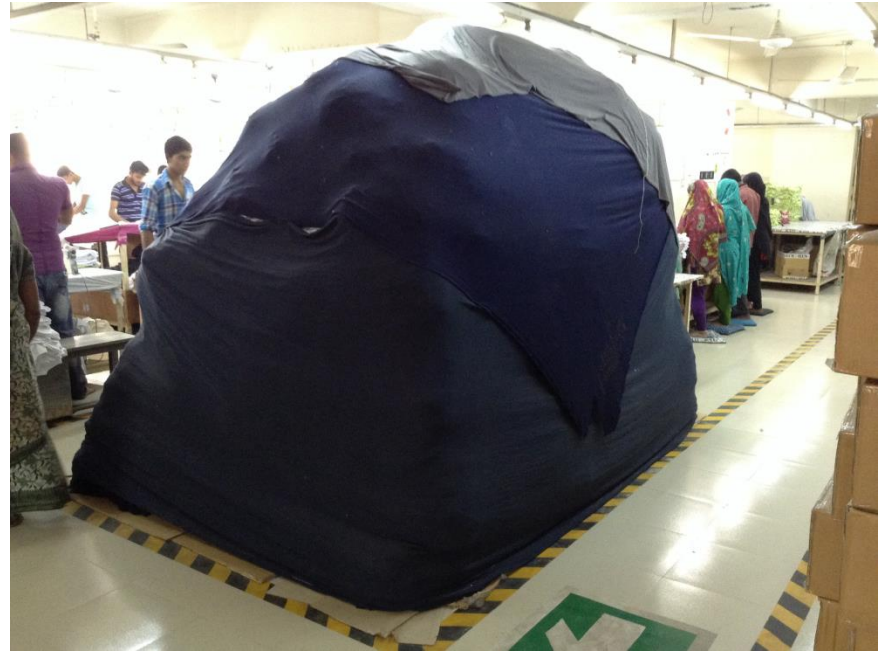
Overloading on 1st floor

Heavy loads, approximately 5kPa to 8kPa observed on 1st floor

ITEM 2: Excess loading on suspended floors

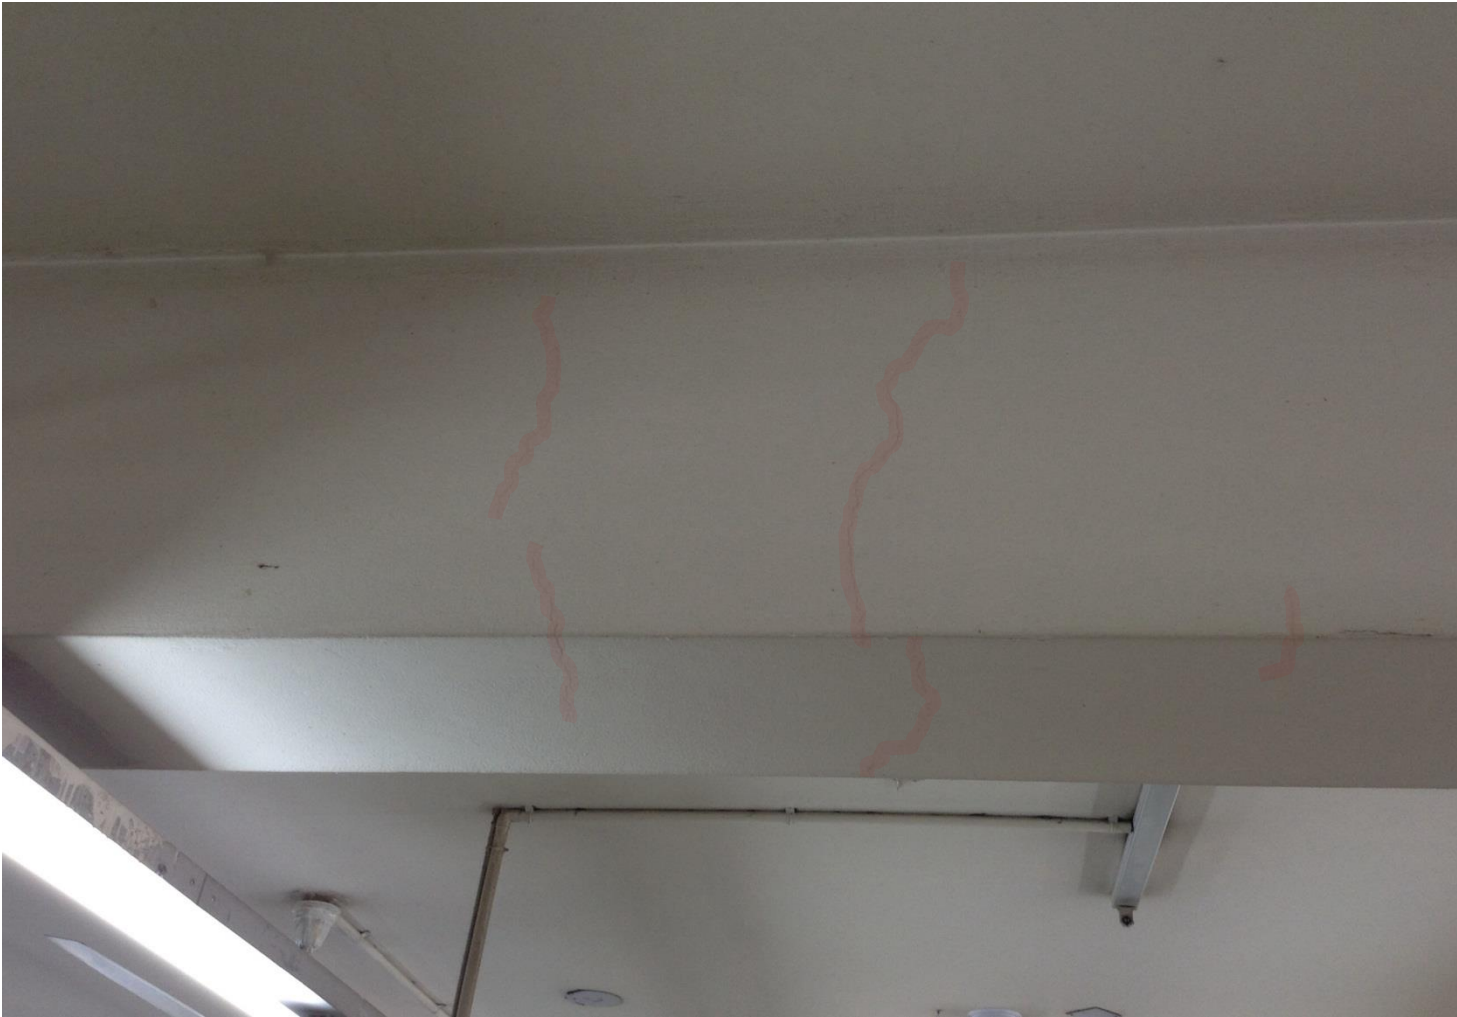
Beam and Slab Cracking

Minor cracks observed in 1st and 2nd floor beams

ITEM 3: Beam and slab cracking

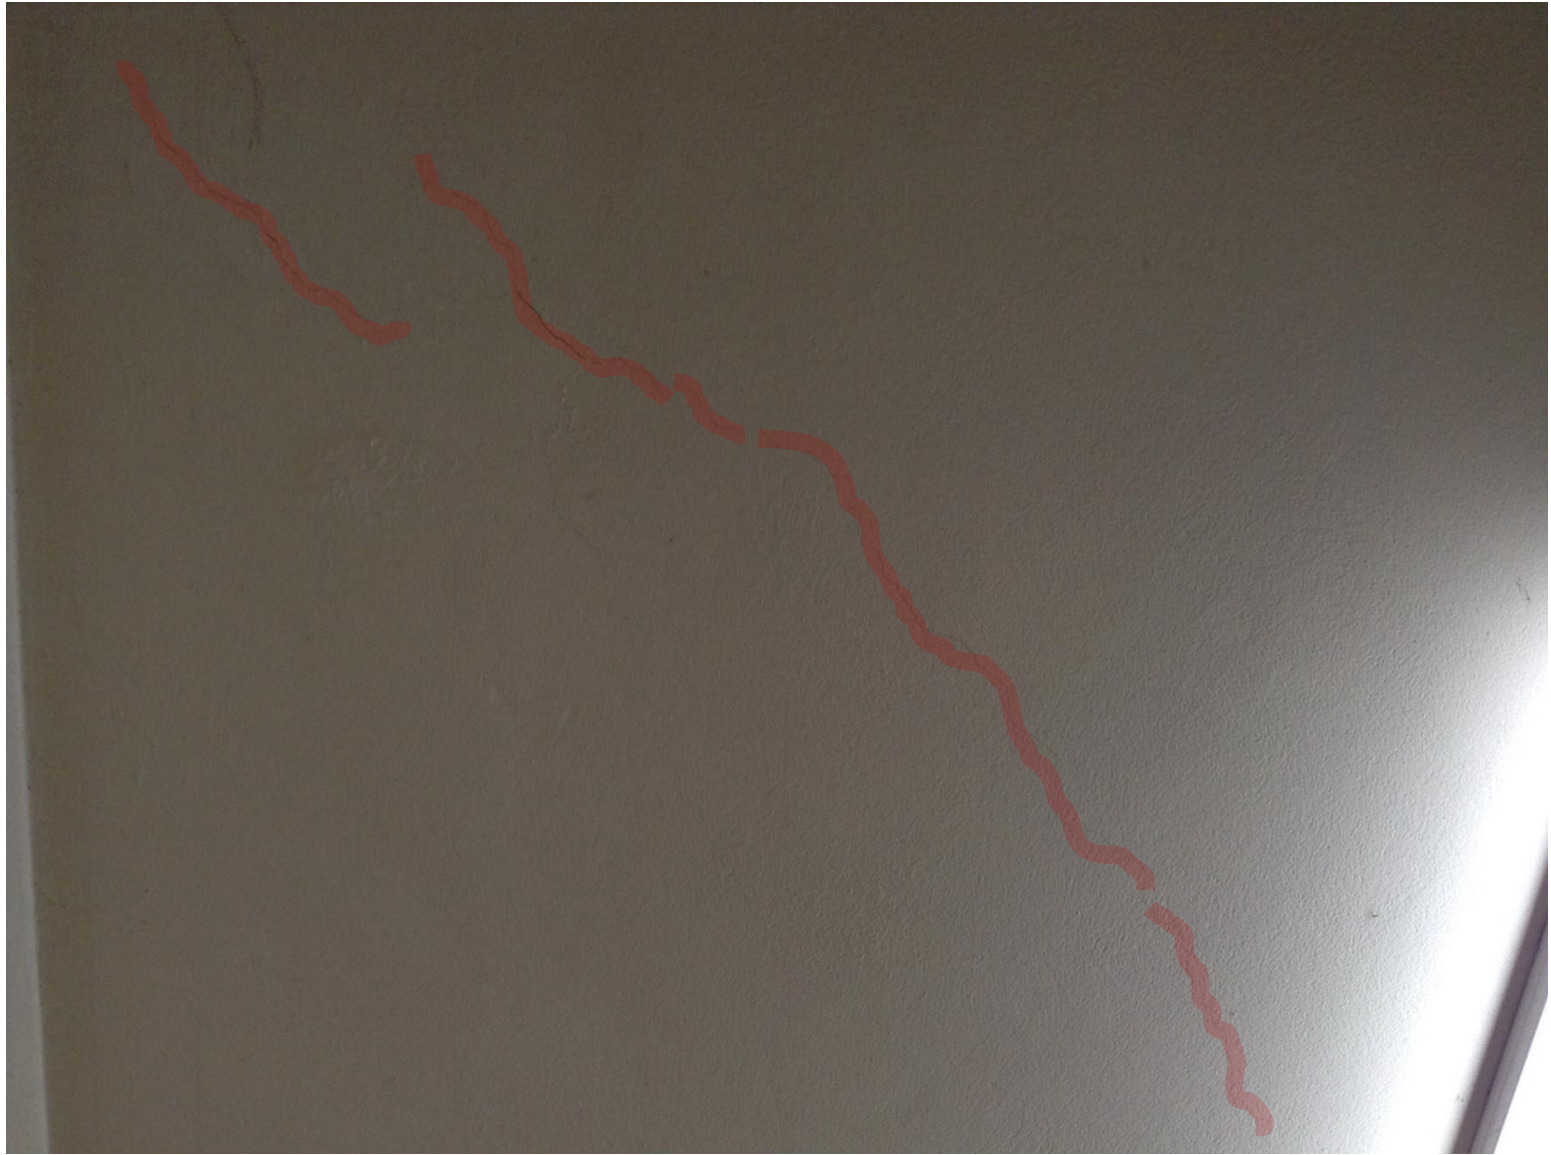
Minor cracks observed in 2nd floor slab

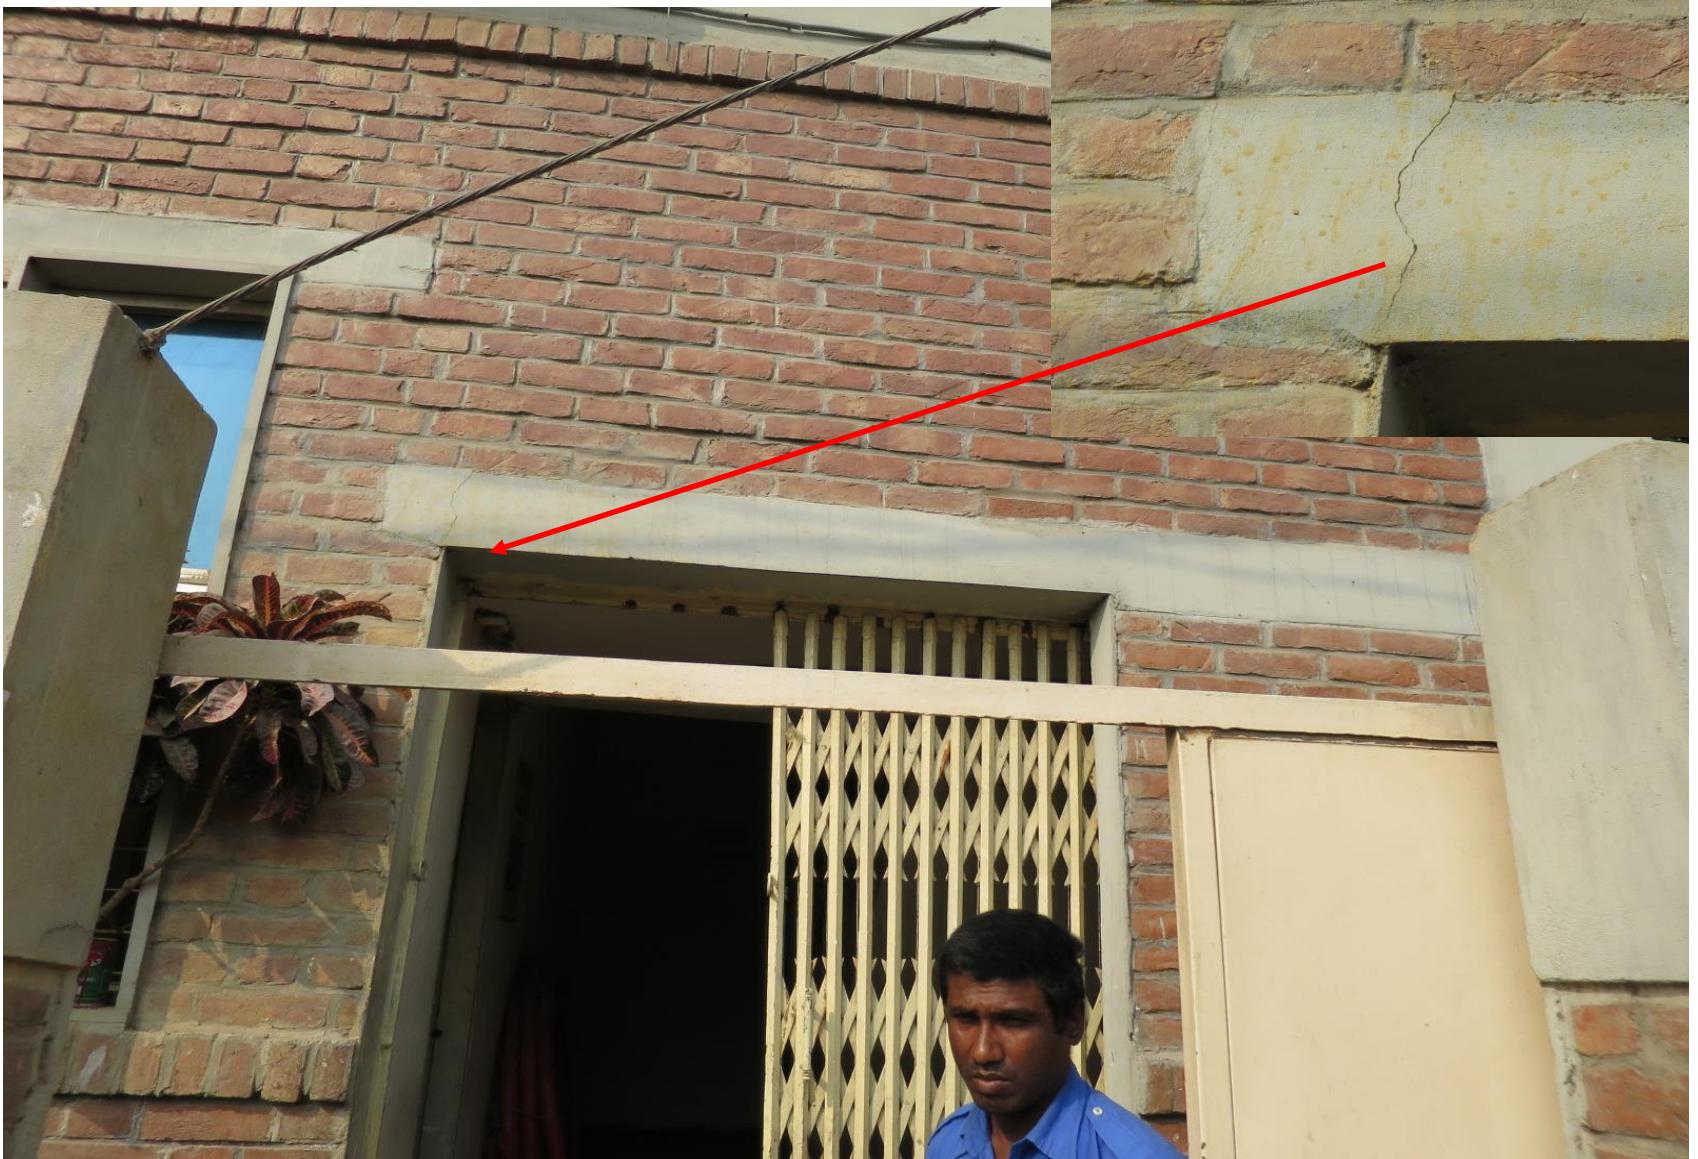
Cracking in lintel over opening at Ground Floor

Cracking in the lintel over the door observed

ITEM 4: Cracked concrete lintel over ground floor opening
