# INITIAL STRUCTURAL INTEGRITY ASSESSMENT REPORT (SIAR)

Factory Name: **Azmat Apparels Ltd. (New Location)**  
Address: **62, Kathgara, Zirabo Ashulia, Savar Ashulia, Savar  
Dhaka Bangladesh**  
Assessor: **Shaheedullah**  
Date: **22 Jul 2018**

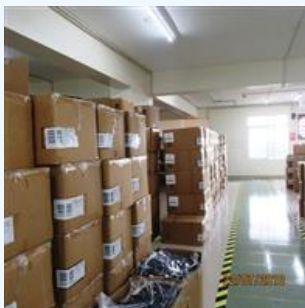
| Description: | Overloading in excess of 42 psf has been noticed in certain storage areas at ground floor over basement. | |
| Source of Findings: | Photograph: excess load, Visual Assessment: Visual inspection. | |

| Suggested Plan of Action: | Loading shall be kept within the limit of 42 psf. | |

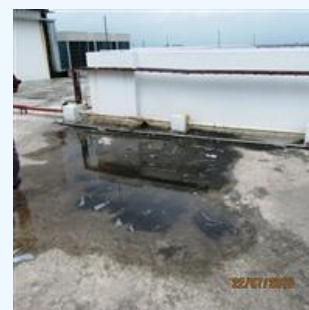
| Description: | Standing water at certain locations has been noticed on roof of 8 storied RC production building. |
| Source of Findings: | Photograph: Standing water on roof, Visual Assessment: Visual inspection. |

| Suggested Plan of Action: | Under guidance from a qualified structural Engineer address all areas of needed maintenance by correcting the identified issue. |

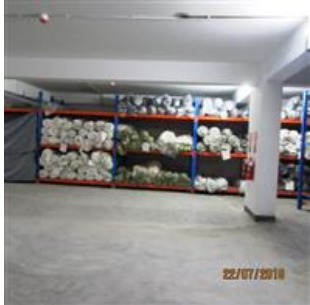
| Question: | Are areas used for storage of work materials and work products, clearly marked to indicate the acceptable loading limits as described in the Load Plan for that floor? | |
| Description: | Load marking has not been found. | |
