Union Sportswear Ltd.

10th March 2015

Observations

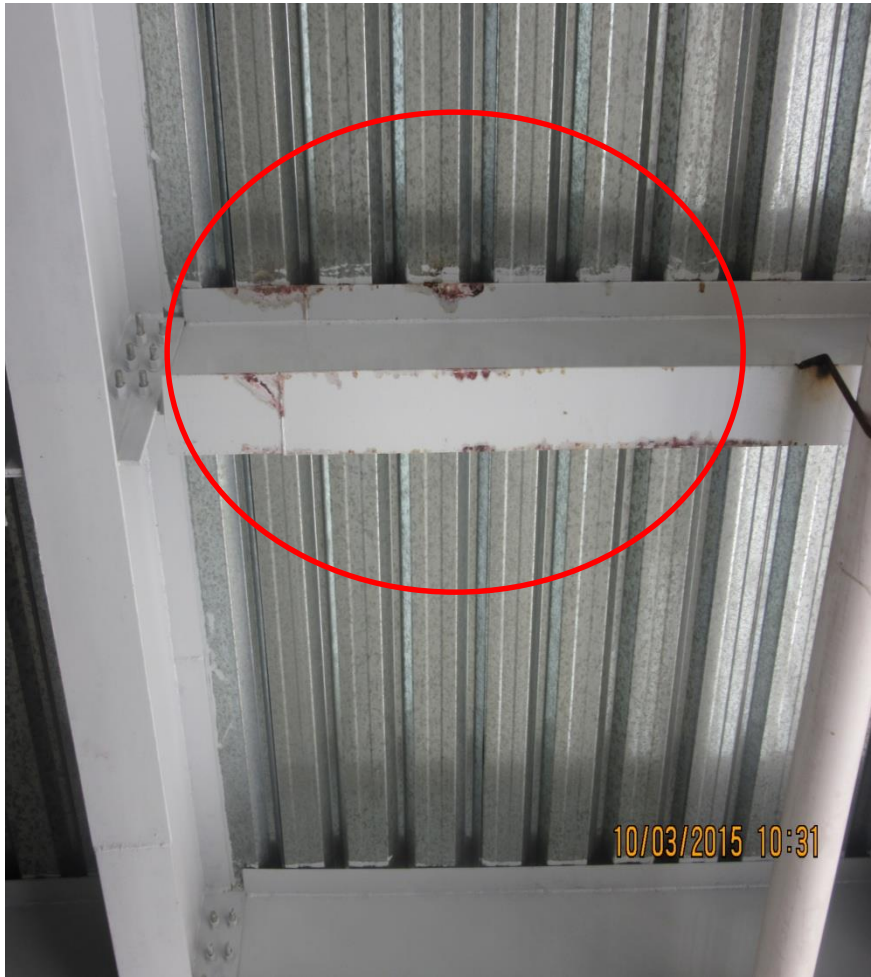
Main Building – Steel corrosion due to water penetration

Corrosion of the steelwork commencing under the concrete roof section of Main Building

Item No.	Observation	Recommended Action Plan	Recommended Timeline
1	Main Building – Steel corrosion due to water penetration	Building Engineer to investigate water penetration through the concrete roof area and from the 1st floor toilet area.	6-weeks
2	Main Building – Steel corrosion due to water penetration	Carry out remedial structural works to prevent water penetration.	6-months
3	Main Building – Steel corrosion due to water penetration	Carry out remedial structural works to paintwork of structural steel (including pre-painting surface preparation) ensuring that all necessary coats are reinstated (e.g. primer, fire protection, finish coats as appropriate).	6-months
4	Ancillary Buildings – Apparently non-engineered steel roof structures	Building Engineer to review the structural design of steel roof structures for their capacity to withstand statutory vertical and horizontal design loads.	6-weeks

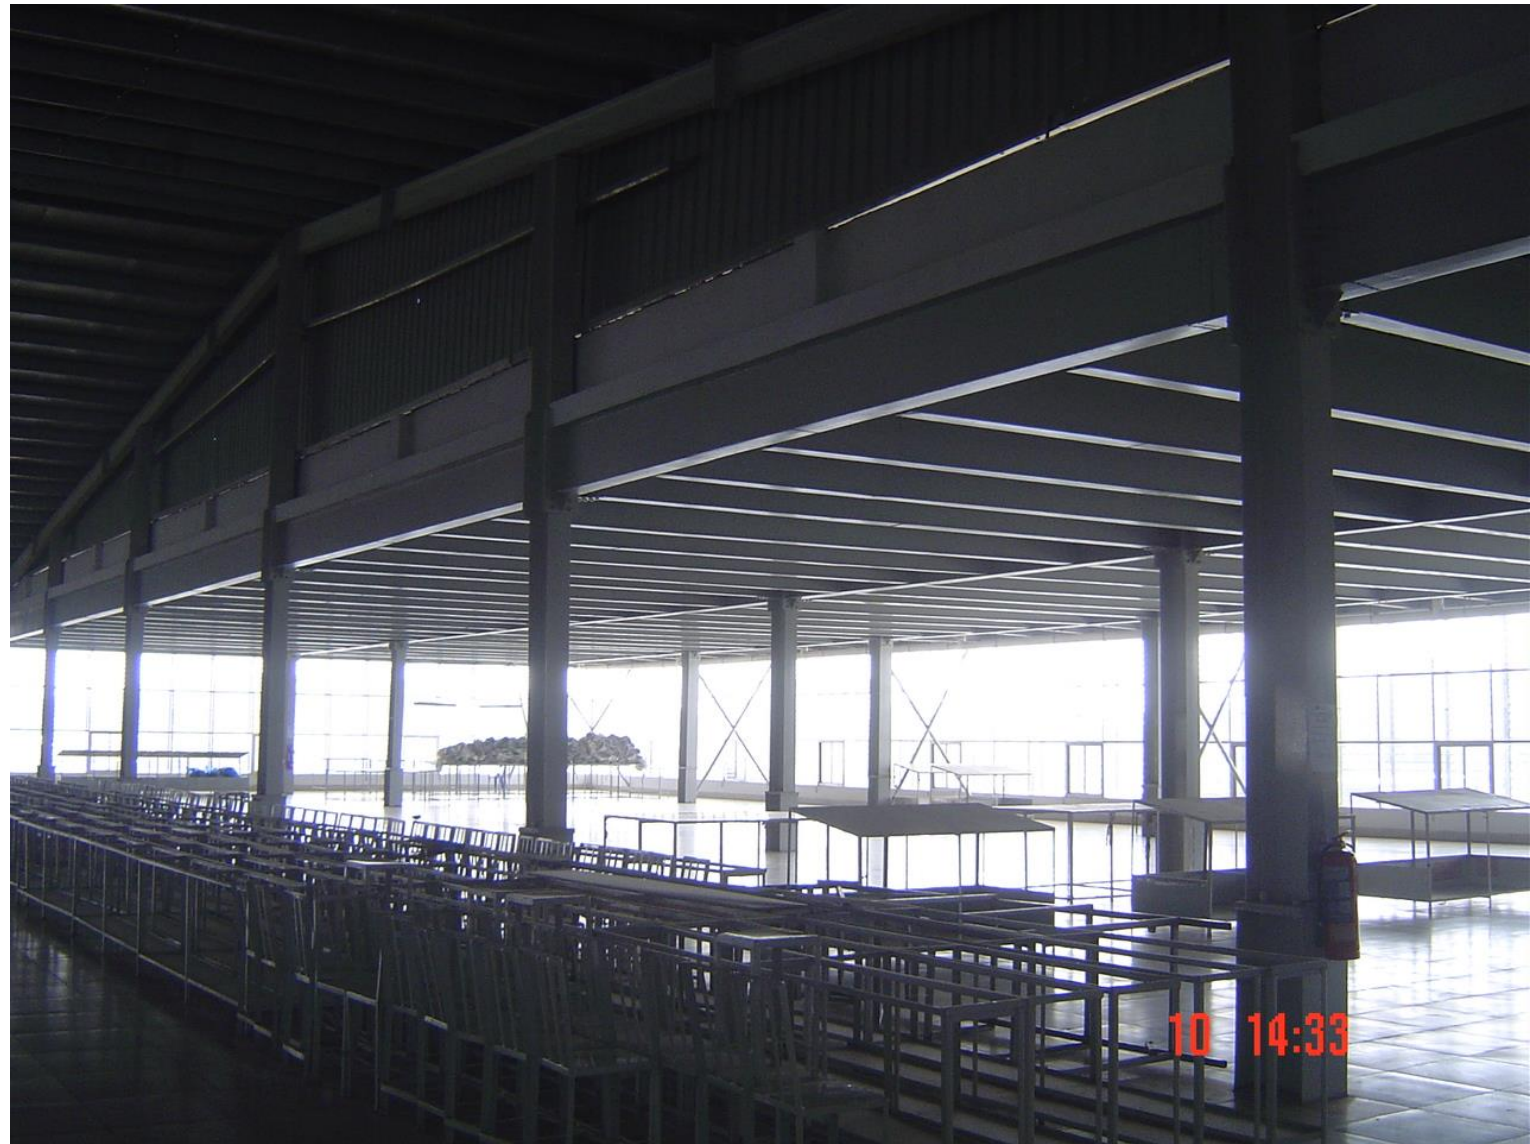
(Non-structural issue):
Main building - No evidence of fire-proofing to structural steel

**Observations – Main Building – No evidence
of fire protection to structural steel**

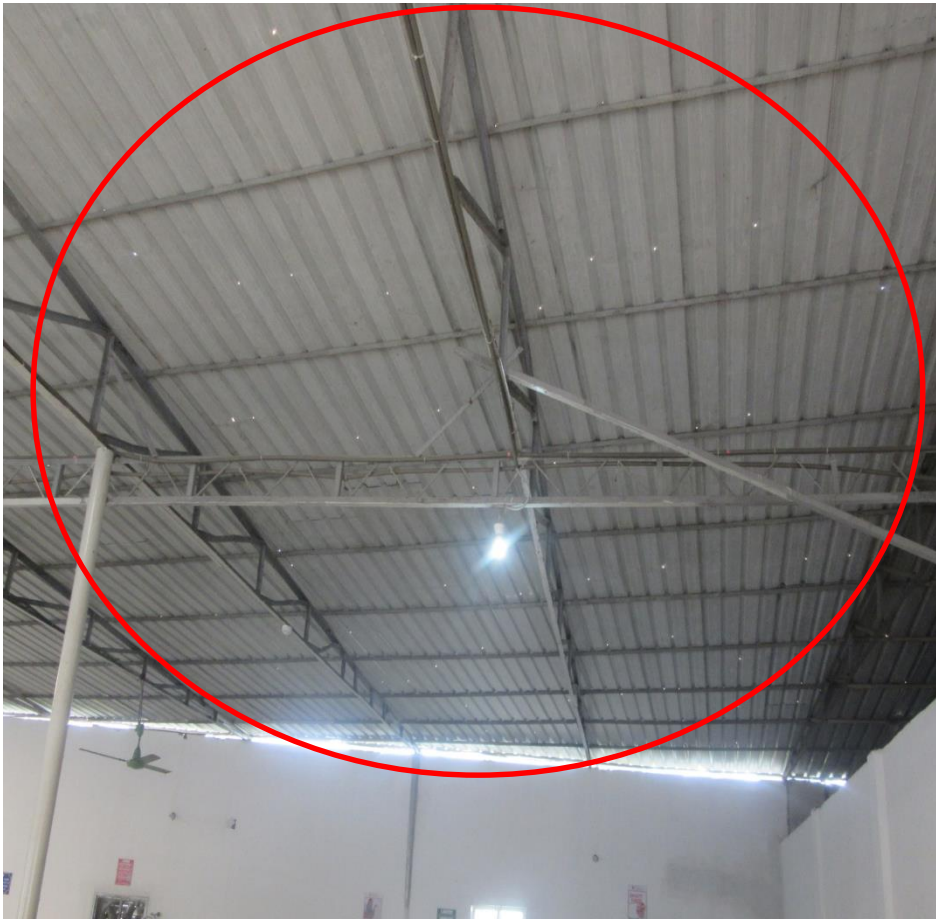
Ancillary Buildings - Apparently non-engineered steel roof structures

No roof bracing in Dining Shed

5	Ancillary Buildings – Apparently non-engineered steel roof structures	Carry out any remedial / strengthening works as required following structural review.	6-months

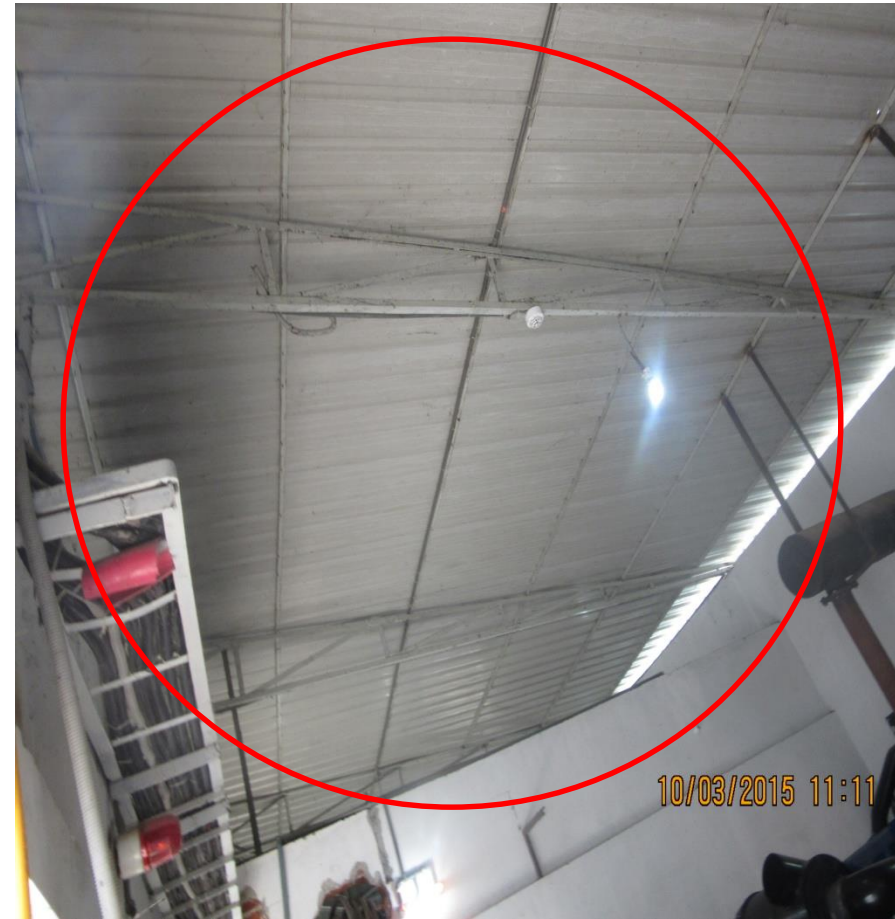
No roof bracing in Generator/Sub-station room
