# Selina Apparels Ltd.

Holan Road, Dakkin Khan, Uttara, Dhaka – 1230  
(23.856753N, 90.431299E)

11 MARCH 2014

# Observations

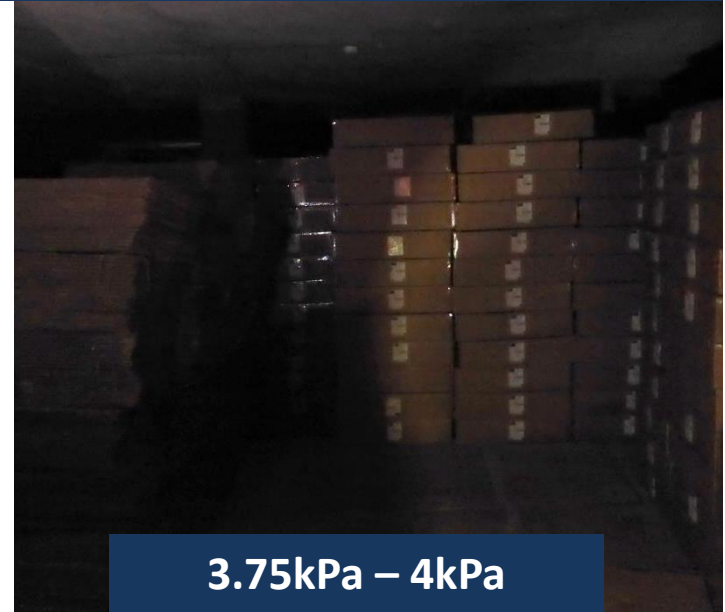
## Ground Floor

**Average Height 2m = 7kPa**

**3.75kPa – 4kPa**

**General high loading throughout ground and basement level (loading on slab between pilecaps).**

**Building engineer to develop loading plans and height restrictions to prevent overloading.**

| Item No. | Observation | Recommended Action Plan | Recommended Timeline |
|---|---|---|---|
| 1 | General areas of high loading throughout Ground and First Floor<br>And localised areas of high loading | The Structural Engineer should check the capacity of the flat slab floors and columns against the design loading, particularly punching shear at columns, and column working stresses. | 6-weeks |
| 2 | General areas of high loading throughout Ground and First Floor<br>And localised areas of high loading | Produce and actively manage a loading plan for all floor plates within the factory giving consideration to floor capacity and column capacity. | 6-weeks |
| 3 | General areas of high loading throughout Ground and First Floor<br>And localised areas of high loading | Continue to implement load plan. | 6-months |

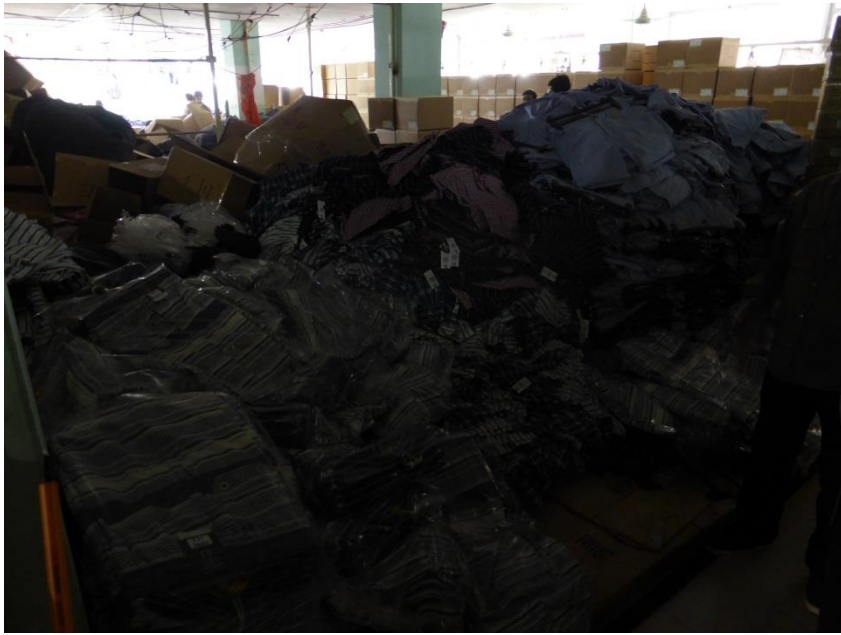
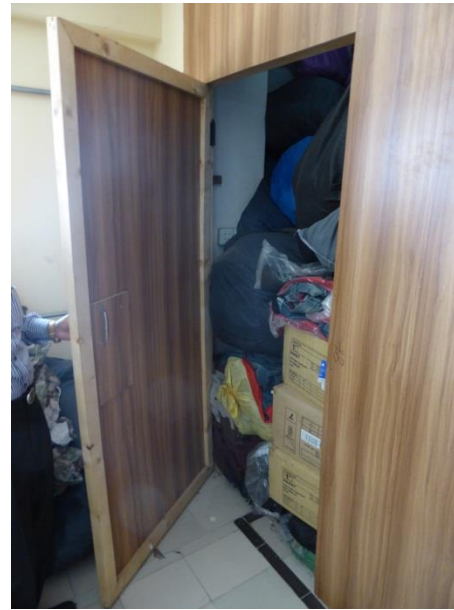
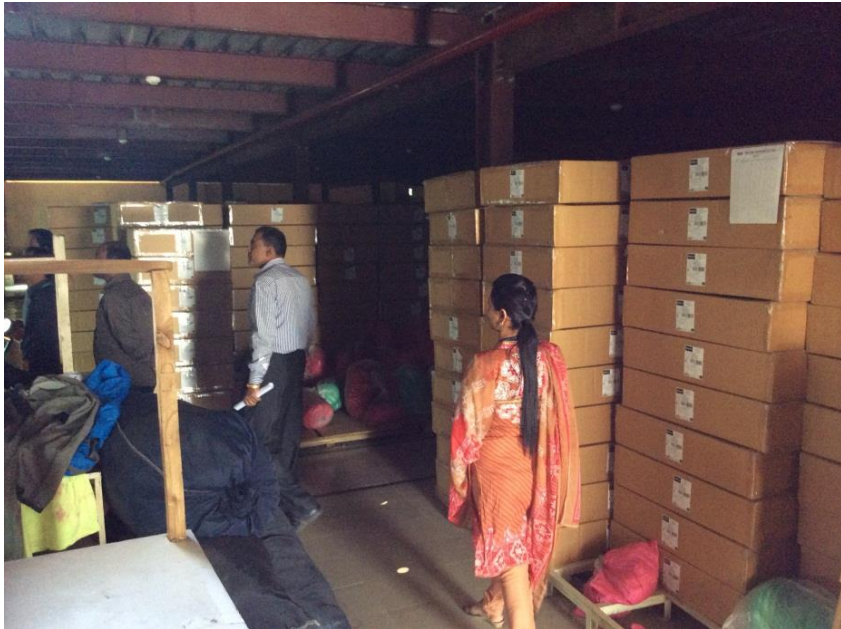
# Localised Areas of High Loading

**Localised areas of high loading at a number of locations building.**

**Building engineer to develop loading plans and height restrictions to prevent overloading.**

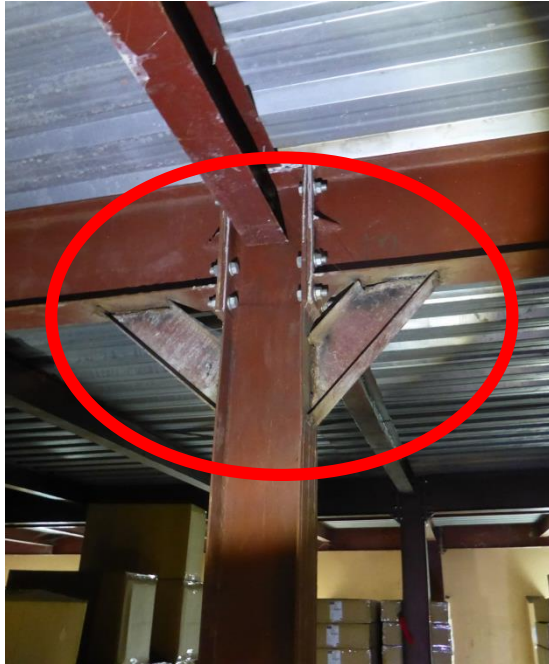
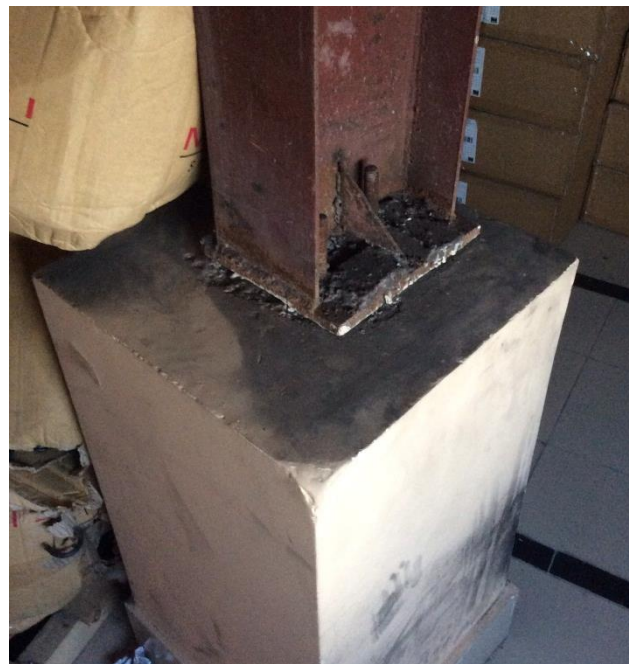
# **Structural Lateral Stability of Level 8 – 9 Steelwork Frame**

**Steelwork construction on 8<sup>th</sup> Floor with support beams bolted to structure column upstands.**

**Building engineer to carry out lateral stability analysis on steelwork construction.**

| Item No. | Observation | Recommended Action Plan | Recommended Timeline |
|---|---|---|---|
| 4 | Check required on lateral stability of steelworks structure on 8th floor | Building engineer to carry out a stability analysis of the 8th and 9th floor and propose additional stability structure if it is necessary. | 6-weeks |

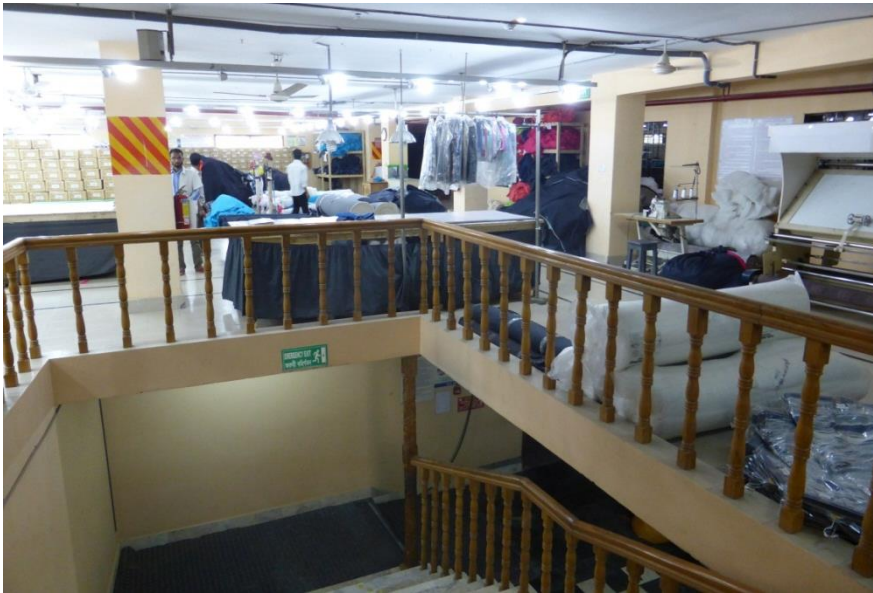
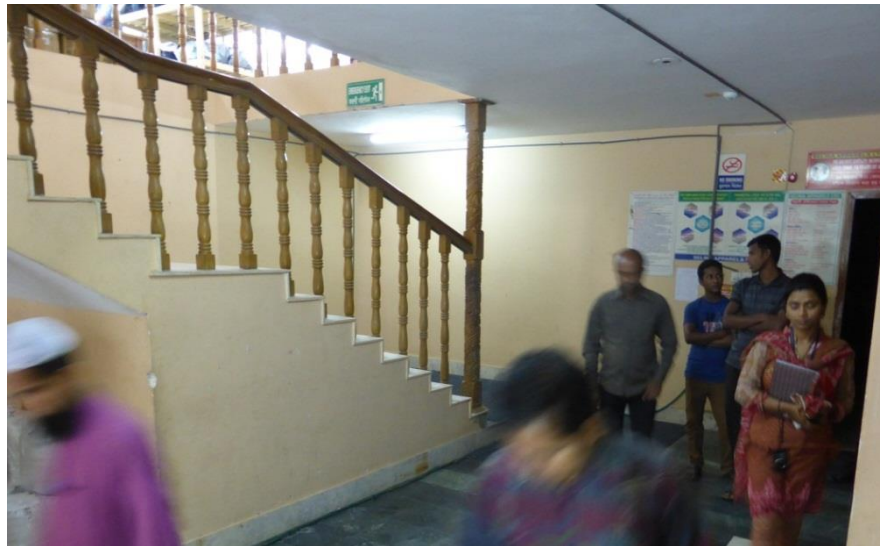
# **Structural Arrangement at Ground – 1<sup>st</sup> Floor Stairs**

**Significant opening and slab cantilevers on first floor at stairs – no additional thickenings or beams observed.**

**Decorative Post at balustrade split, possibly due to slab deflections**

**Structural System unclear.**

| Item No. | Observation | Recommended Action Plan | Recommended Timeline |
|---|---|---|---|
| 5 | Check on structural arrangement of ground – 1st floor stairs | Building engineer to carry out full design check on first floor slab in bays adjoining the stair opening. | 6-weeks |
| 6 | Check on structural arrangement of ground – 1st floor stairs | Carry out strengthening if required. | 6-months |

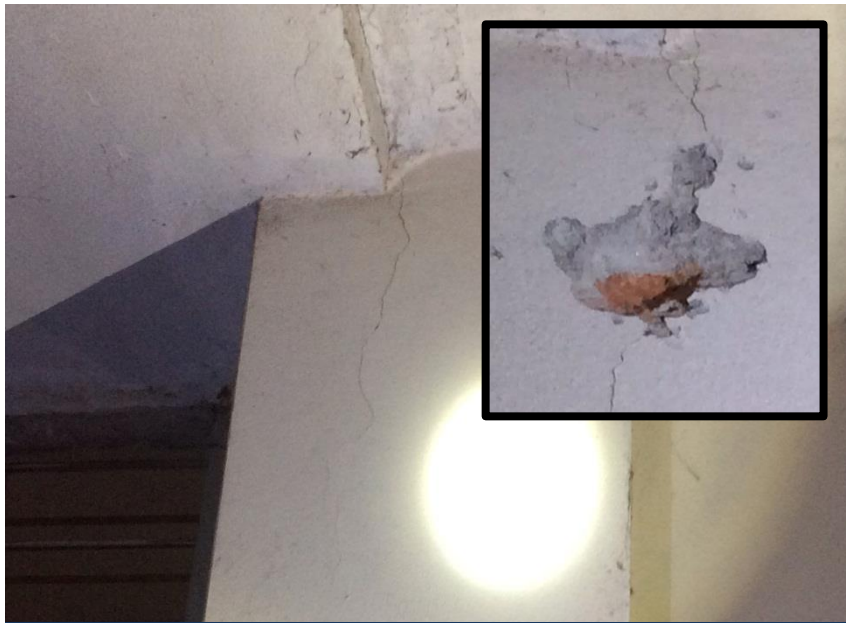
**Brick Column at Ground Floor**

**Cracking to brick column finished tight to soffit of structural cantilever.**

| Item No. | Observation | Recommended Action Plan | Recommended Timeline |
|---|---|---|---|
| 7 | Assessment of localised cracks in structure | Sections of plaster finish to wall to be removed and extent of crack to be reviewed by Building Engineer. | 6-weeks |
| 8 | Assessment of localised cracks in structure | For cracks to the building structure, Building Engineer to carry out design check on beams to confirm that these cracks are not of a serious structural nature | 6-weeks |
| 9 | Assessment of localised cracks in structure | Carry out repairs as required. | 6-months |

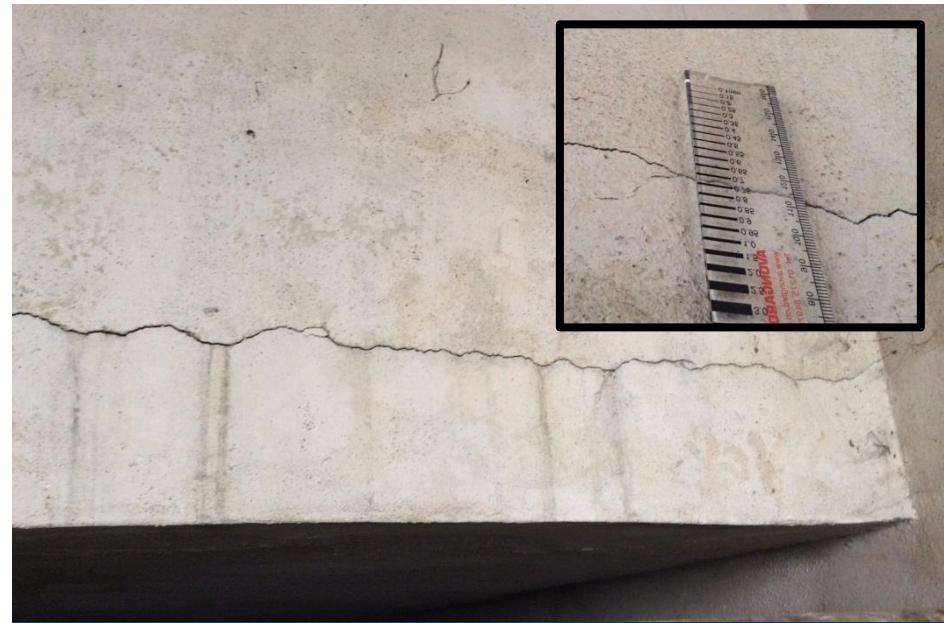
**Water Tank Structure**

**Cracking to water tank structure; No evidence of water leakage.**

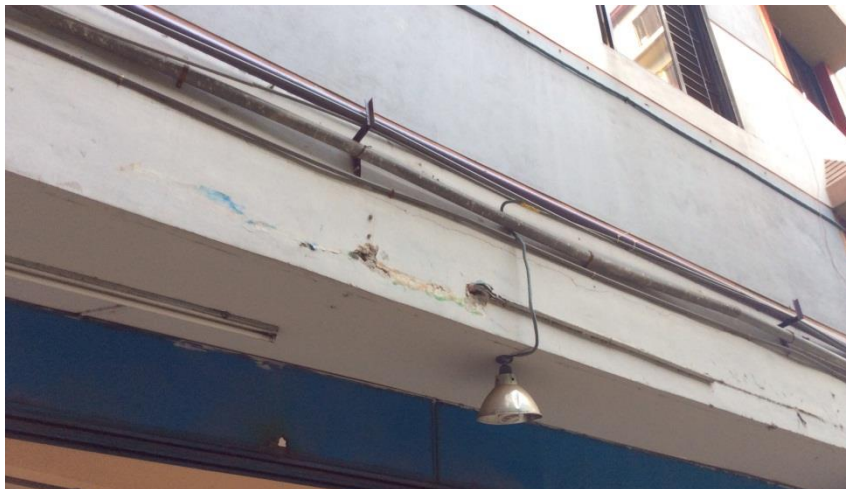
**Brickwork Façade**

**Cracking to brickwork façade on North Elevation.**

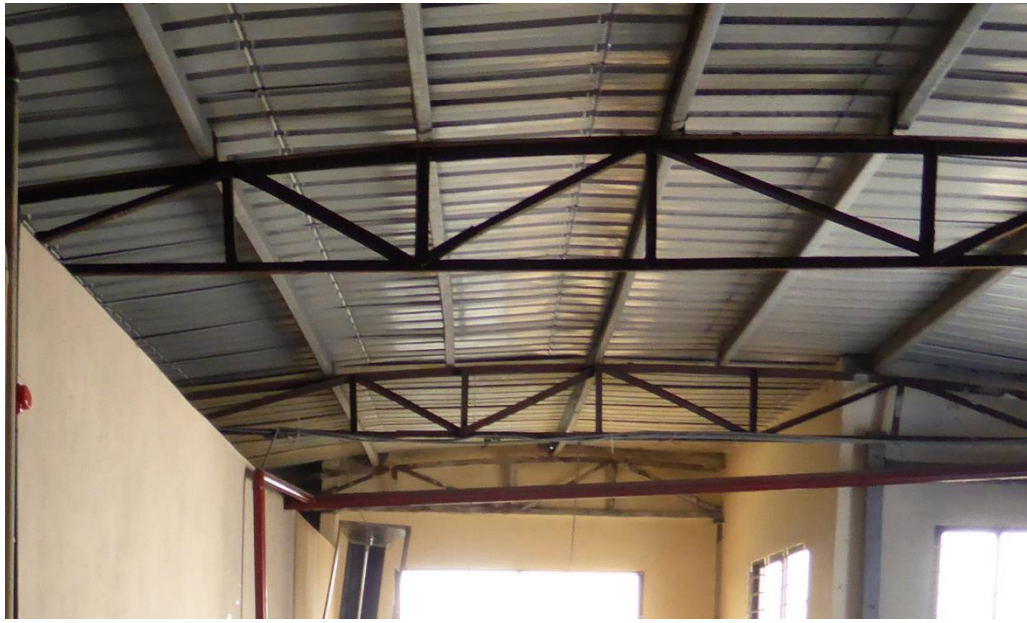
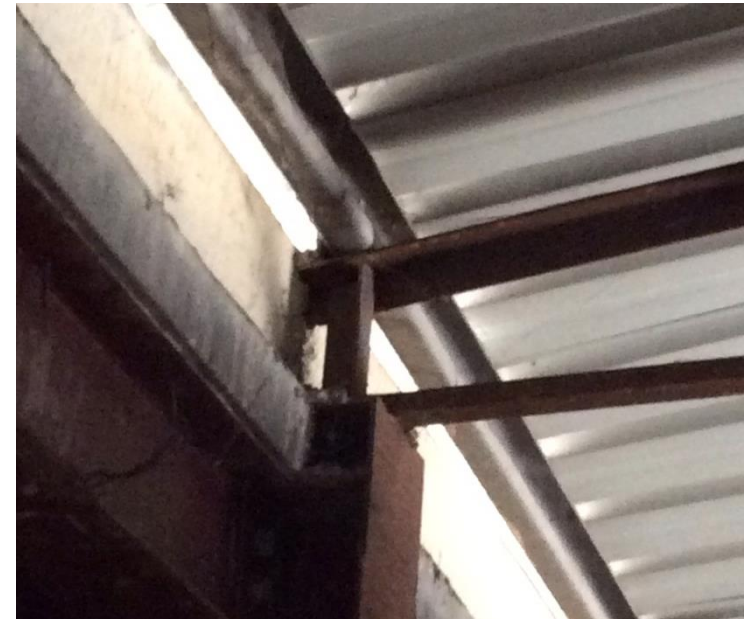
# Lightweight Steel Structure on Roof

**Lightweight roof structure with open façade elements.**  
**Adequacy of lightweight steel structure for uplift/lateral loading to be checked by Building Engineer.**

**Adequacy of roof tie-downs to be checked.**

| Item No. | Observation | Recommended Action Plan | Recommended Timeline |
|---|---|---|---|
| 11 | Undocumented lightweight steel roof additions and adequacy for wind loads | Additional structures to be design checked to ensure adequacy for code vertical and wind loads by the building Engineer. | 6-weeks |
| 12 | Undocumented lightweight steel roof additions and adequacy for wind loads | Undertake strengthening if required | 6-months |
| 13 | Undocumented lightweight steel roof additions and adequacy for wind loads | Building engineer to produce appropriate documentation and as built drawings. | 6-months |
