FIRE SAFETY INSPECTION REPORT

Sams Attire Ltd. (Extension)

ACCORD ID: 23740

Bhuiya Tower, Plot #10, Jamgora, Ashulia Road, Savar, Dhaka, Bangladesh

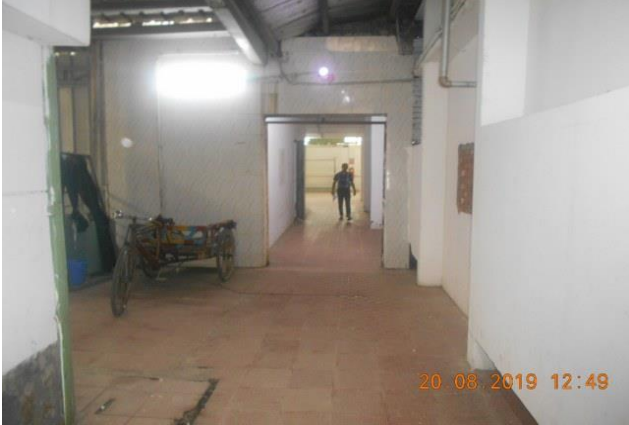
SI No.	Category	Findings	Required Action	Remediation Time Frame
F-1	Fire Rated Construction	[Building 2] Secondary exit stair discharges the occupants in an unprotected passageway.	1. Modify stair to discharge directly outside. Or 2. Provide 2-hr fire-rated exit passageway leading directly outside (vestibules to separate any storage areas). Or 3. Provide sprinkler protection for discharge floor in accordance with NFPA 13.	Within 3 months

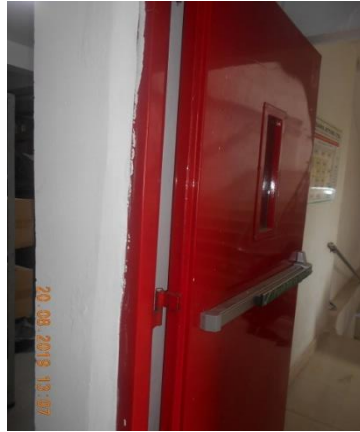
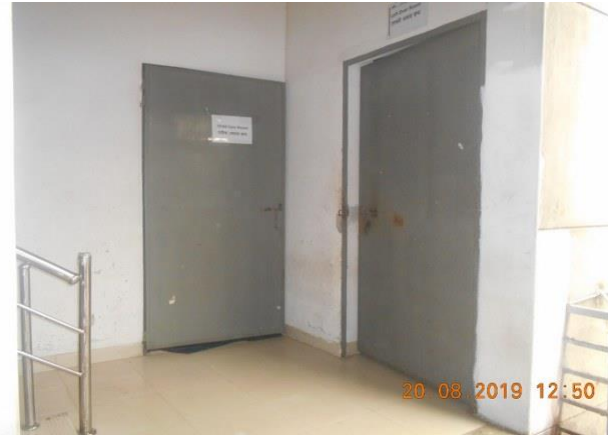
<p>F-2</p>	<p>Fire Rated Construction</p>	<p>[Building 2] The exit stairs are not separated from work areas & other spaces on each floor by fire rated construction.</p>	<p>Provide minimum 1.5-hr fire rated doors and seal all unprotected openings to separate the exit stairs from work areas and other building spaces on all floor levels. Ensure that the fire rated doors are self-closing and positive latching and that they are provided with fire exit (panic) hardware where serving production floors.</p> <p>If fire rated doors are required to be held open for functional reasons, provide automatic closing devices tied to the fire alarm system.</p> <p>Once fire doors are installed, every door in a stair enclosure serving more than 5 stories shall be provided with re-entry unless it meets ACCORD standard 6.8.3.1</p> <p>Each & every component of fire doors shall be put through proper maintenance for proper functioning & sustainability.</p>	<p>Within 3 months</p>

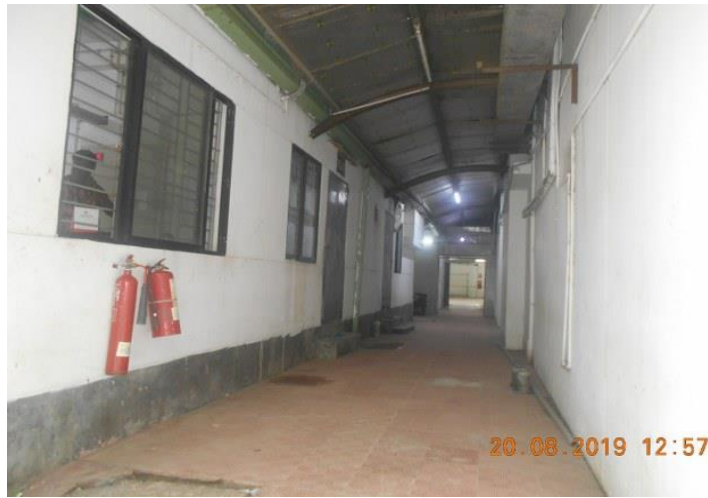
<p>F-3</p>	<p>Fire Rated Construction</p>	<p>[Shed 5] Exit access corridor serving more than 30 occupants is not separated by fire rated construction.</p>	<p>1. Separate the corridor by a minimum 1-hr fire rated construction. Or 2. Provide automatic sprinkler system throughout the storey as per NFPA 13</p>	<p>Within 3 months</p>
-------------------	---------------------------------------	--	--	-------------------------------

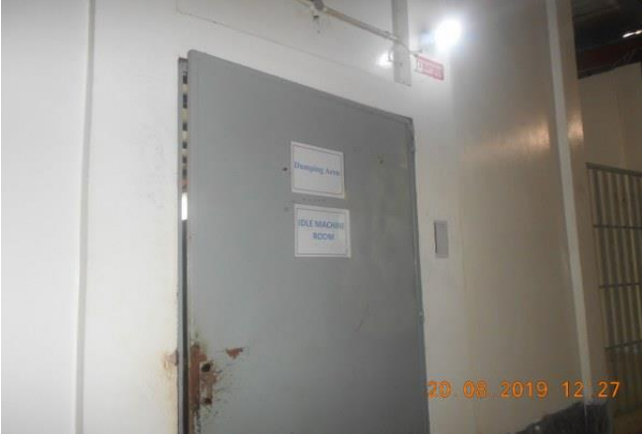
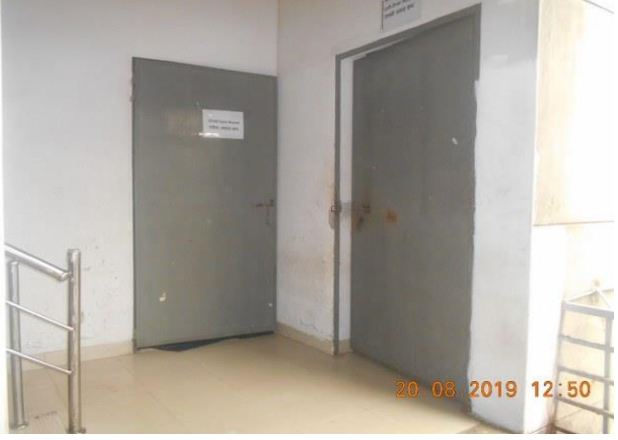
<p>F-4</p>	<p>Fire Rated Construction</p>	<p>Rooms used for combustible goods storage are not separated by proper fire rated construction. Location: Ground floor (Building 2), Dumping Area (Shed 5)</p>	<p>Separate the storage rooms by minimum 1-hr fire rated construction from any other occupancy. The opening protective shall also be minimum 1-hr fire rated.</p>	<p>Within 3 months</p>

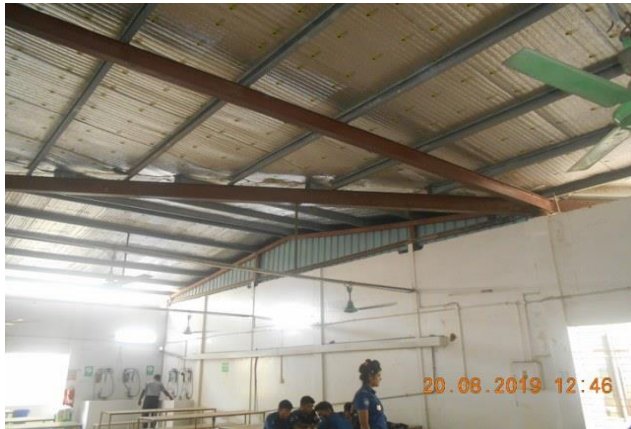
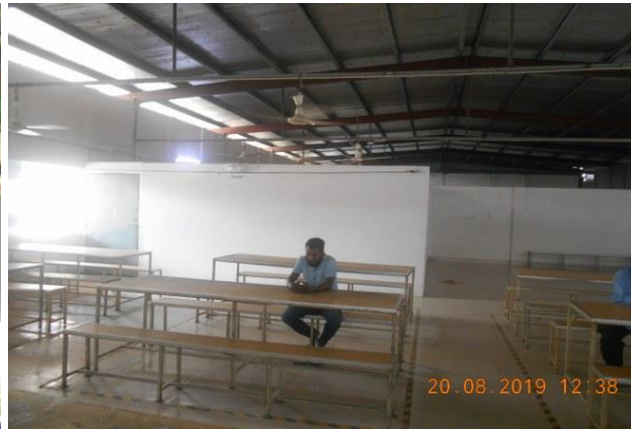
F-5	Fire Rated Construction	[Shed 5] The dining area is not separated by production areas & other occupancies by fire rated construction.	Separate the dining area by minimum 2-hr fire rated construction from other occupancies. Seal and/or protect all openings & penetrations to maintain the fire separation.	Immediate
-----	--------------------------------	---	---	------------------

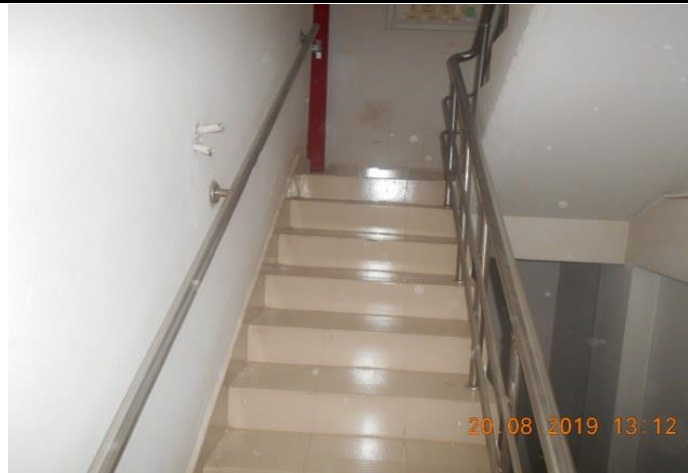
F-6	Egress	[Building 2] Building did not have stair designation signs and occupant load signs at several floors	Provide stair designation signs and occupant load signs at a conspicuous space near entries at each floor level.	Within 1 month
F-7	Egress	[Building 2] Secondary exit stair width (.75 m) is less than the minimum requirement as per Accord Building Standard.	Provide minimum stair width of 0.9 m.	Within 6 months

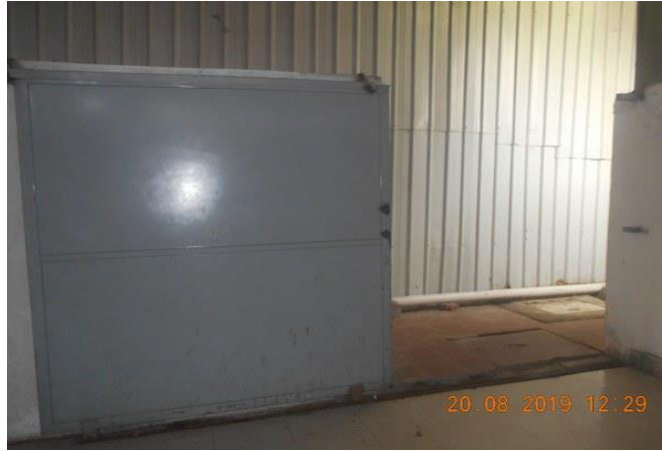
F-8	Egress	[Shed 5] A sliding gate was observed at the secondary exit of dining area.	<p>Replace all collapsible gates/ sliding doors/ rolling shutter doors along the means of egress with side-hinged, swinging (to the travel direction) egress doors.</p> <p>Provide panic exit hardware if occupant load exceeds 49 persons. Locking feature shall be in compliance with NFPA 101.</p>	Within 1 month
-----	---------------	--	---	-----------------------

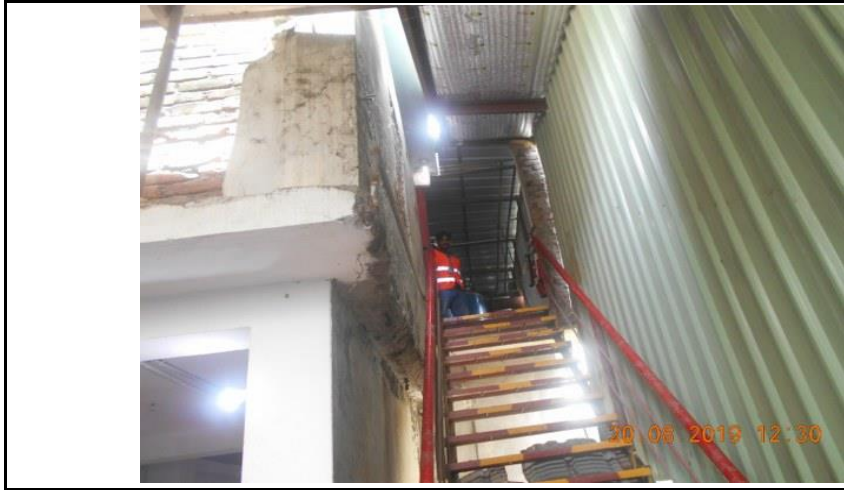
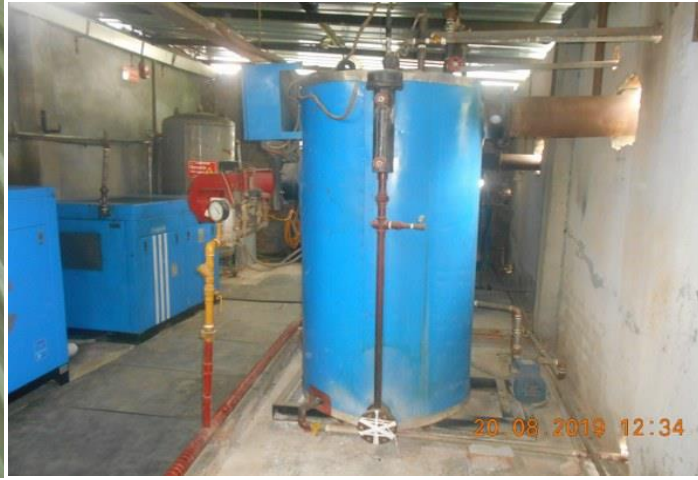
F-10	Fire Protection System	[Building 2] Fire pumps are not provided and appears to be needed as per Accord Building Standard 5.5.1	<p>Provide fire pumps.</p> <p>Installation of the new fire pumps shall be required to provide shop drawing & hydraulic calculations as outlined in NFPA 13, 20, 22 and 24. These drawings shall include all details as outlined in NFPA 13, 20, 22 & 24.</p> <p>All fire protection water supply system installation design documents shall be submitted for review by the Chief Safety Inspector of Accord prior to commencement of installation.</p> <p>Upon approval & installation the owner shall contact the Accord prior to conducting the final acceptance testing of the installation to allow the Accord the option of witnessing this testing & conduct a final inspection of the installation.</p>	Within 6 months
F-11	Fire Rated Construction	[Building 2] The boiler & compressor room is not separated by fire rated construction. (Unprotected opening with exit discharge of shed 5)	<p>Separate the boiler, generator & transformer rooms by a minimum 2-hr fire rated construction. Seal and/or protect all openings to maintain fire separations.</p> <p>Provide adequate ventilation as per manufacturer's requirement. Provide fire dampers of at least 2-hr rating interfaced with FACP if required.</p>	Within 3 months

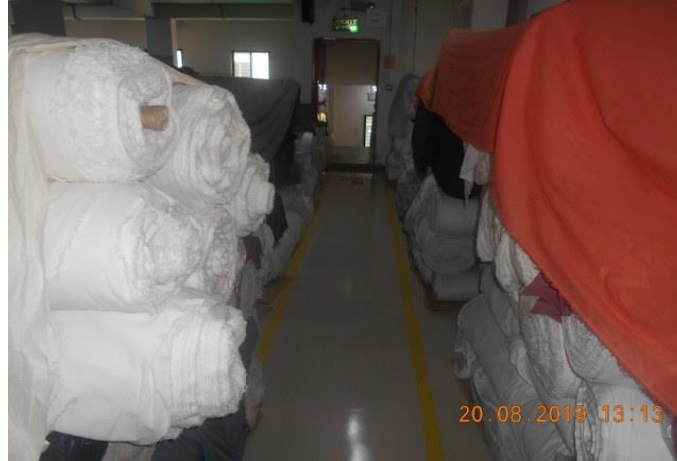
F-12	Egress	[Building 2] Aisles were not provided of adequate width specially at 1st floor.	Provide clear aisle width of minimum 36 inch. Aisle shall be cleared of any kind of obstruction.	<i>Within 1 month</i>
-------------	---------------	---	--	------------------------------

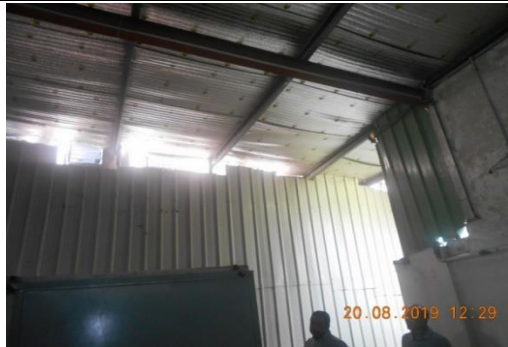
F-13	Egress Lighting	[Building 2] Secondary exit of dining was not provided with exit signages. Directional exit signs were missing at the change of exit direction.	Provide illuminated exit signs at every required exits. Provide illuminated directional exit signs where the change of direction is not obvious. Exit signs shall always be illuminated as long as the factory is occupied. Illumination at source shall be 50 lux at least.	Within 1 month
-------------	------------------------	---	--	-----------------------

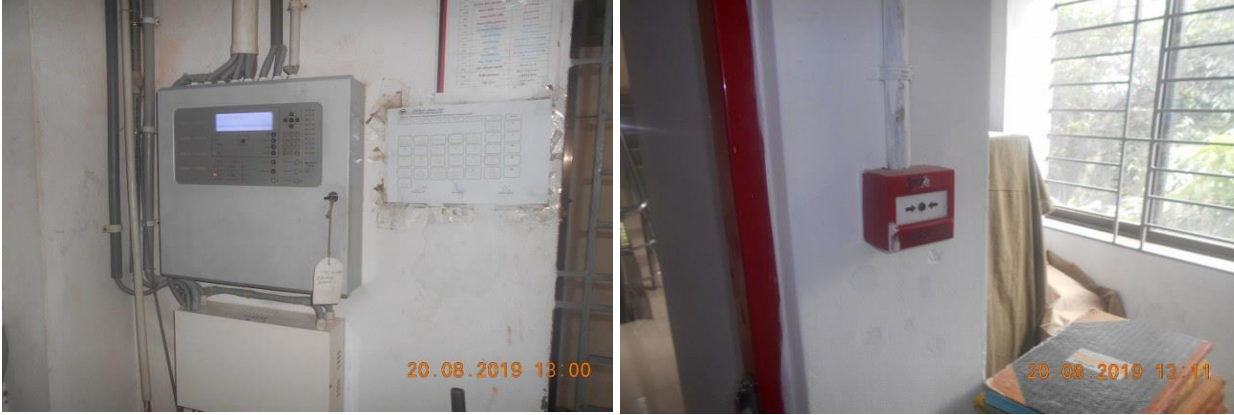
F-14	Fire Detection & Alarm	[Building 2] Fire detection & alarm system installation requires detailed review to confirm compliance with NFPA 72 and ACCORD standards	<p>Submit as-built drawings, testing records, equipment certification and other relevant documentation to the ACCORD for review and approval.</p> <p>Upon approval the owner shall contact the Accord prior to conducting the final acceptance testing of the fire detection & alarm system installation.</p>	Immediate
